AIRPROX REPORT No 2010174

Date/Time: 16 Dec 2010 1714Z NIGHT

Airspace: S TMA/Prestwick CTR (Class: D)

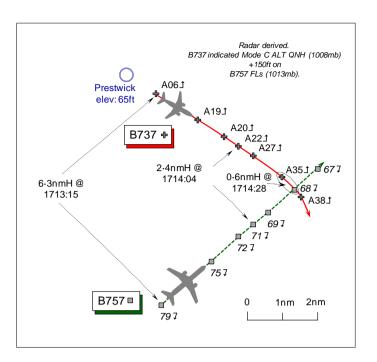
3250ft V @ 0.5nm min H

The B757 passed through the 12 o'clock of the B737 at a range of 0.6nm at 1714:28. The B737 was climbing through ALT 3500ft QNH (1008mb) as the B757 was descending through FL68, 6nm SE of Prestwick. Horizontal separation reduced to 0.5nm at 1714:32 as the B757 crossed into the B737's 11 o'clock. STCA did not activate on the GAL-T controller's situation display.

[UKAB Note (1): The B757 was displayed at FL068 within the Scottish TMA and the B737 at ALT 3700ft (1008mb) within the Prestwick CTR giving vertical separation of about 3250ft at minimum horizontal separation of 0.5nm.]
