AIRPROX REPORT No 2022015

Date: 09 Feb 2022 Time: 1017Z Position: 5248N 00240W Location: RAF Shawbury – elev 248ft

PART A: SUMMARY OF INFORMATION REPORTED TO UKAB

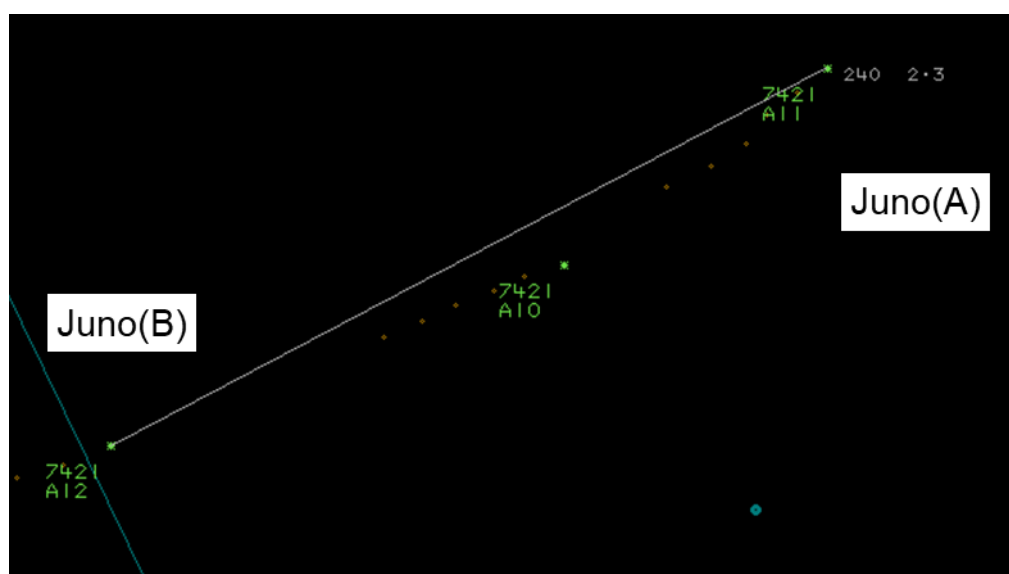
Figure 1: Juno (B) is instructed to make their approach to Area Right.

As part of the joining instruction to the Juno (B) pilot they were given Traffic Information detailing that there was “one other joining, one area right, Juno five and a half miles to land”. The join clearance was acknowledged by the Juno (B) pilot although only the one ahead was readback. The Aerodrome Controller broadcast the Juno (B) pilot’s intentions on the quiet frequency. Sixty-six seconds later the Juno (B) pilot was instructed to make their approach to Area Right, during this time the Aerodrome Controller gave a joining clearance to another VFR joiner providing them with accurate Traffic Information and assessed that the Juno (B) pilot would not have sufficient time to cross the runway ahead of the radar traffic. Separation was 2.3NM and 100ft.

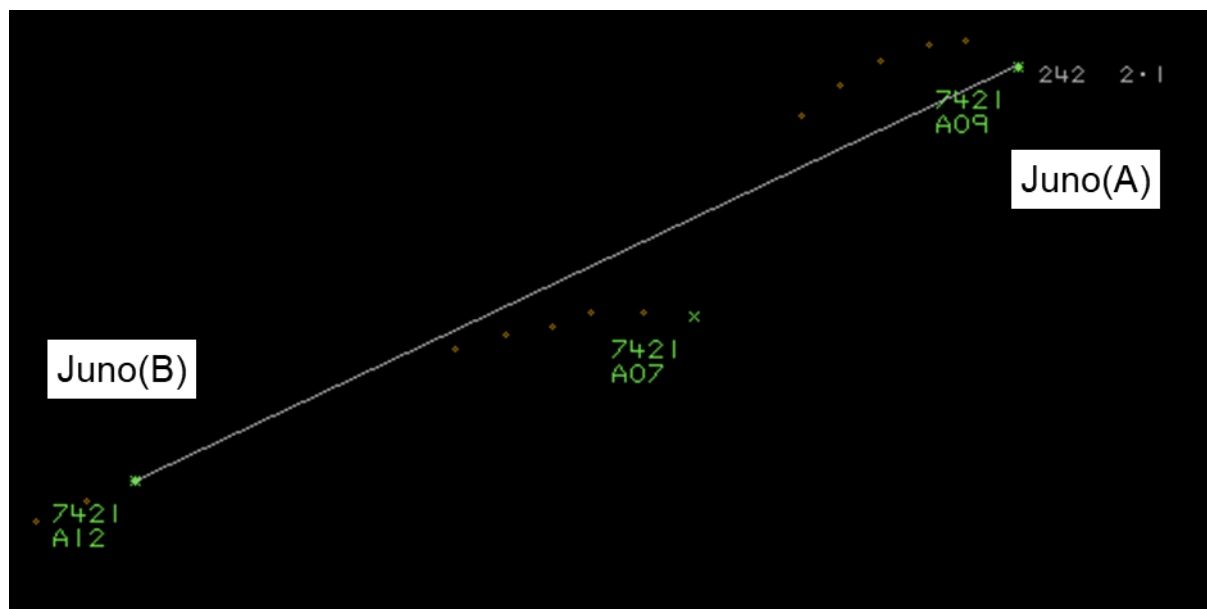
Figure 2: Juno (B) pilot acknowledges the change to Area Right.

Eighteen seconds later the Juno (B) pilot acknowledged the change to Area Right, delayed due to broken comms. Separation was measured at 2.1NM and 300ft.

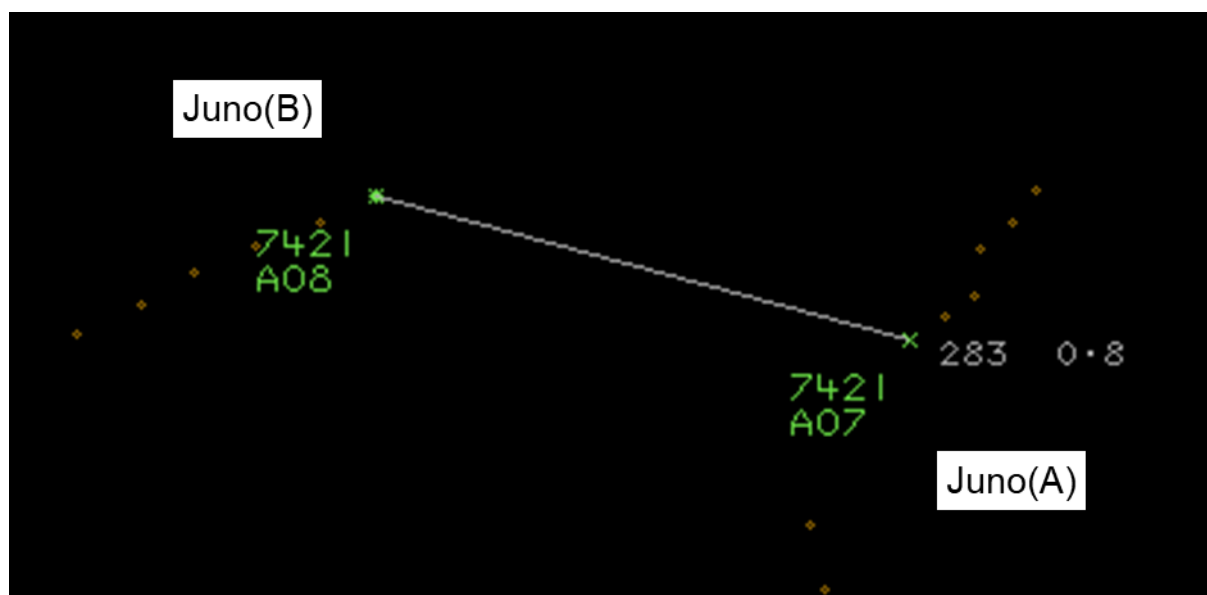
Figure 3: IFR traffic given a clearance

Thirty-nine seconds later the Aerodrome Controller provided a clearance to use the runway which was followed by a broadcast of intentions on both Aerodrome frequencies. Separation decreased to 0.8NM and 100ft.

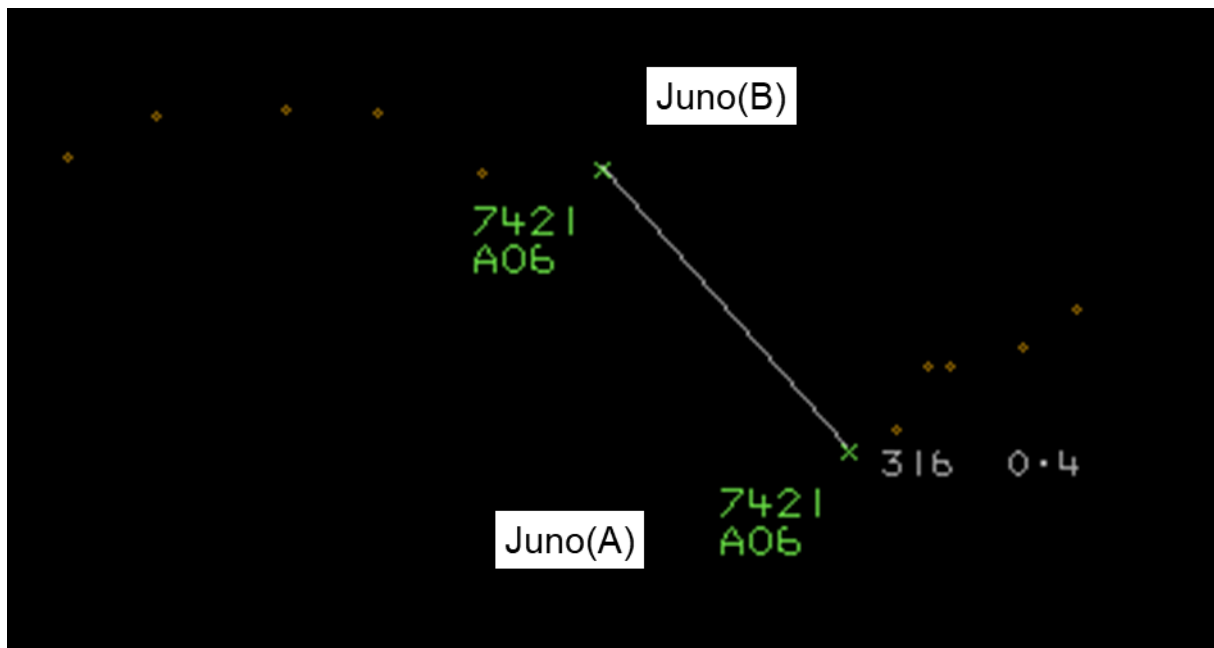
Figure 4: Juno (B) pilot broadcasts final to Area Right.

Fifteen seconds later the Juno (B) pilot broadcast that they were on final to Area Right, however, this was not broadcast on the Juno (A) pilot's frequency. Separation decreased to 0.4NM and 0ft.

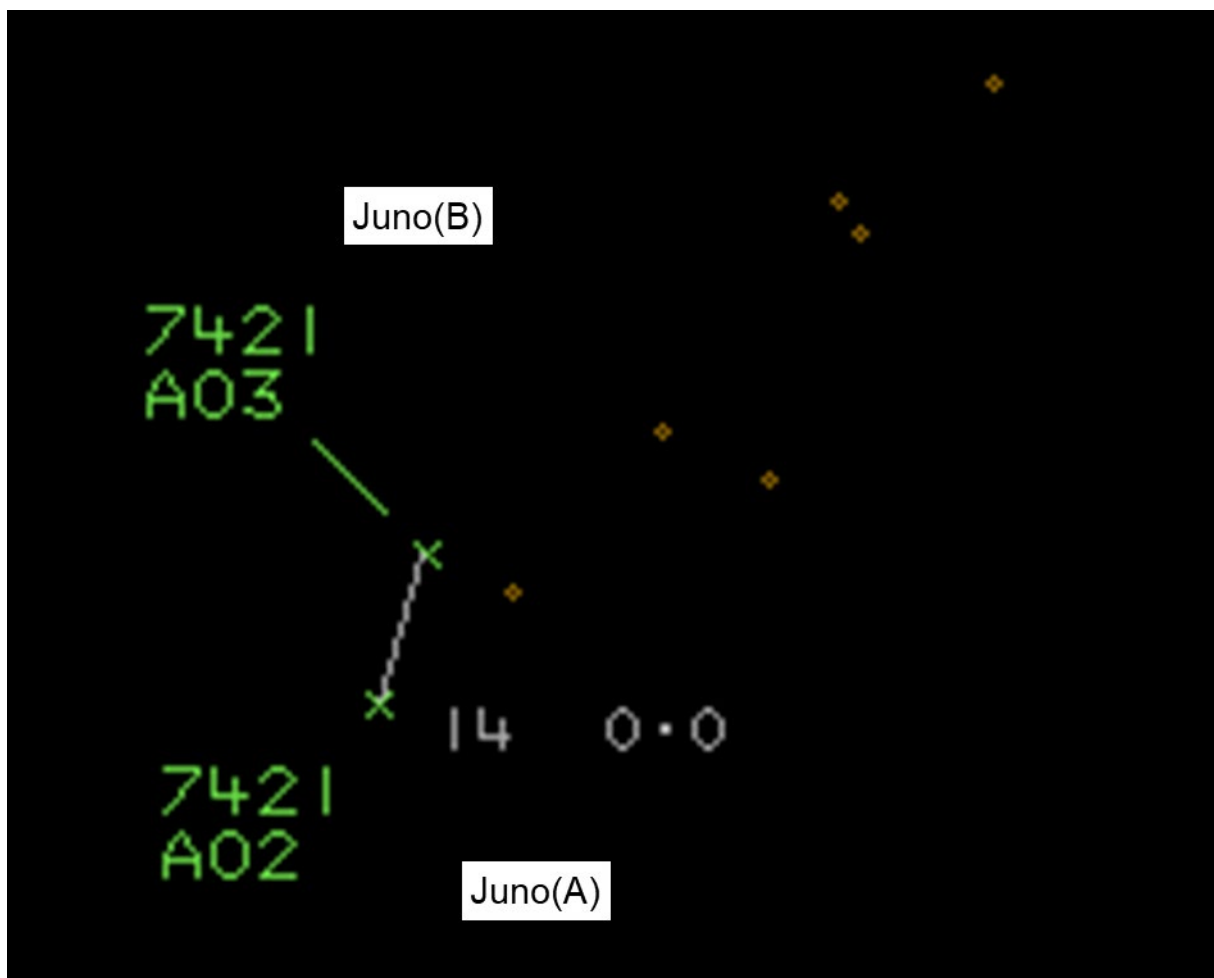
Figure 5: CPA.
