## AIRPROX REPORT No 2022030

Date: 14 Mar 2022 Time: 1531Z Position: 5159N 00118W Location: 3NM NW of Upper Heyford

### PART A: SUMMARY OF INFORMATION REPORTED TO UKAB

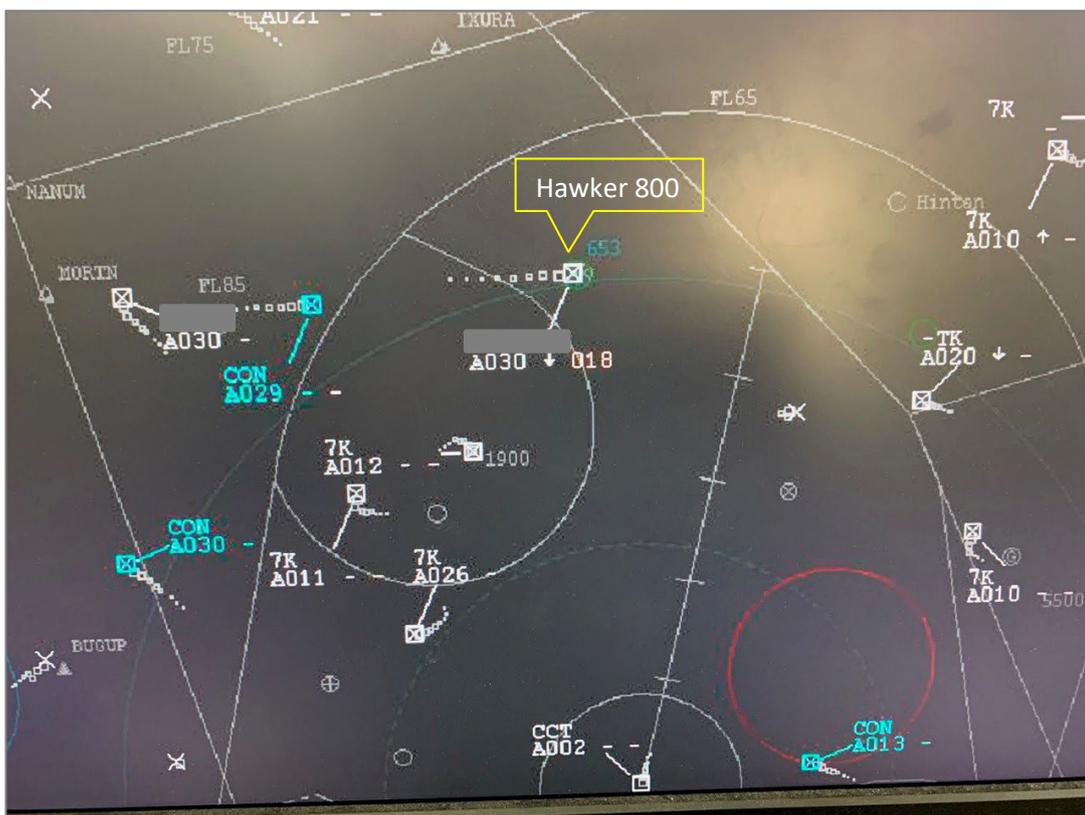
Figure 1 – Closing Heading & Primary Contact

Based on the report received, it is understood that this Airprox occurred on an approximately 7 mile final to Oxford’s RW19. Therefore, the Airprox is believed to have occurred at approximately **15:30**. Whilst the radar trainee was transmitting a closing heading to [the Hawker 800 pilot], a primary contact can be observed operating just east of the final approach track, but this faded whilst the transmission is being made (see Figure 1).

Owing to the sporadic nature of the return, it would be reasonable for the controller to dismiss this as clutter. Given the information available to Oxford, it also cannot be confirmed that this was the glider involved in this Airprox or was a true return of any aircraft for that matter. As noted in the initial review, a further primary contact was observed whilst the [Hawker 800] was turning and establishing on its closing heading (see Figure 2).

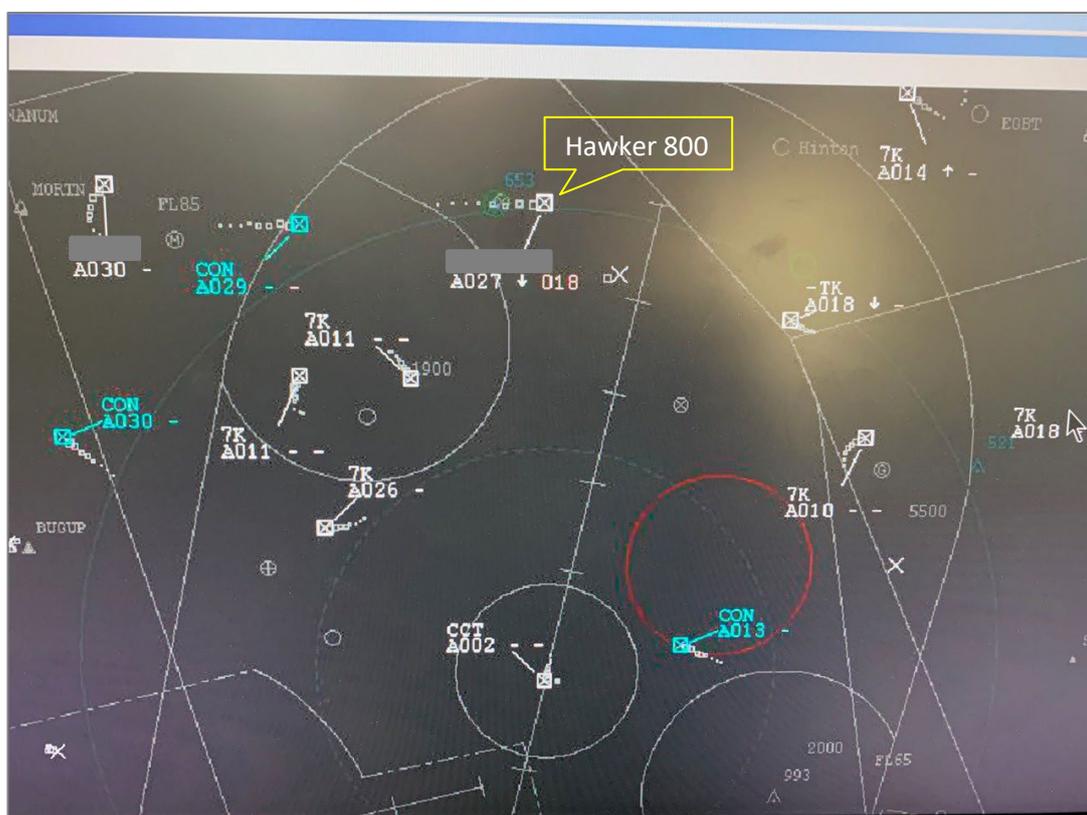
Figure 2 – Closing Heading & Primary Contact 2

Again, given the information available to Oxford it cannot be confirmed whether this was a true return from an aircraft or, if so, if this was the glider involved in the Airprox. There were no radar contacts observed in the vicinity when the aircraft was transferred from Radar to the Tower controller at time **15:32** (aircraft on a six mile file at this point).

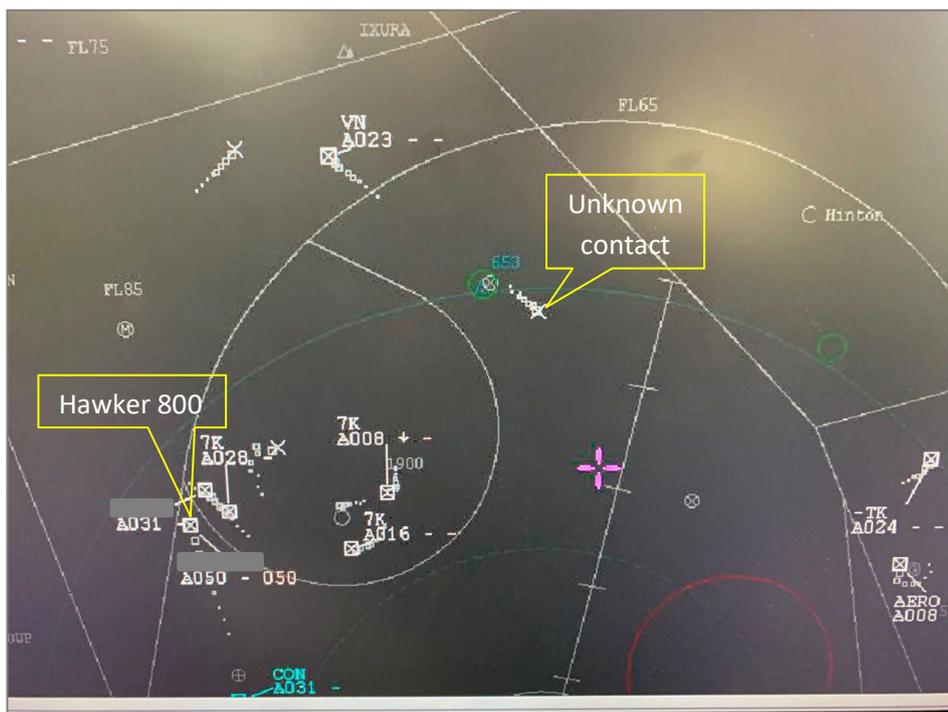
Figure 3 – Unknown Contact

On review of the radar replay, in the period preceding the Airprox there were various contacts observed in the vicinity of the final approach track. The most consistent of these was observed approaching the final approach track from the west, tracking eastbound. The contact was flying on a consistent track eastbound but this contact faded at time **15:29** whilst west abeam an eight mile final (see Figures 3 and 4). Owing to the limited resources available, this again cannot be verified as the aircraft to which this Airprox relates.
