**AIRPROX REPORT No 2022114**

Date: 22 Jun 2022 Time: 1552Z Position: 5110N 00106W Location: 3NM SW Lasham

**PART A: SUMMARY OF INFORMATION REPORTED TO UKAB**

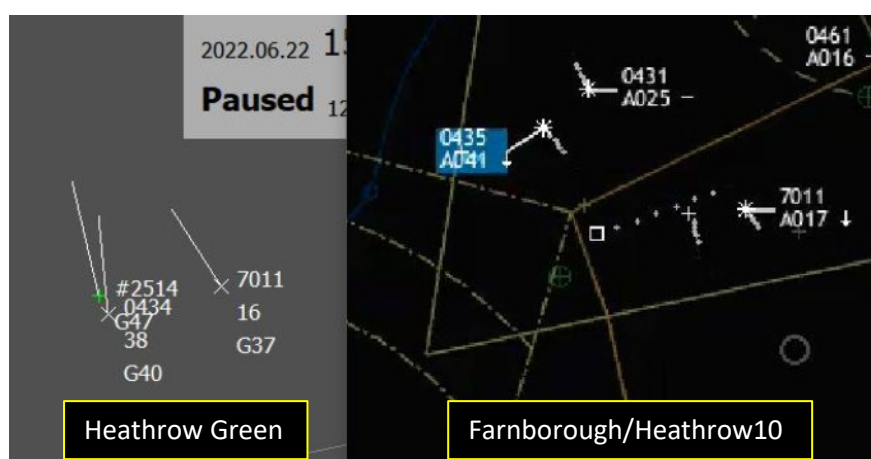
Figure 1 - 1549:00

Figure 1 below shows [the EV97's] Mode A not displaying on the Farnborough/Heathrow10 assigned radar, however the Heathrow Green<sup>1</sup> picked up [the EV97] and a glider, labelled as #0434 and #2514.

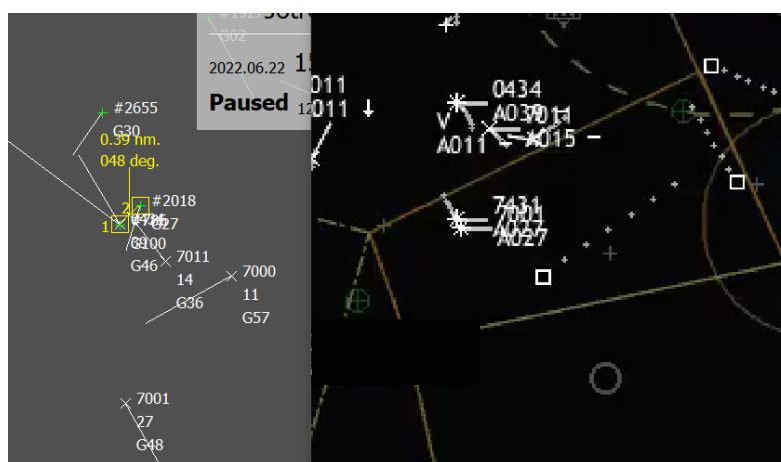
Figure 2 - 1551:28

At 1551:28 [the EV97] could be seen on radar tracking approximately 3NM southwest of Lasham and a primary radar return could be seen in the vicinity of the aircraft, but faded from radar. The Heathrow Green radar did pick up a contact of which [the EV97] passed within 0.39NM, height unknown, Figure 2.

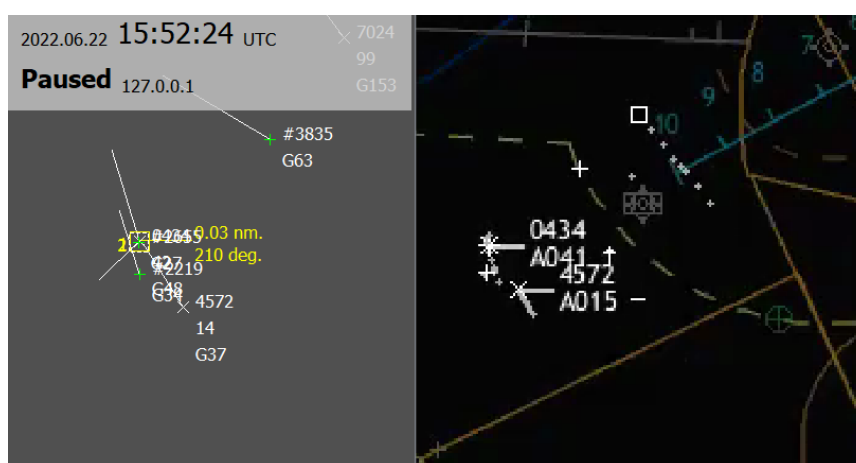
Screenshot 3 - 1552:24

At 1552:24, [the EV97] could be seen on radar 3NM west-southwest of Lasham, tracking northwest-bound, and was observed to overfly a primary return, which was seen on the Heathrow Green, they got within 0.02NM, height unknown.
