## AIRPROX REPORT No 2022118

Date: 22 Jun 2022 Time: 0931Z Position: 4955N 00618W Location: Isles of Scilly

### PART A: SUMMARY OF INFORMATION REPORTED TO UKAB

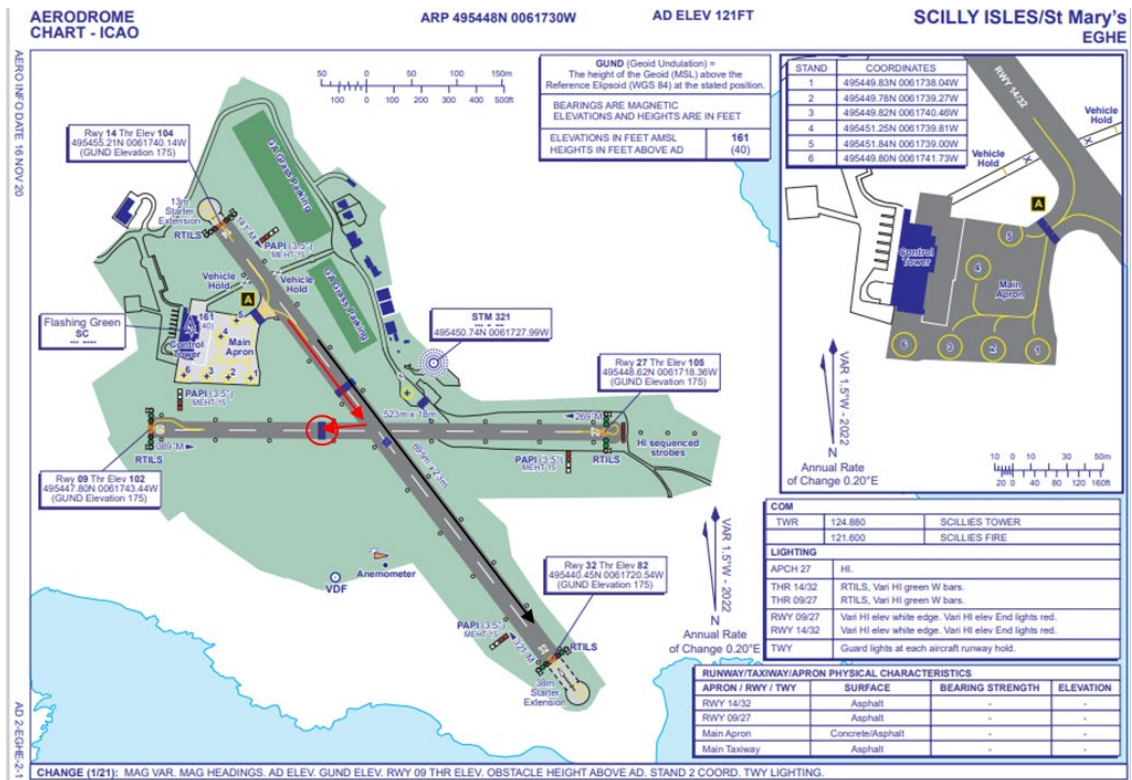
Taxi route and intermediate holding point of the DHC6 (in red). Taxi route of the DA40 (in black).

When the DHC6 pilot reported ready for taxi, the controller started to issue line-up instructions and then realised that the runway was occupied by the DA40 and instructed the DHC6 pilot to hold position. The DHC6 pilot was subsequently issued with taxi instructions to an intermediate holding point on RW09 via the runway in use.

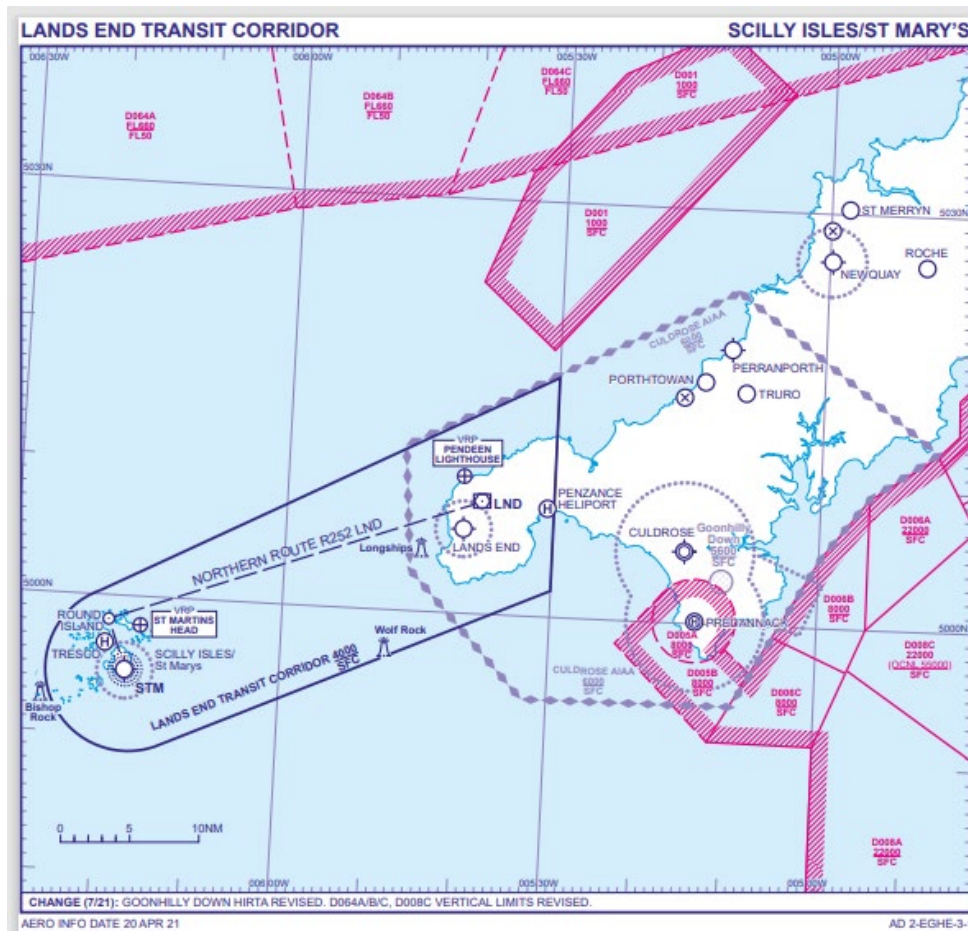
Map (orientated with north at the top) detailing the position of each of the islands that were used as reporting points.
