AIRPROX REPORT No 2022165

Date: 07 Aug 2022 Time: 0931Z Position: 5312N 00116W Location: 4NM NW Mansfield

PART A: SUMMARY OF INFORMATION REPORTED TO UKAB

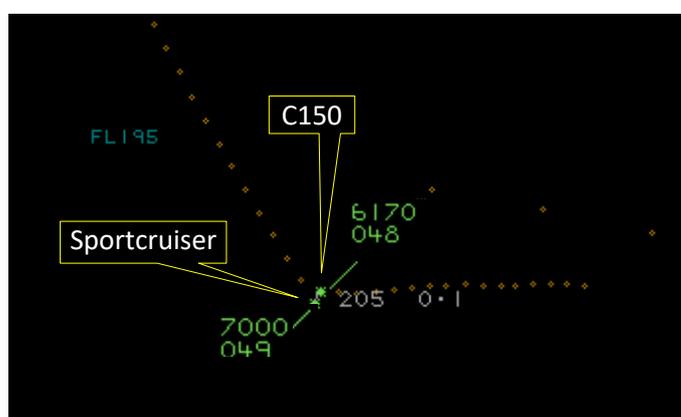
Figure 1 - CPA at 0931:28

An analysis of the NATS radar replay was undertaken and the Sportcruiser could be positively identified from Mode S data (see Figure 1). The C150 pilot was traced from information available to the Secretariat. The CPA was assessed and the diagram constructed from the radar replay.

The squawk displayed by the C150 (6170) is listed with the description that it 'may be used when flying in the vicinity of Doncaster Sheffield, operating outside of Doncaster Sheffield CTR/Doncaster Sheffield CTA and monitoring Doncaster Sheffield radar frequency'.
