AIRPROX REPORT No 2022218

Date: 21 Sep 2022 Time: 1412Z Position: 5124N 00142W Location: 1.5NM SE Marlborough

PART A: SUMMARY OF INFORMATION REPORTED TO UKAB

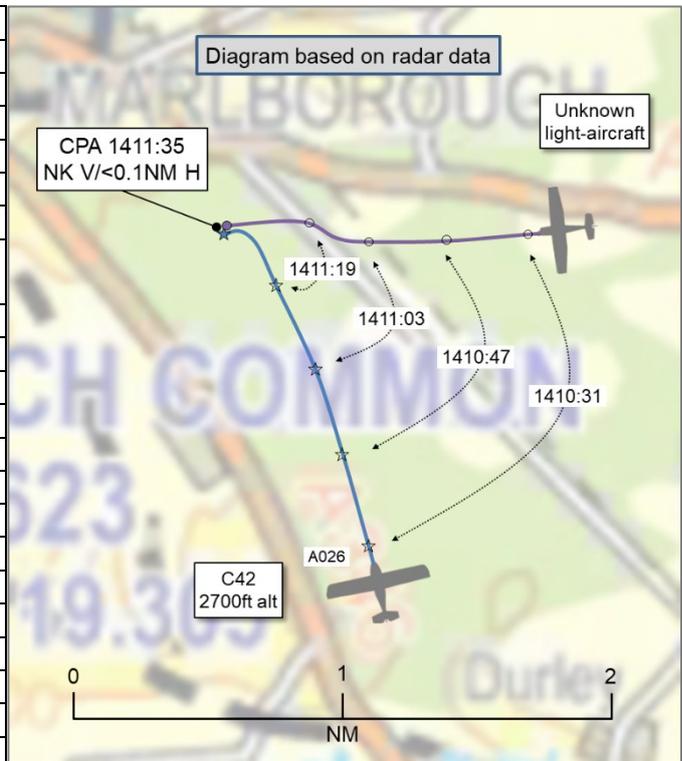
An analysis of the NATS radar replay was undertaken and the C42 was detected and identified using Mode S data. The unknown light-aircraft was detected as a primary-only radar contact with no associated data to enable identification. Extensive and exhaustive efforts were made to trace the unknown light-aircraft, which involved attempting to identify either the departure or destination airfield; however, the primary-only radar return faded and so this was not possible. Airfields in the locality of the Airprox were contacted, none had had any aircraft movements that could have been the unknown light-aircraft.

The C42 pilot's reported left turn avoiding action was detected and recorded by the radar one radar sweep, 4secs, before CPA, and their reported orbit was observed after CPA.

The primary-only return of the unknown light-aircraft was subject to a small amount of radar jitter and, although the trace shows a track adjustment prior to CPA this may not be entirely representative of the aircraft's actual flight path.
