AIRPROX REPORT No 2022249

Date: 04 Oct 2022 Time: 1603Z Position: 5204N 00045W Location: 6NM W Cranfield

PART A: SUMMARY OF INFORMATION REPORTED TO UKAB

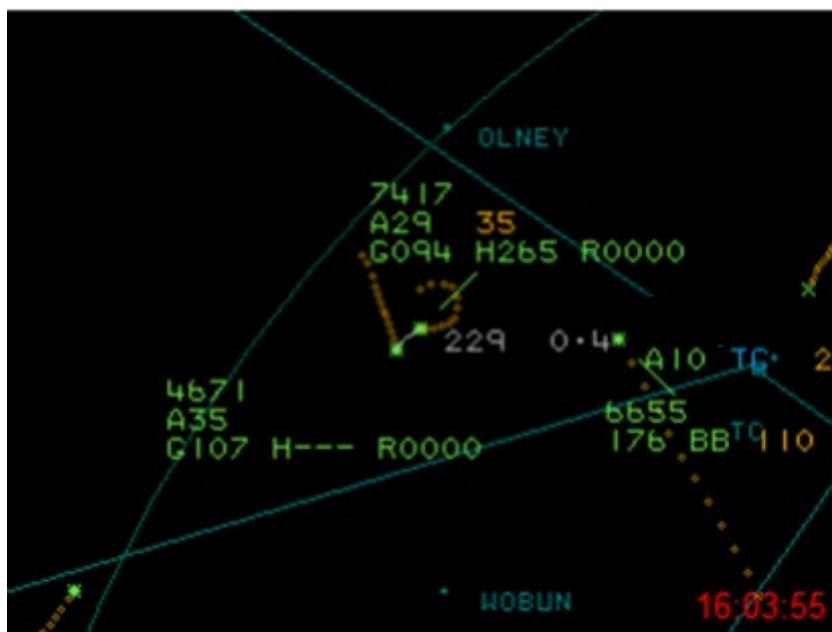
Figure 1 - CPA measured on the Multi-Track Radar as 0.4NM and 600ft.

The GW INT controller was then occupied with a stream of Luton arrivals, together with coordinating a runway lighting check and an aircraft crossing the final approach track. [EC155 C/S] continued tracking towards the Luton zone whilst an aircraft displaying Mode A code 7417, the Cranfield Airport IFR Conspicuity code, was tracking in a north-northeasterly direction at the same level. Mode S data identified this aircraft as [DA40 C/S]. This aircraft initially passed approximately 1NM ahead of [EC155 C/S] indicating the same altitude (3500ft), however the aircraft entered a right-hand orbit and descended to an indicated altitude of 2900ft. This turn brought [DA40 C/S] closer to [EC155 C/S], with the Closest Point of Approach (CPA) occurring at 1603:55 (Figure 1).

An analysis of the NATS radar replay was undertaken, both aircraft were identified using Mode S data. As referenced in the NATS investigation report, at 1602:59 the DA40 crossed 1.4NM ahead and at the same level as the EC155, see Figure 2. The DA40 then descended and turned back towards the EC155 until CPA (Figure 1).
