AIRPROX REPORT No 2022252

Date: 20 Oct 2022 Time: 1418Z Position: 5038N 00220W Location: 6.5NM NE Portland Bill

PART A: SUMMARY OF INFORMATION REPORTED TO UKAB

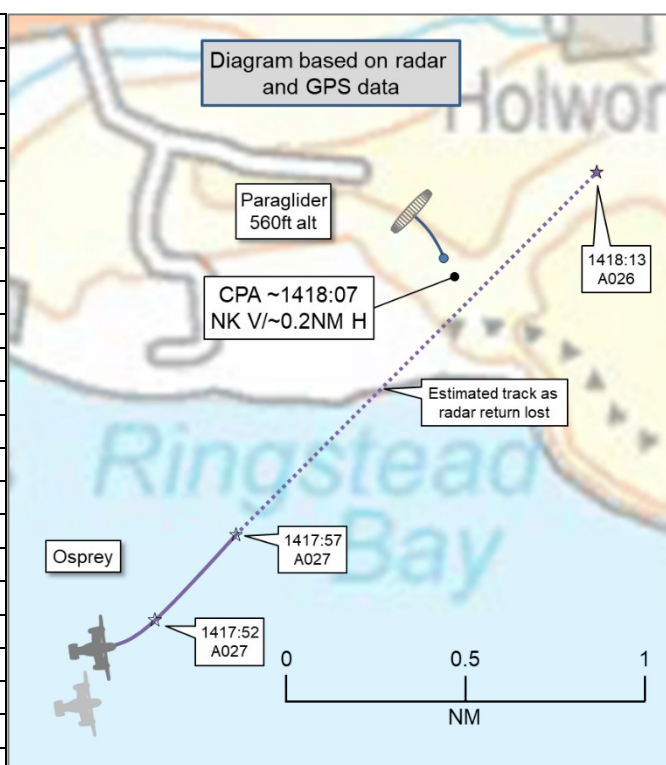
Recorded	Aircraft 1	Aircraft 2
Aircraft	Paraglider	Osprey
Operator	Civ Hang	Foreign Mil
Airspace	London FIR	London FIR
Class	G	G
Rules	VFR	VFR
Service	None	Basic
Provider	N/A	Yeovil Approach
Altitude/FL	560ft	NK
Transponder	Not fitted	A, C, S
Reported		
Colours	NR	Grey
Lighting	Nil	Nav
Conditions	VMC	VMC
Visibility	5-10km	>10km
Altitude/FL	600ft	2000ft
Altimeter	amsl (NK hPa)	amsl (NK hPa)
Heading	NK	NR
Speed	NK	NR
ACAS/TAS	FLARM	Other ¹
Alert	Unknown	Unknown
Separation at CPA		
Reported	400ft V/<500ft H	'Well clear'
Recorded	NK V/~0.2NM H

An analysis of the NATS radar replay was undertaken and, although the Osprey pilots were operating as a pair, only one Osprey had been detected, and its radar return had been intermittent. The paraglider was not detected by the NATS radars, however, the paraglider pilot kindly supplied the UKAB Secretariat with a GPS data file detailing their flight. The diagram has been produced by combining the two data sources. It has not been possible to determine which of the Ospreys the radar detected nor, due to the intermittent radar return, its exact track and altitude at the time it passed the Paragliders' position. Therefore, only the lateral separation has been measured and this has been recorded as an approximation.

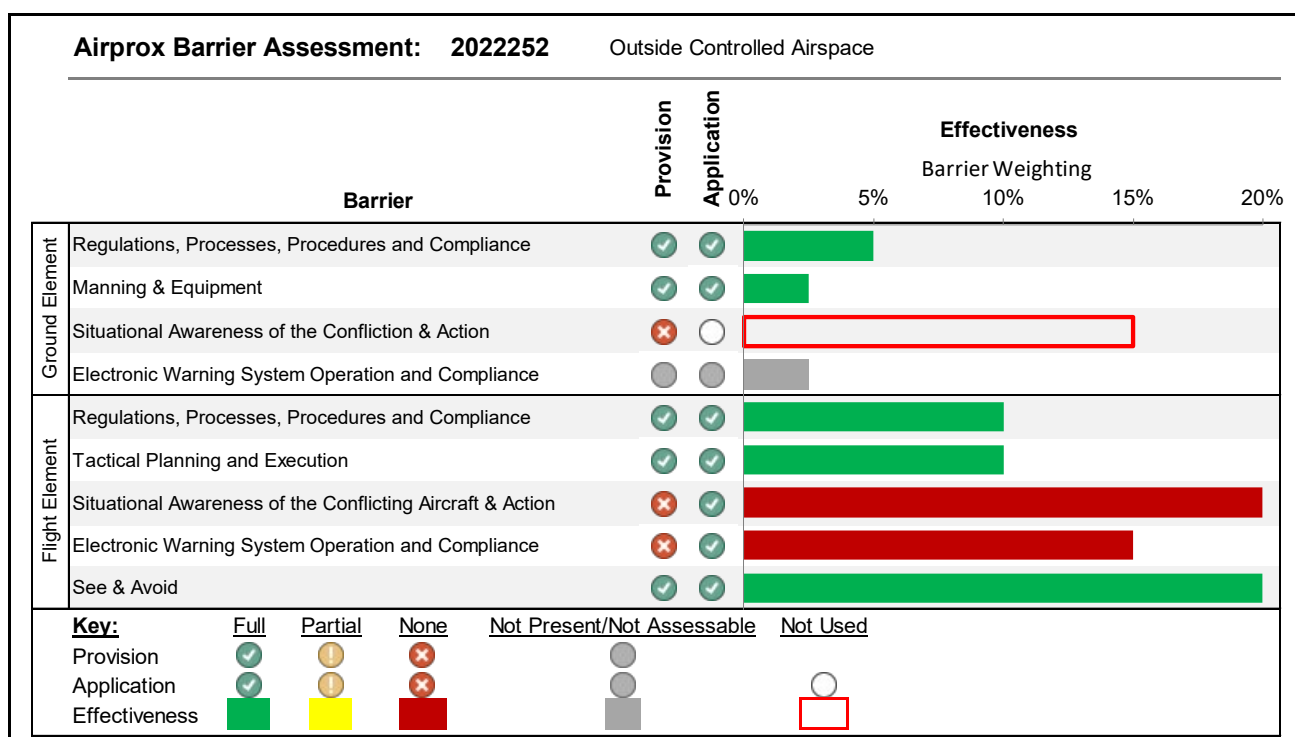
Safety Barrier Assessment⁷

Situational Awareness of the Confliction and Action were assessed as **not used** because, under the Basic Service that the Yeovil Approach controller had been providing, they had not been required to monitor the flight of the Ospreys.

Situational Awareness of the Conflicting Aircraft and Action were assessed as **ineffective** because the Osprey pilot had only had a generic awareness of the likelihood of the presence of the paraglider from the NOTAM, and the Paraglider pilot had not had any awareness of the presence of the Osprey prior to sighting it.

Electronic Warning System Operation and Compliance were assessed as **ineffective** because the EC equipment carried by the Paraglider pilot had been unable to detect, and therefore incompatible with, equipment carried by the Osprey pilot.
