## AIRPROX REPORT No 2022254

Date: 18 Oct 2022 Time: 0930Z Position: 5336N 00032W Location: 7NM WNW Humberside

### PART A: SUMMARY OF INFORMATION REPORTED TO UKAB

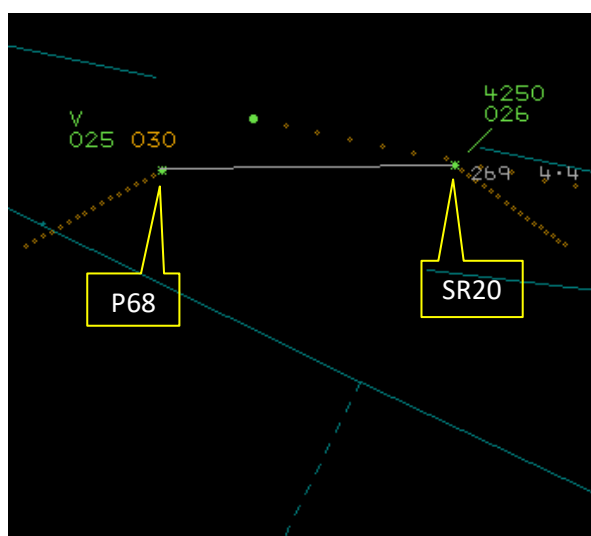
Figure 1 – 0929:21

An analysis of the NATS radar replay was undertaken. Both aircraft could be identified using Mode S information. At 0929:11 the P68 had changed from a Doncaster squawk to a VFR squawk (7000), the aircraft were 4.5NM apart, the P68 indicating FL025 and the SR20 indicating FL026, see Figure 1.

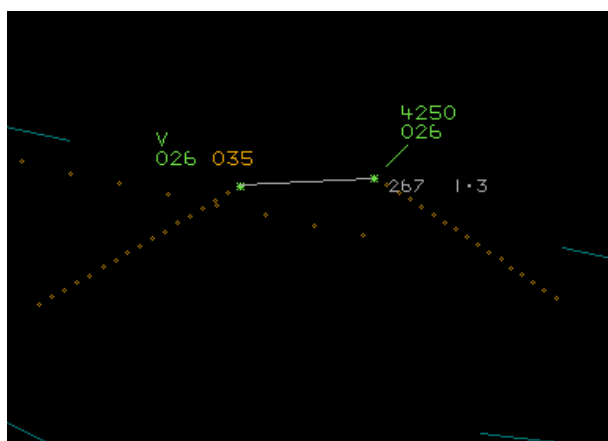
Figure 2 – 0930:03

At 0930:03, with the two aircraft 1.3NM apart, the P68 began to climb (see Figure 2). The P68 climbed to FL027 until, at 0930:27, the two aircraft crossed between radar sweeps (Figure 3).
