**AIRPROX REPORT No 2023007**

Date: 20 Jan 2023 Time: ~1542Z Position: 5430N 00540W Location: 5NM S Newtownards

**PART A: SUMMARY OF INFORMATION REPORTED TO UKAB**

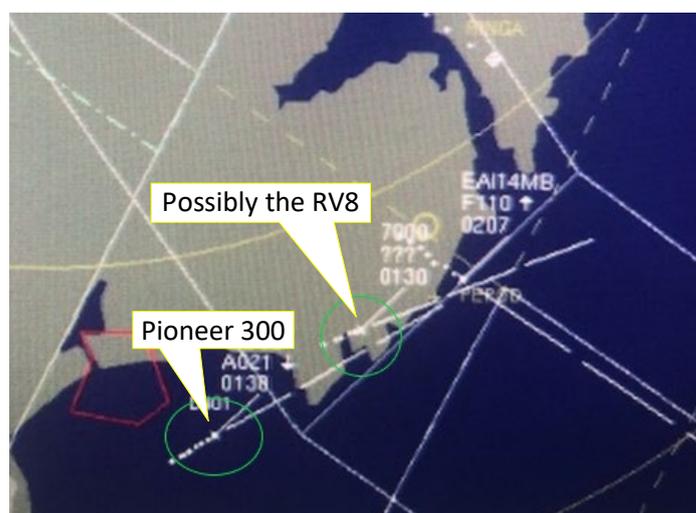
At 1535:20, [the Pioneer 300] and the 7000 squawk were visible on radar simultaneously; at this point, the contacts were a little over 5NM apart (see Figure 1).

Figure 1 – 1535:20. The last moment that the Pioneer 300 and the aircraft squawking 7000 (presumed to have been the RV8) were visible on radar simultaneously.
