**AIRPROX REPORT No 2023003**

Date: 09 Jan 2023 Time: 1334Z Position: 5121N 00033W Location: Fair Oaks ATZ

**PART A: SUMMARY OF INFORMATION REPORTED TO UKAB**

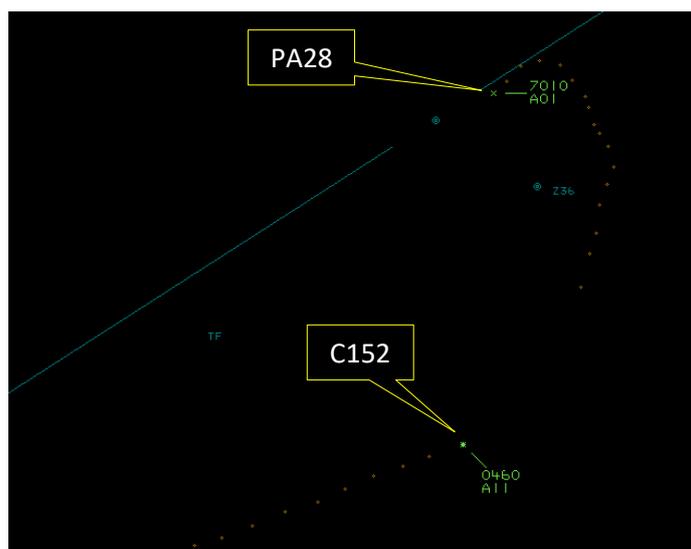
Figure 1 – 1330:47. The PA28 pilot performed a go-around as the C152 pilot was on the downwind leg

The PA28 faded from radar as the pilot performed a go-around at approximately 1331 (see Figure 1) and it reappeared on radar at 1331:25 in the position marked by the purple circle in Figure 2. At that moment, the C152 had been at the position marked by the blue circle in Figure 2. Subsequently, the C152 and PA28 followed the blue and purple lines respectively (see Figures 3 to 8) to the point of CPA at 1333:47 marked by the black star.

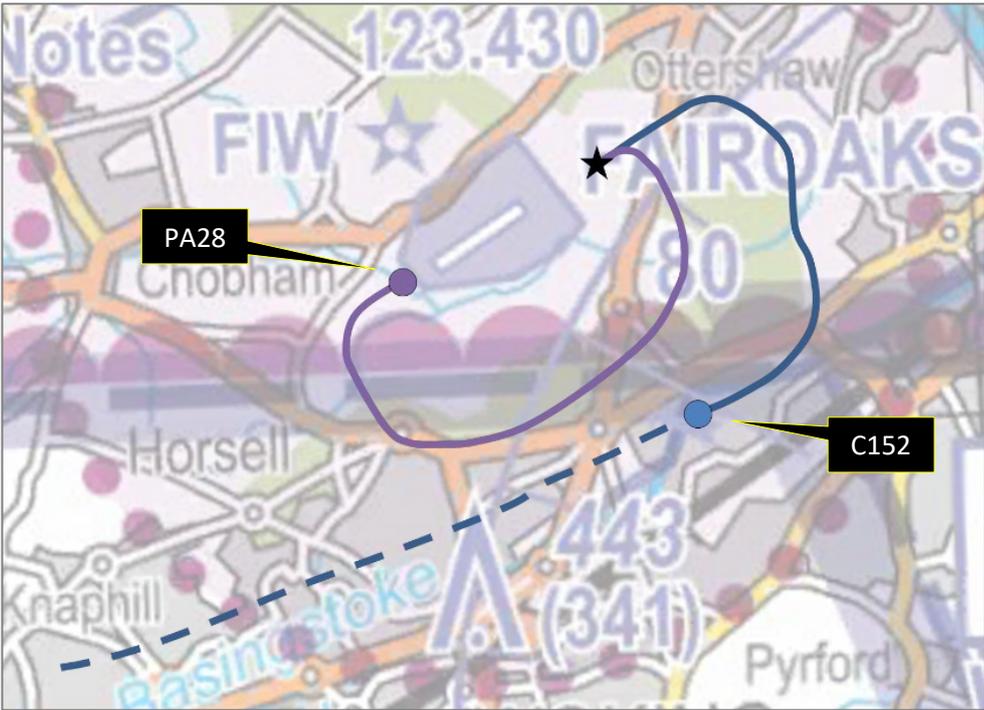
Figure 2 – The tracks flown by each aircraft. The coloured circles represent the positions of the aircraft at 1331:25

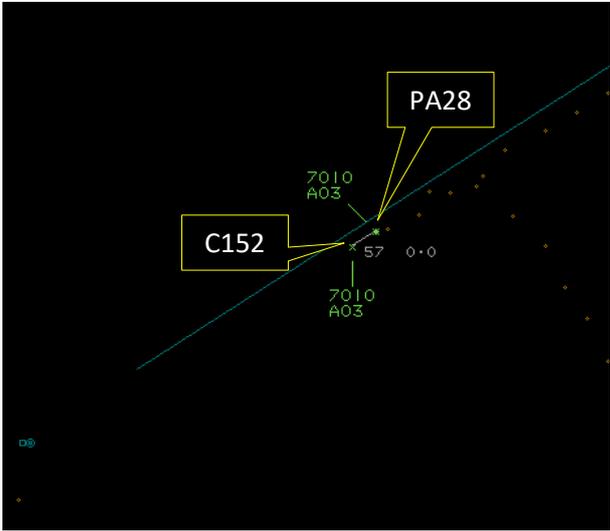
Figure 8 – CPA at 1333:47

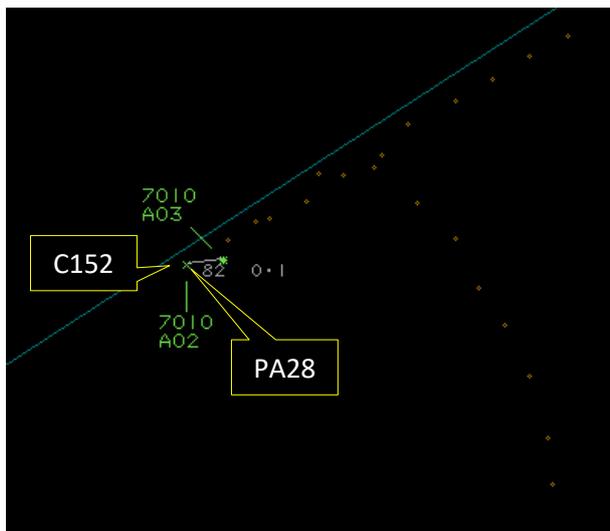
Figure 9 - 1333:51

After CPA, the two aircraft were observed to have been within 100ft and 0.1NM for approximately a further 12sec, before the pilot of the PA28 turned left by 30° and started to climb (see Figures 9 and 10).
