AIRPROX REPORT No 2023031

Date: 15 Mar 2023 Time: 1207Z Position: 5712N 00147E Location: 4NM west Culzean Oil Rig

PART A: SUMMARY OF INFORMATION REPORTED TO UKAB

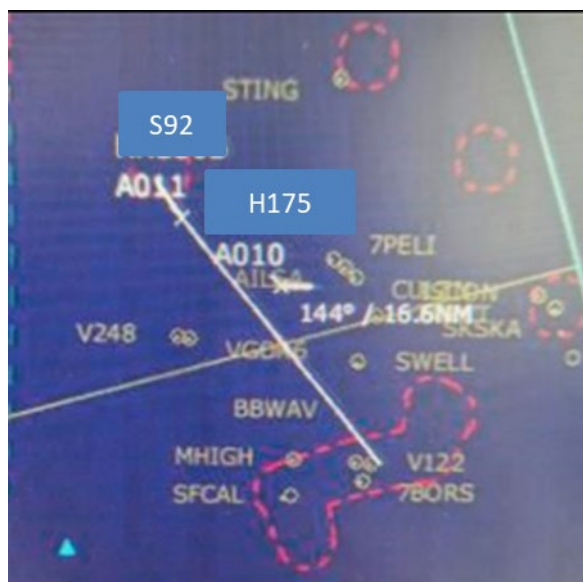
Figure 1

1205:37 the H175 reached 1000ft, the same altitude as the S92, and started to track west towards Aberdeen. Lateral separation between the S92 and H175 was 6.20NM/100ft (Figure 1).

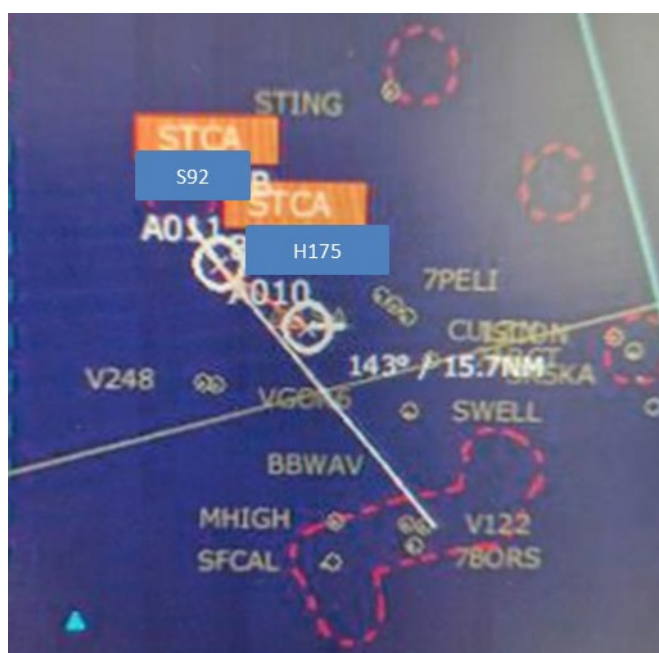
Figure 2

1205:58 The RDP STCA flashed an amber warning. The REBROS trainee was still passing Traffic Information to [another aircraft]. Both the S92 and the H175 were at 1000ft and separation between them was 4.75NM/100ft (Figure 2).

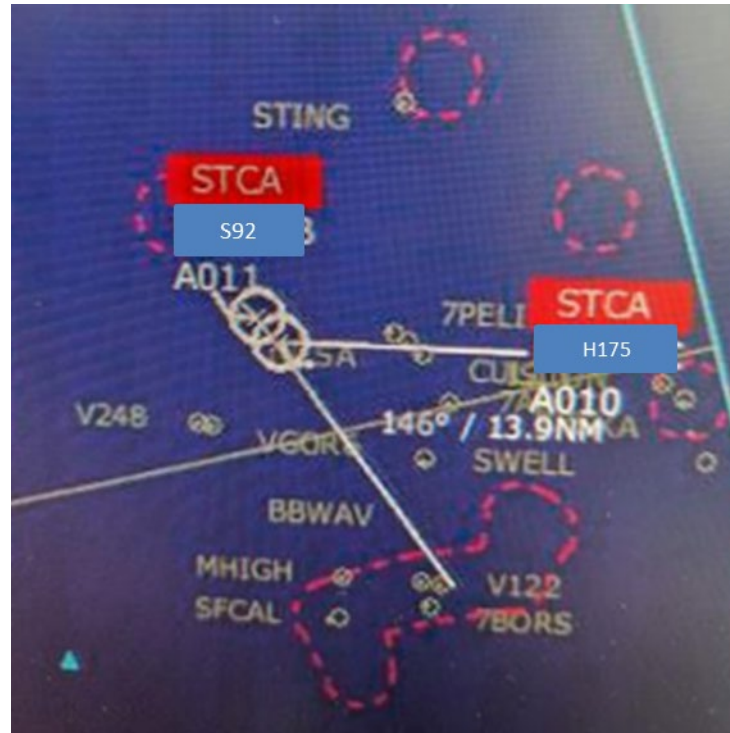
Figure 3

1206:48 the H175 had made a right turn to face north and at the same time the S92 had made a left turn, east which put the aircraft into closer conflict. Separation between the S92 and H175 was 1.33NM/125ft (Figure 3).

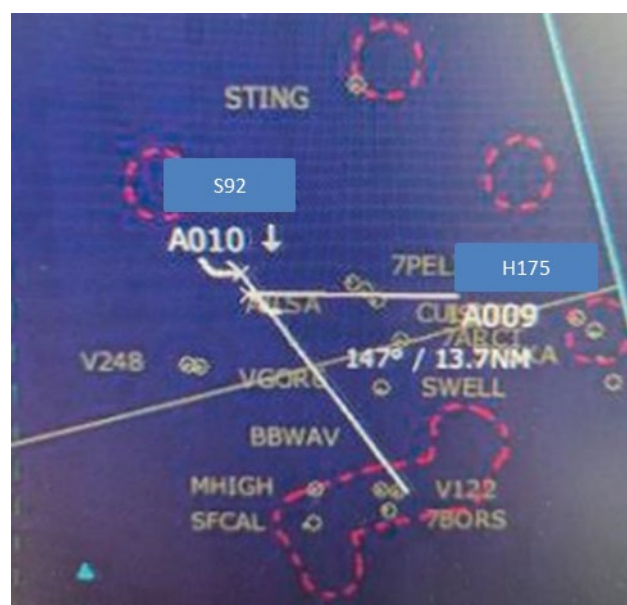
Figure 4

1206:56 the S92 and H175 were at their Closest Point of Approach, both were at 1000ft with a separation of 1.07NM/75ft.(Figure 4)

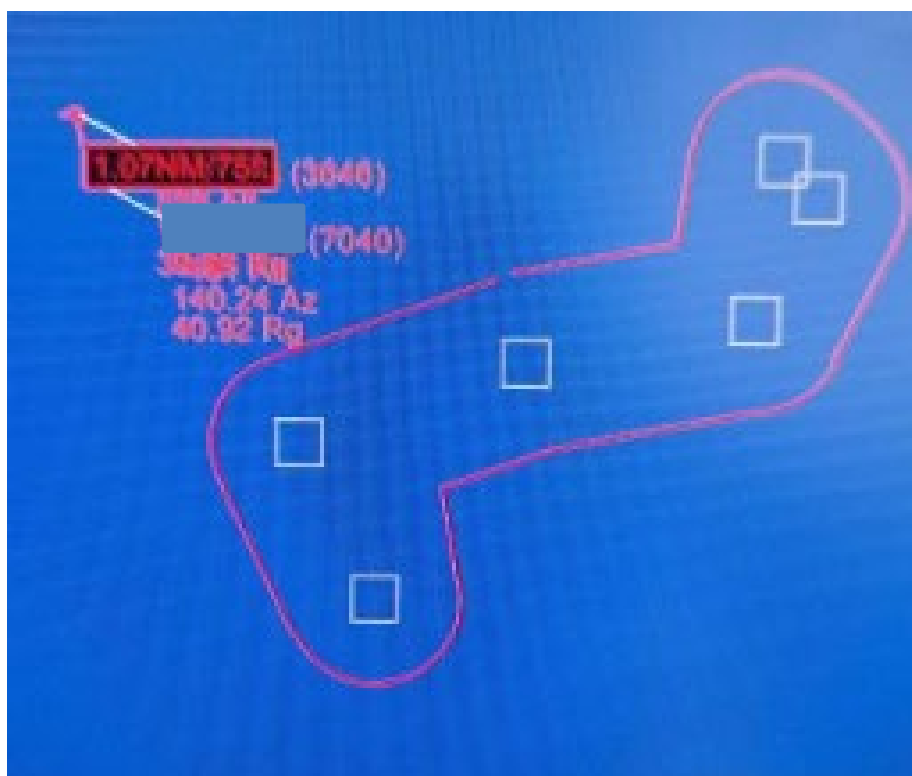
Figure 5

1206:56 RDP raw data recording showed a separation of 1.07NM/75ft between the S92 and the H175 (Figure 5).
