AIRPROX REPORT No 2023038

Date: 03 Apr 2023 Time: 0920Z Position: 5135N 00109W Location: Wallingford, Oxfordshire

PART A: SUMMARY OF INFORMATION REPORTED TO UKAB

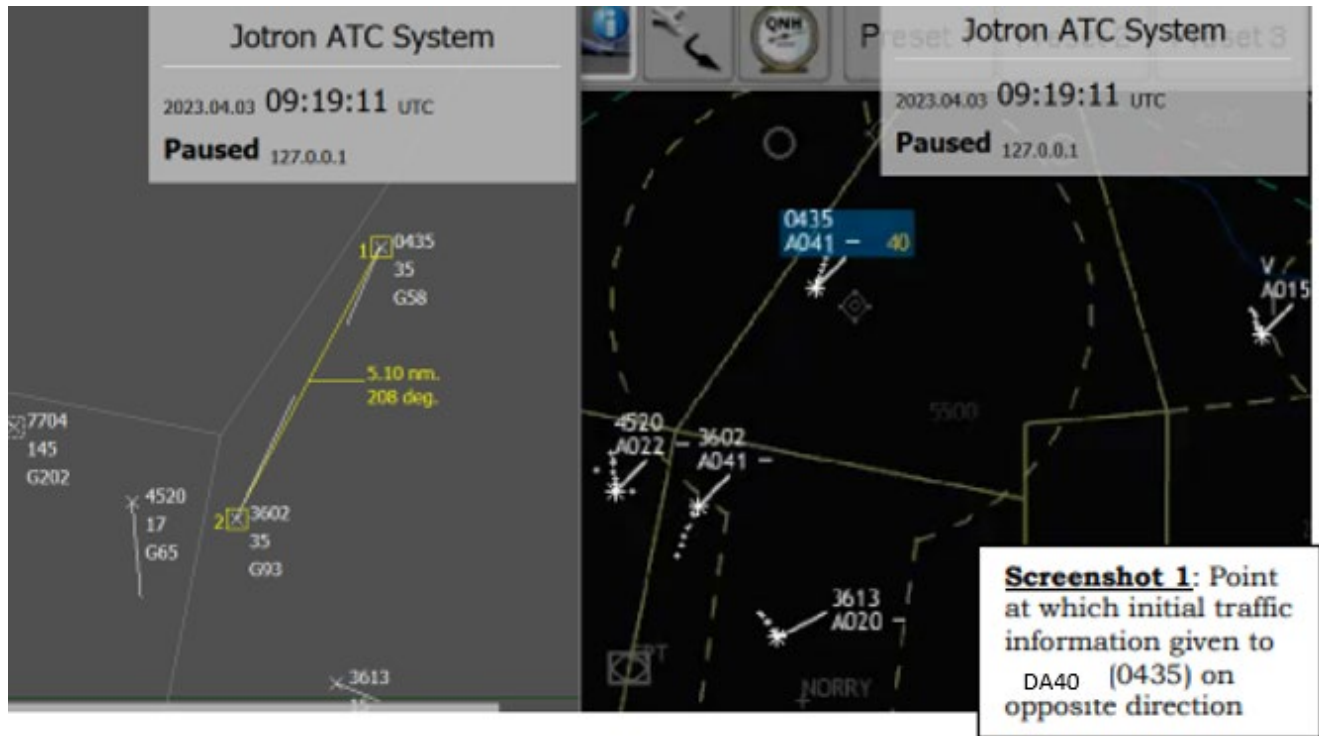
Figure 1

Radar data indicated that the pilots were at 5.22NM opposite direction when the following Traffic Information was passed (Figure 1):

```
0919:07 - ATC: [DA40 C/S] traffic 1 o'clock 5NM opposite direction indicating 4000ft working Benson
0919:12 – DA40: Roger [C/S]
```

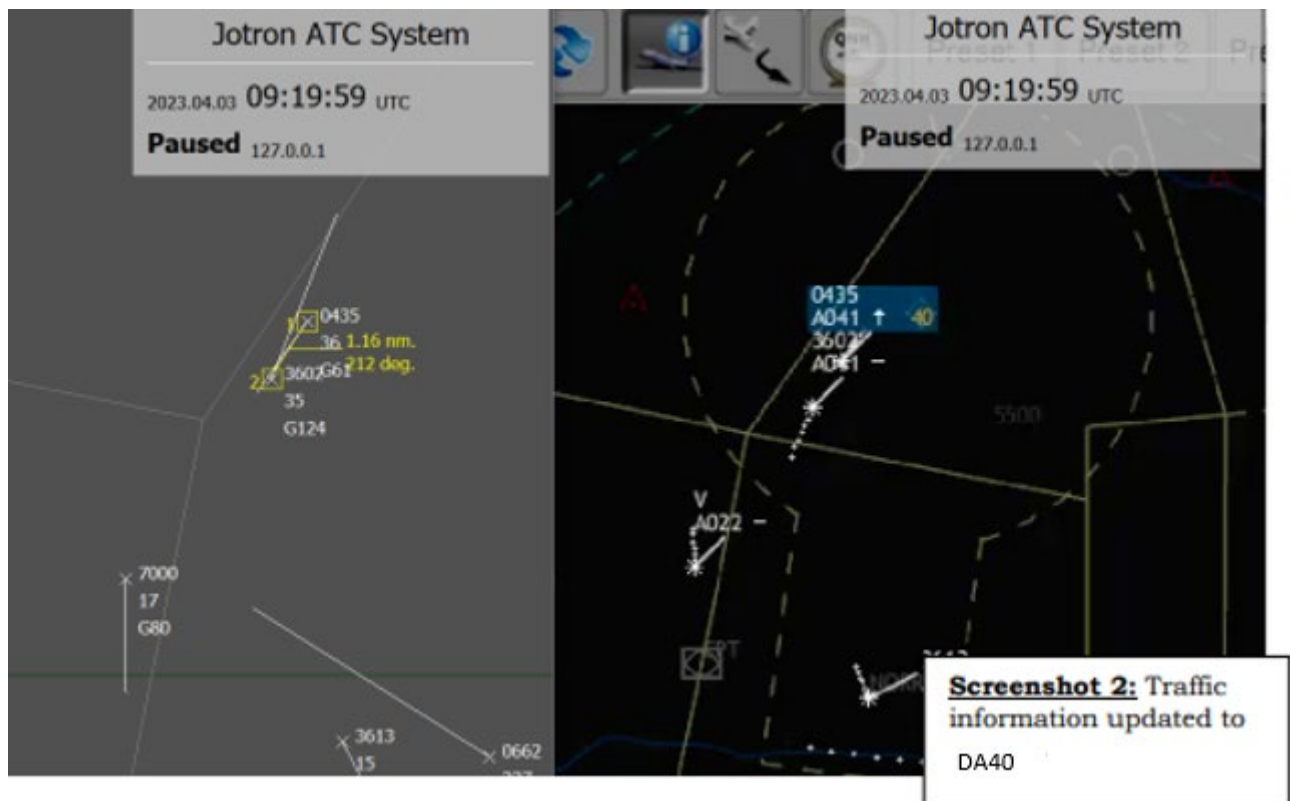
Figure 2

When the radar contacts were 1.15NM, opposite direction, the Traffic Information was updated (Figure 2).

0919:59 - ATC: [DA40 C/S] that traffic is 12 o'clock 1.5NM opposite direction same level.

0920:04 – DA40: In sight [C/S]

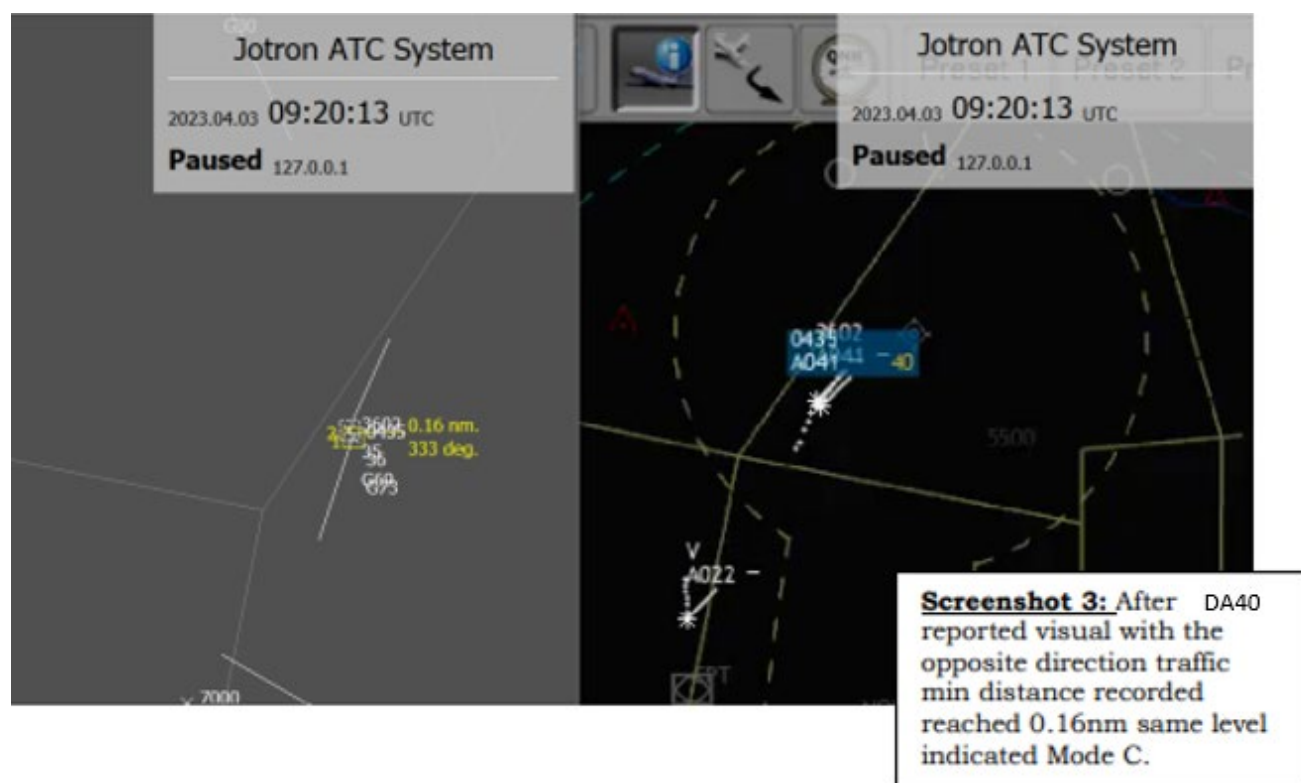
Figure 3

The contacts then passed at 0.16NM with the same level indicated Mode C, passing down the right-hand side of each other with [DA40 C/S] tracking south-westerly and [DA42 C/S] tracking north-easterly. This was the minimum observed distance between the two contacts (Figure 3).

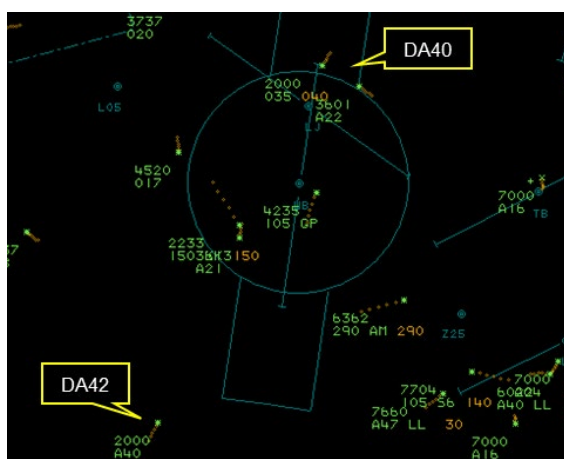
Figure 1 (0916:37). The DA42 contacted the Benson Zone controller.

At 0916:37, the DA42 pilot contacted the Benson Zone controller and requested a Basic Service, to which a Benson SSR code (3602) was issued, and Basic Service applied.

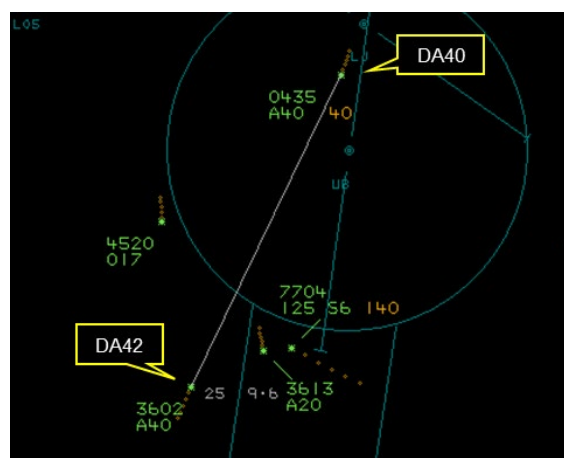
Figure 2 (0918:15). The DA40 SSR code change.
(Separation 9.6NM)

At 0918:35, the DA40 SSR code changed from an IFR Conspicuity SSR code (2000) to a Farnborough LARS West SSR code (0435).

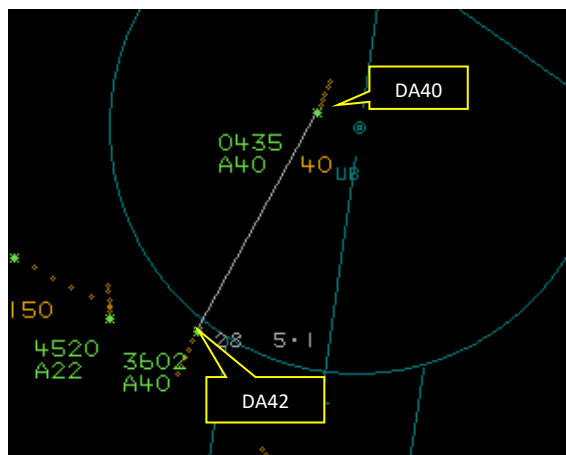
Figure 3 (0919:12). Free-call received by the Benson Zone controller.
(Separation 5.1NM)

At 0919:12, the Benson Zone controller received a free-call for a Basic Service and subsequent MATZ crossing by a microlight to the northeast of RAF Benson.

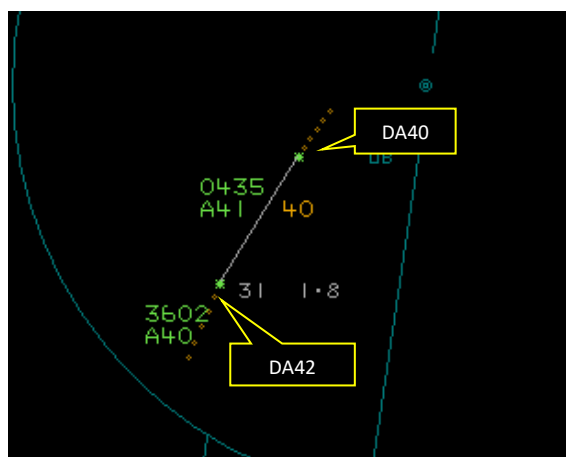
Figure 4 (0919:50). Handover conducted by the Benson Zone controller.
(Separation 1.8NM)

At 0919:50, the Benson Zone controller initiated a handover for an aircraft, previously prenoted, to Oxford Radar.

At 0920:05, the Benson Zone controller responded to the previously received microlight free-call, with Basic Service issued and the QNH passed. No Traffic Information was passed to the DA42 pilot regarding the DA40 by the Benson Zone controller.

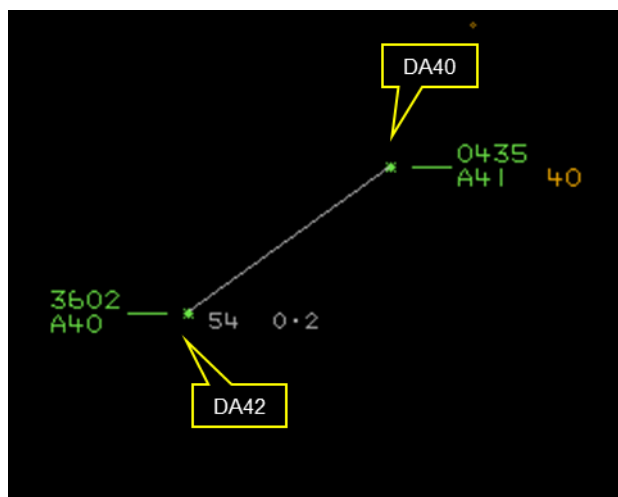
Figure 5 (0920:11): CPA.

CPA [on the NATS area radar] was measured at 0.2NM and 100ft separation.

The local investigation conducted by RAF Benson identified the cause of the Airprox as a loss of safe separation between non-co-operating aircraft due to the DA42 pilot having no awareness of the DA40. Several BM-related causal/aggravating factors were then identified that were believed to have contributed to the Airprox:

Entry within the Benson ATC Standards Bulletin regarding consideration of equipment release/testing and how controller distraction can be minimised.
