**AIRPROX REPORT No 2023053**

Date: 15 Apr 2023 Time: 1428Z Position: 5247N 00245W Location: 3NM W Shawbury

**PART A: SUMMARY OF INFORMATION REPORTED TO UKAB**

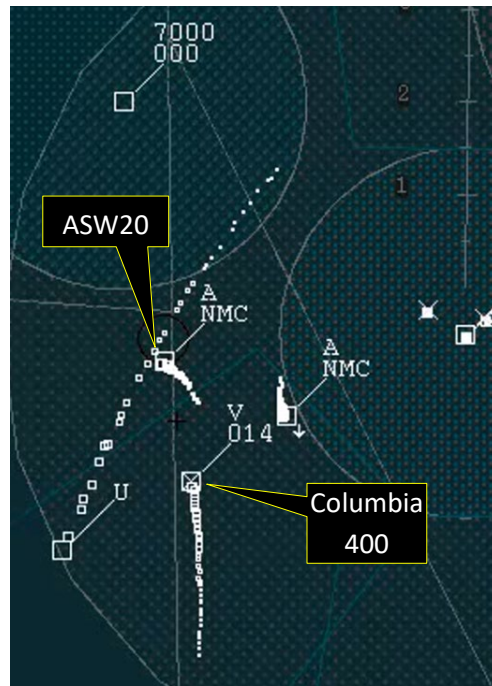
Figure 1 - 1427:35

As the glider commenced its turn, the Columbia would have been flying towards it from the glider pilot's 8 o'clock direction, at similar altitude (so probably obscured by the glider's port wing), and at a range of about 1.4NM (see Figure 1). As the glider turned towards the Columbia, the latter would have been in the glider pilot's field of view, but head-on at a similar altitude from the glider pilot's perspective. The difficulties of sighting another aircraft approaching head-on with no relative motion are well-known. Many pilots now opt to permanently switch on forward-pointing high-intensity landing lights, even in full daylight, to aid visual conspicuity in this direction.

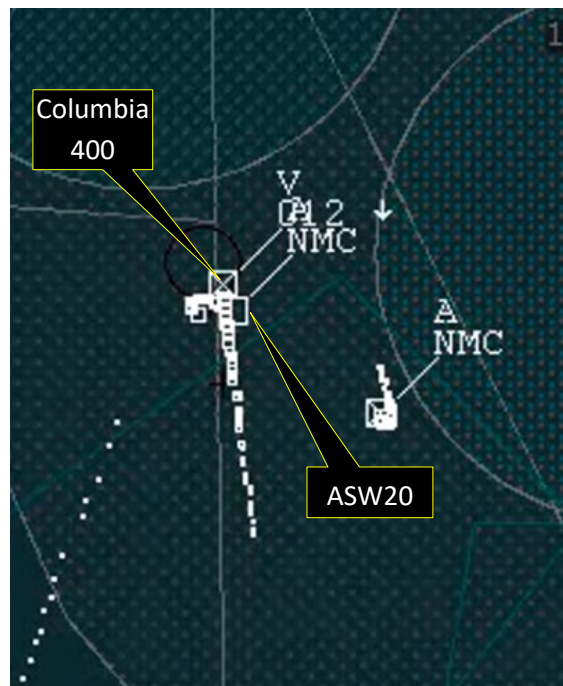
Figure 2 - CPA at 1428:06

RAF Shawbury was not active at the time of the Airprox but the Unit radar had been operational throughout the period. Figures 1 and 2 are screenshots taken from the Shawbury Unit radar replay. An analysis of the NATS radar replay was undertaken and the Columbia 400 could be positively identified from Mode S data. The ASW20 was not observed on the NATS radar at the time of CPA (see Figure 3). The pilot of the ASW20 kindly supplied GPS track data for their flight. It was by combining these separate data sources that the diagram was constructed and the separation at CPA determined.
