AIRPROX REPORT No 2023063

Date: 25 Apr 2023 Time: 1654Z Position: 5114N 00006W Location: Redhill Aerodrome circuit

PART A: SUMMARY OF INFORMATION REPORTED TO UKAB

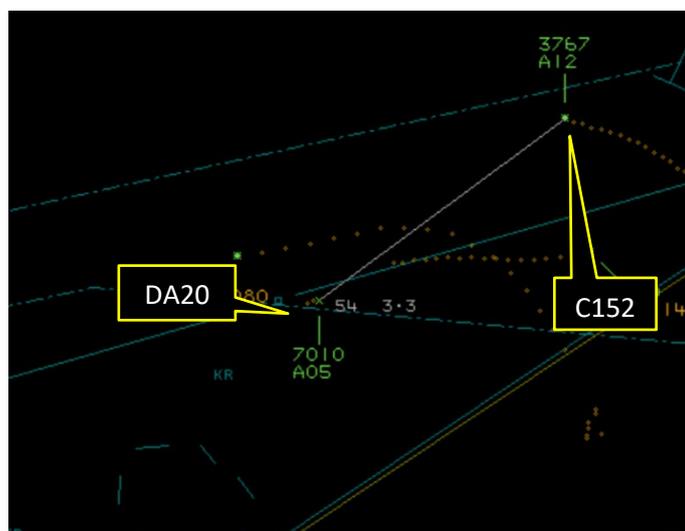
An analysis of the radar replay showed that at 1652:50 the DA20 pilot had been climbing out from RW06 at Redhill at an indicated altitude of 500ft and the C152 pilot had been leaving the Godstone VRP, at an indicated altitude of 1200ft, to join the circuit left-hand downwind as cleared (Figure 1).

Figure 1 – 1652:50 positions of C152 and DA20 with 3.3NM separation.

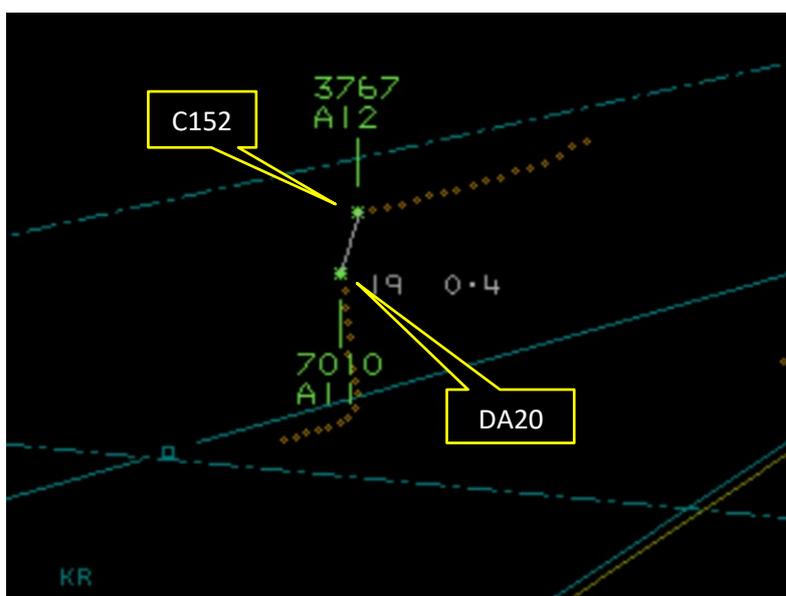
At 1654:10 the C152 pilot had been joining left-hand downwind in the circuit for RW06 and the DA20 pilot was on the crosswind sector of the circuit (Figure 2).

Figure 2 – 1654:10 C152 joining downwind and DA20 crosswind with 0.4NM separation.

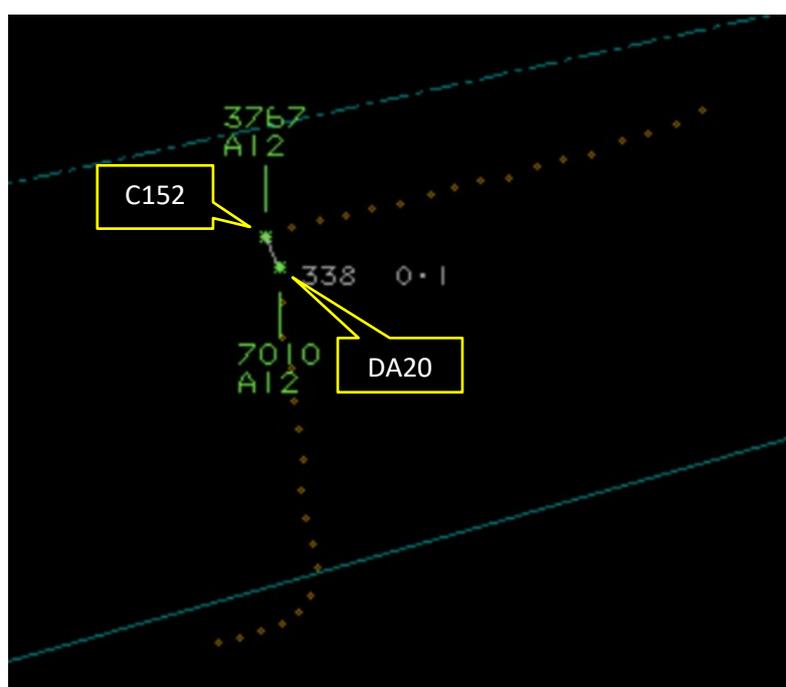
The closest point of approach had been at 1654:18 as the C152 pilot had joined downwind and the DA20 pilot had been completing their crosswind sector in the left-hand circuit for RW06 (Figure 3).

Figure 3 – 1654:18 CPA with 0.1NM separation.

At the point of CPA both pilots had reported manoeuvring to the right to avoid the other aircraft and the DA20 pilot had continued in a right-hand orbit to follow behind the C152 downwind.
