AIRPROX REPORT No 2023068

Date: 30 Apr 2023 Time: 0745Z Position: 5105N 00033W Location: 2NM SW Dunsfold

PART A: SUMMARY OF INFORMATION REPORTED TO UKAB

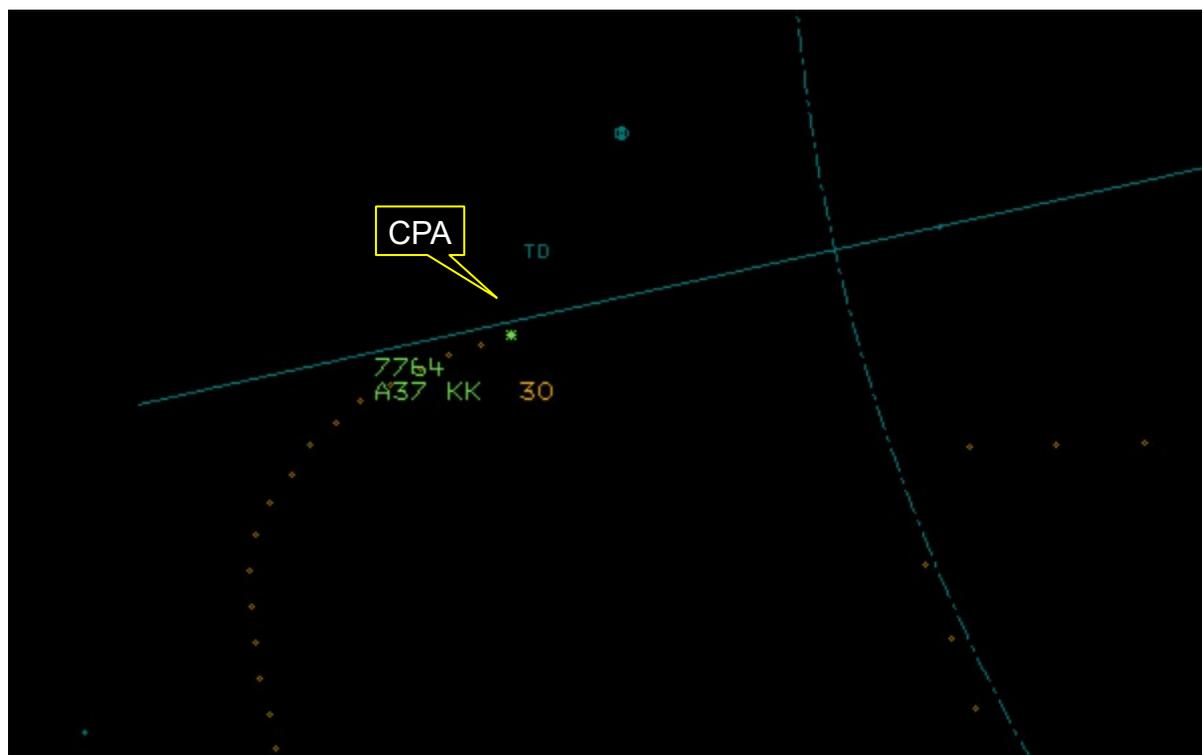
Figure 1: CPA 0744:42

Analysis of the radar showed that a primary return had been displayed at 0732:42, which correlated with the approximate position the A320 pilot reported the Balloon to have been, however this return disappeared shortly after. No further related radar returns had been observed. It had not been possible to definitively correlate the radar return to the Balloon. The pilot of the aircraft following reported that the Balloon had been directly abeam them at 0735:14, which correlated to the approximate position of that primary return. The pilot added that it looked to them to be "more than 2000ft, perhaps 3000ft", the base of controlled airspace in the area in which the primary return had appeared is 2500ft. The pilot of a following aircraft gave position reports of the Balloon which suggested it to have been tracking in a NNW direction, towards the final approach track for RW08R at Gatwick, and gave altitude reports ranging from 2500ft to above 3000ft.

The A320 pilot stated that they had been unable to continue at 0744:22 and reported the Balloon to be "right in front of them, 12 o'clock, about a thousand feet below". At this time the A320 had been on the localiser at 14NM DME, indicating an altitude of 3800ft. The controller issued a right turn onto
