AIRPROX REPORT No 2023073

Date: 14 May 2023 Time: 1241Z Position: 5153N 00118W Location: 4NM N Oxford

PART A: SUMMARY OF INFORMATION REPORTED TO UKAB

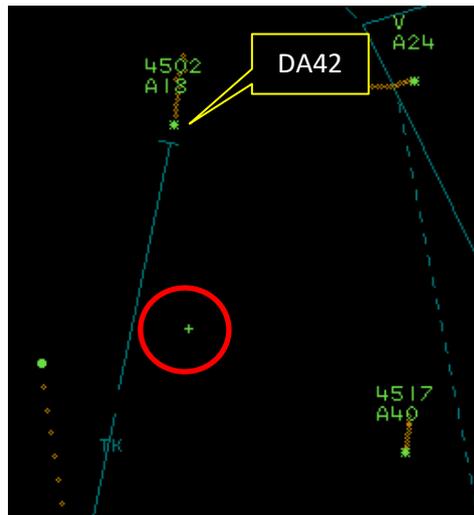
The radar controller reported that they had been aware that there was gliding activity in the D129 and Weston-on-the-Green area. After instructing the DA42 pilot to contact the Tower, they noticed that a primary radar contact had turned towards the gap between the D129 boundary and the Oxford ATZ boundary (close to the visual circuit area). They called the Tower controller at 1240:03 and asked them if they had two aircraft in the circuit, the Tower controller confirmed that there was only one aircraft in the circuit and advised the radar controller that they could not sight the unknown primary radar contact.

Figure 1 – 1240:03

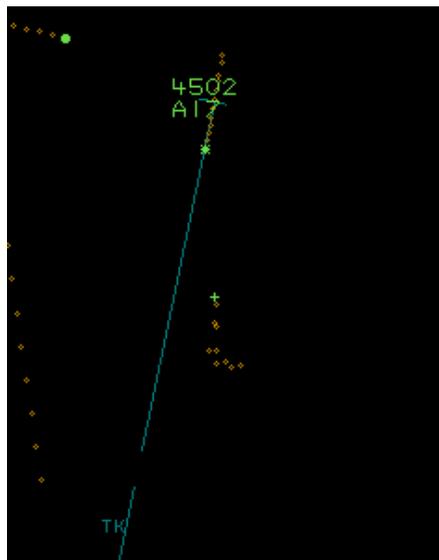
At 1240:38 the DA42 pilot made initial RT contact with the Tower controller and advised that they were established on the ILS and requested a low approach and circuit. The pilot was instructed to continue the approach. The radar controller then called the Tower controller with Traffic Information to be passed to the DA42 pilot on the primary contact. The Tower controller passed Traffic Information to the pilot, *“left eleven o’clock, one mile, reciprocal to you.”* Note: this differed very slightly to what had been said by the radar controller, in that they had given the range as one and a half miles.

Figure 2 - 1240:38 the DA42 pilot made initial contact with the Tower controller.

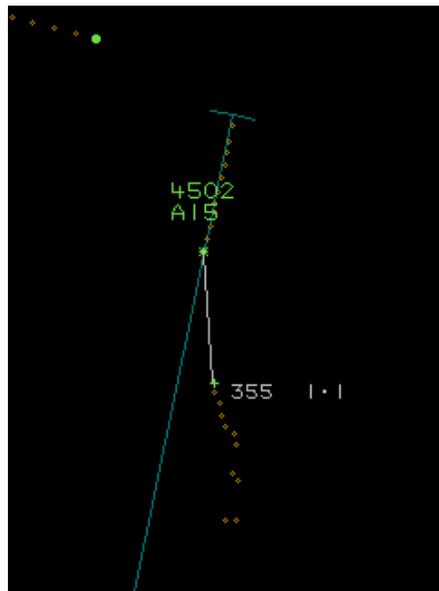
Figure 3 - 1241.00 first set of Traffic Information was passed and acknowledged.

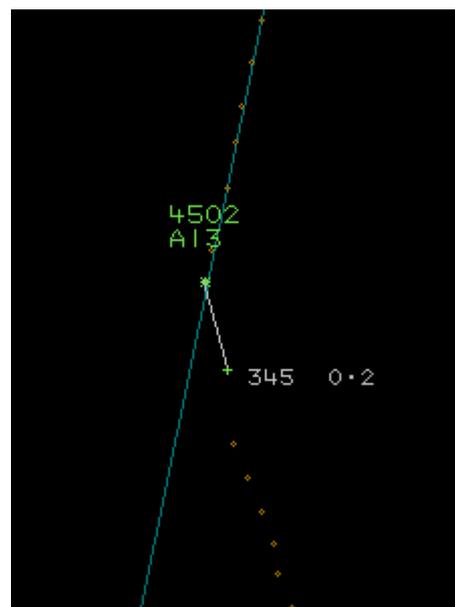
The Tower controller then immediately updated the Traffic Information, “left eleven o’clock half a mile now, reciprocal to you, no height” and the DA42 pilot reported that they had the traffic in sight. The controller asked if the pilot had a rough altitude and an aircraft type, and the pilot responded that it was a motor-glider at 1300ft.

Figure 4 - 1241.14 Traffic Information was updated, and the pilot reported visual.

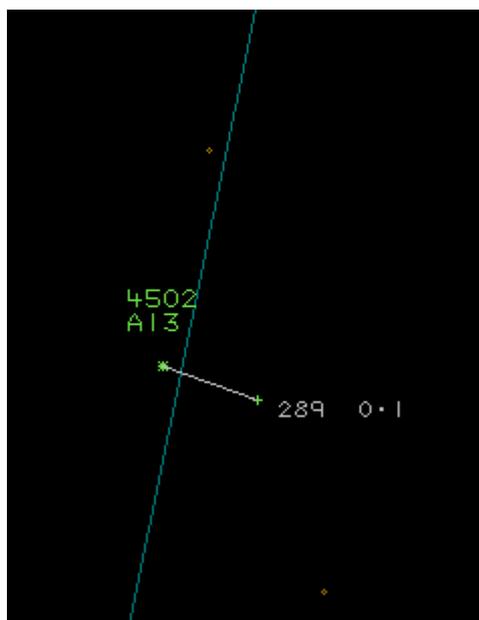
At 1241:17 CPA occurred, with the aircraft separated by 0.1NM. The DA42 pilot reported that both aircraft were at the same level.

Figure 5 - 1241.17 CPA 0.1NM (using LLFIN)
