AIRPROX REPORT No 2023082

Date: 21 May 2023 Time: ~1856Z Position: 5311N 00215W Location: 2NM NW Congleton

PART A: SUMMARY OF INFORMATION REPORTED TO UKAB

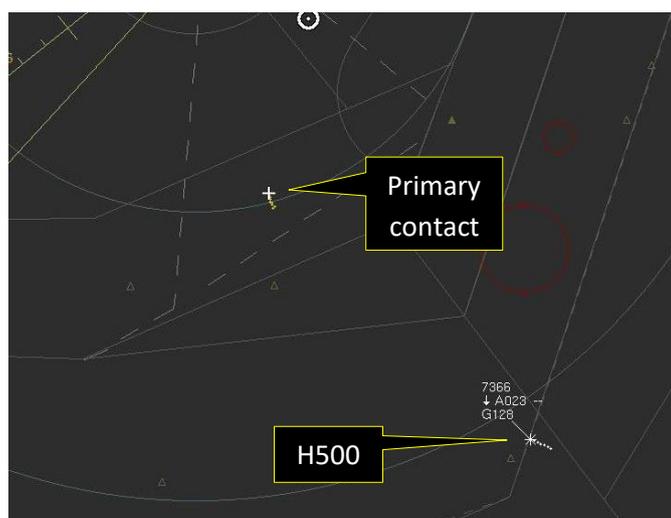
Figure 1 – 1848:56

Two-way contact was made with APS (see Figure 1). A primary radar contact could be seen in the vicinity of Congleton, but no callsign was visible on the raw data. At 1850:00, the contact was still visible on Manchester Approach South radar (see Figure 2).

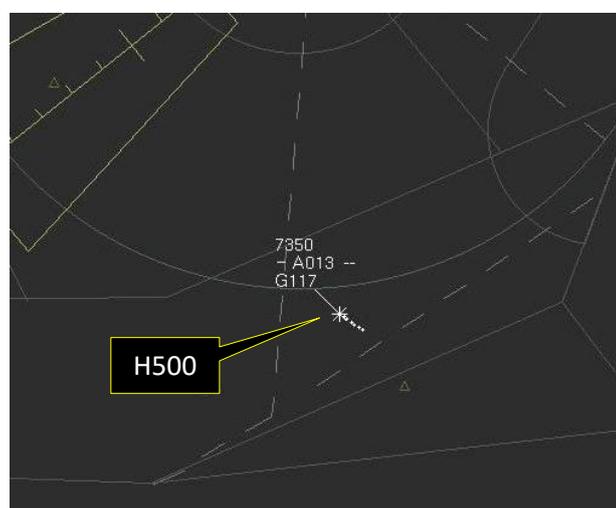
Figure 3 - 1855:48

At 1855:48, [the H500] was 2NM NW of Congleton (see Figure 3), the location of the Airprox in the pilot's report to the CAA. The primary contact was no longer visible. No report was made to ATC of an Airprox.

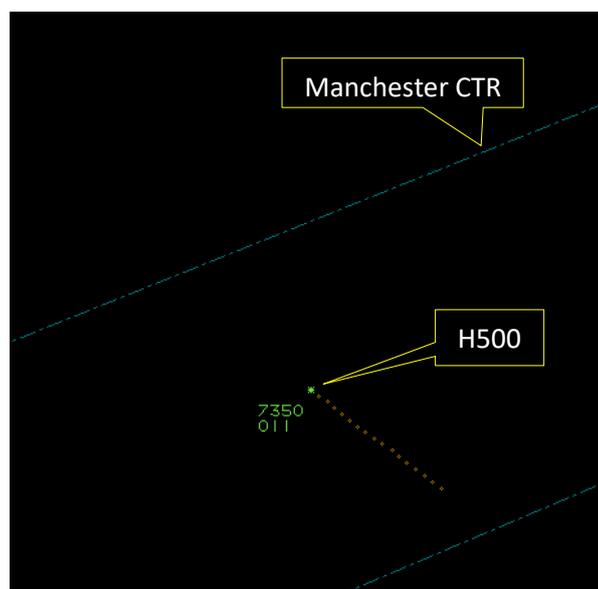
Figure 4 – 1855:58. Estimated time of CPA

An analysis of the NATS radar replay was undertaken and the H500 could be positively identified from Mode S data (see Figure 4). The paramotor could not be identified on the NATS radar replay. The exact moment of CPA could not be determined but has been estimated to be the moment that the track of the H500 crossed what would have been a northbound track towards the destination airstrip as reported by the pilot of the paramotor. The separation at CPA could not be determined.
