**AIRPROX REPORT No 2023089**

Date: 23 May 2023 Time: 1022Z Position: 5405N 00442W Location: 4NM SW of Ronaldsway

**PART A: SUMMARY OF INFORMATION REPORTED TO UKAB**

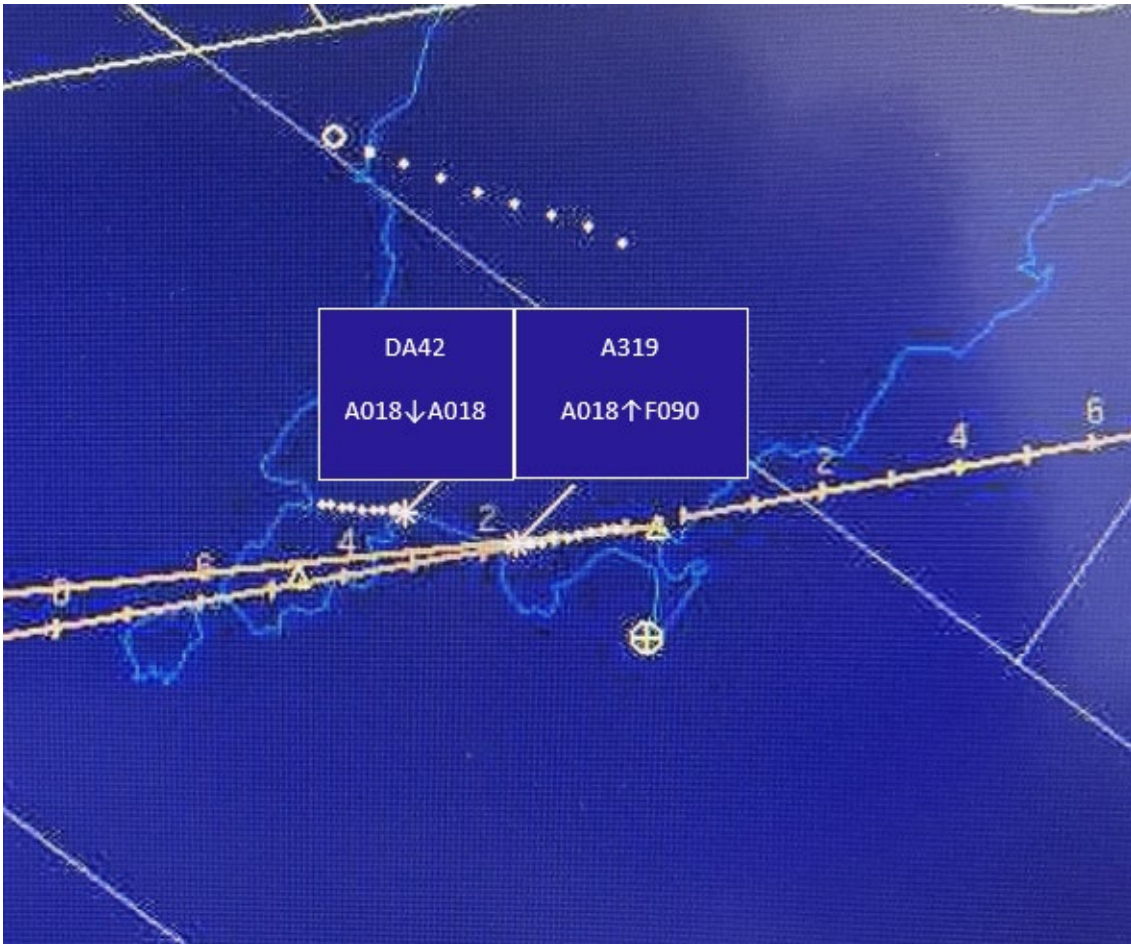
Figure 1 - 1022:00. The A319 appeared on the radar screen co-alt with the DA42.

The Isle of Man Airport investigation has provided a radar display depiction of the two aircraft being co-altitude (Figure 1) and a further viewing of the NATS radar replay depicted the A319 at A013 with the DA42 at A014 at approximately the same time, just 5sec later (Figure 3).

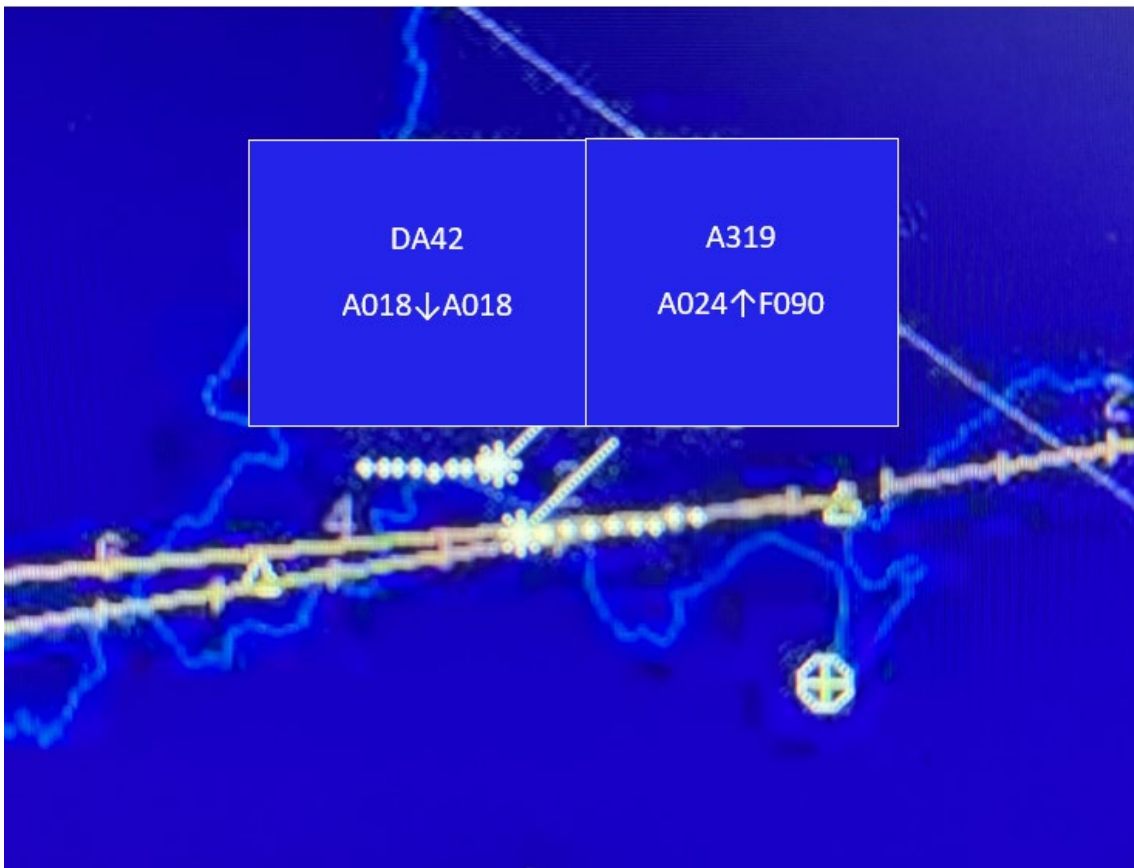
Figure 2 - 1022:17Z radar display depiction (redacted).

1022:17 - With reference to the ATS recordings, this was the time of the closest point of approach between [the A319] and [the DA42]. This was approximately 0.75NM at the same indicated altitude. A redacted screenshot of the radar display is shown at Figure 2.

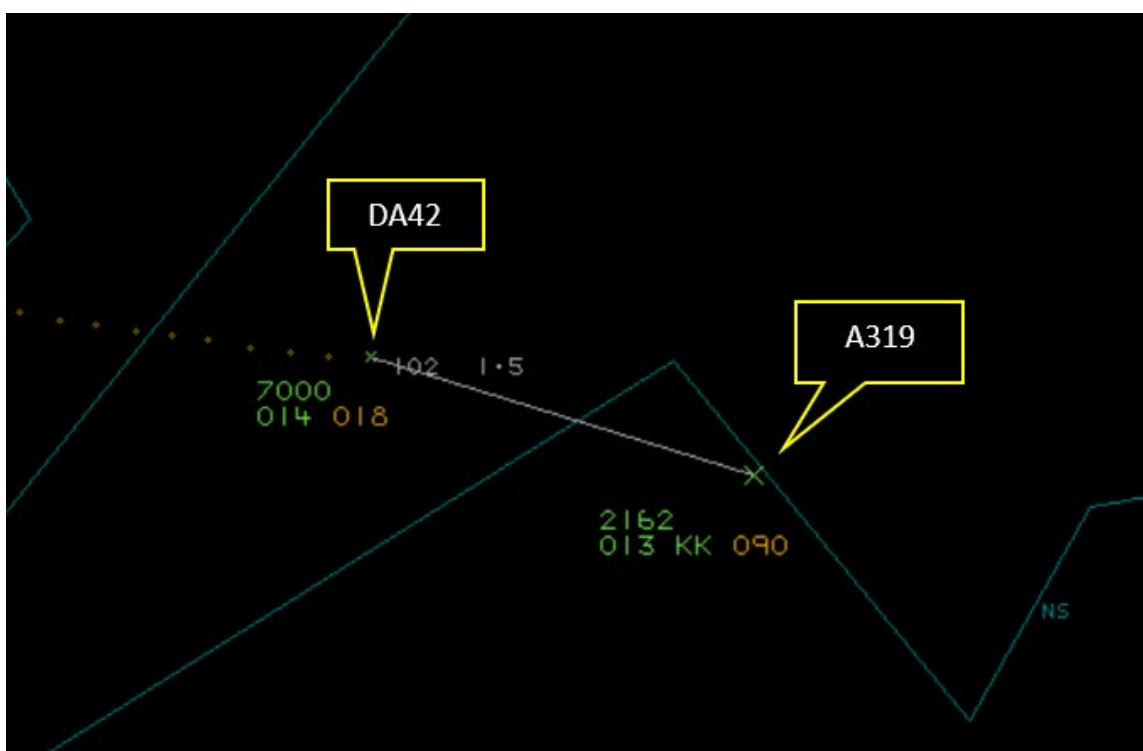
Figure 3 - 1022:05 – separation was 1.5NM and 100ft
