**AIRPROX REPORT No 2023106**

Date: 03 Jun 2023 Time: 1200Z Position: 5209N 00106W Location: 1NM SSE DTY VOR/DME

**PART A: SUMMARY OF INFORMATION REPORTED TO UKAB**

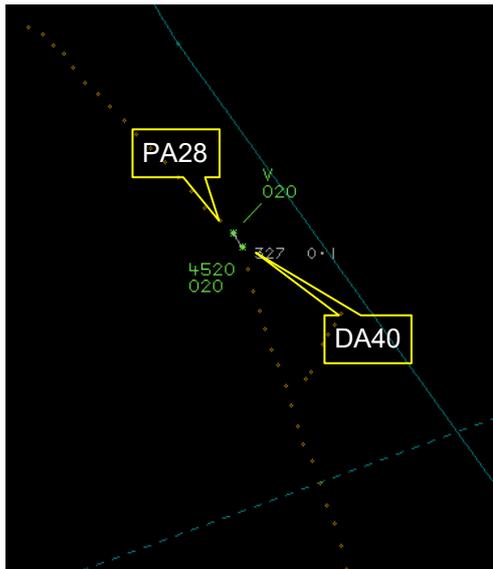
Figure1: CPA – (minus) 1sec.

The CPA occurred at 1159:46, approximately 2NM south of the DTY VOR/DME. The situation display showed the returns of the DA40 and an aircraft on a 7000 squawk merge, with both Mode C readouts indicating A023. No communication on this occurrence had been relayed via the RT, and the ATC watch logs likewise do not reference it.

CPA at 1159:46 0ft V/<0.1NM H
