AIRPROX REPORT No 2023110

Date: 07 Jun 2023 Time: 1338Z Position: 5302N 00040W Location: 5NM W Cranwell

PART A: SUMMARY OF INFORMATION REPORTED TO UKAB

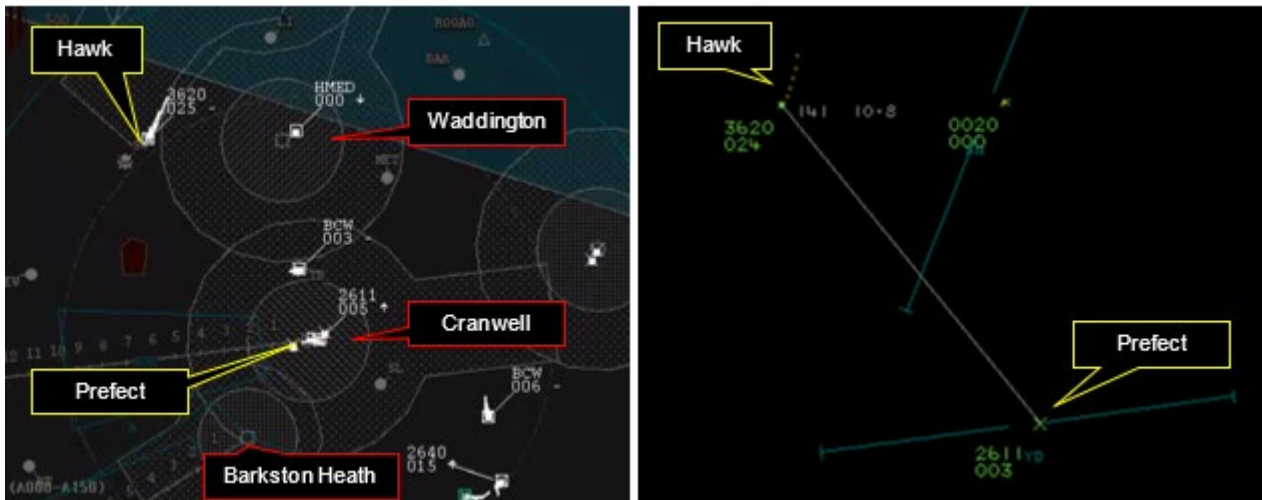
Figure 1 (1334:48) - Waddington Supervisor informed Cranwell Approach of instrument recovery to Waddington 02RH. Separation: 10.8NM

At 1334:48, on behalf of the Waddington Approach controller, the Waddington Supervisor informed the Cranwell Approach controller of the Hawk conducting an extended instrument pattern recovery to Waddington RW02RH.

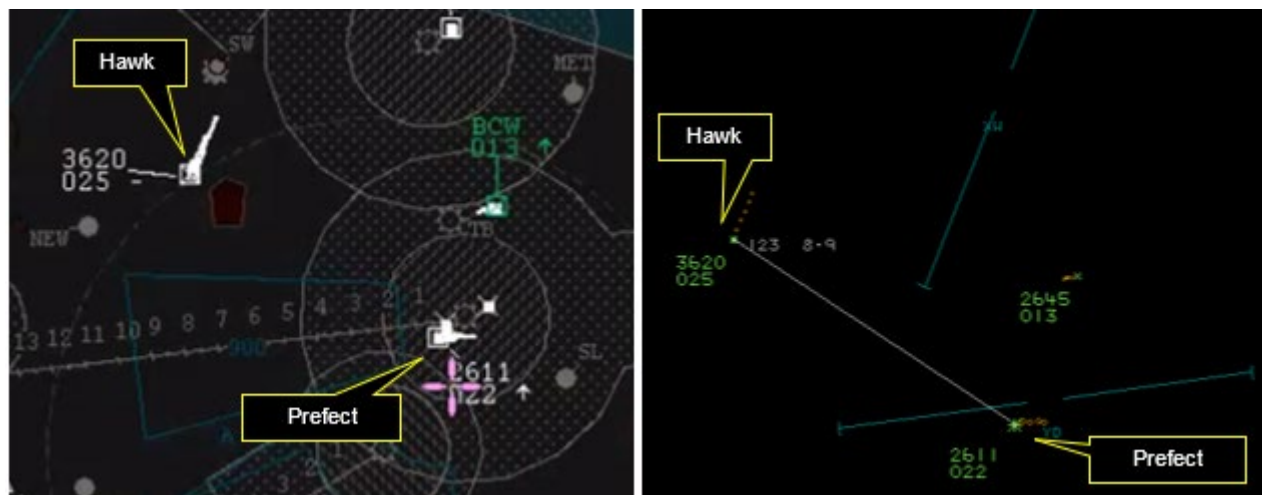
Figure 2 (1335:55) - Prefect contacted the Cranwell Departures controller. Separation: 8.9NM

At 1335:55, the Prefect pilot contacted the Cranwell Departures controller, requesting a Traffic Service in the climb and passing 2300ft Cranwell QFE. The Cranwell Departures controller subsequently identified the Prefect and provided a Traffic Service. The Cranwell Departures

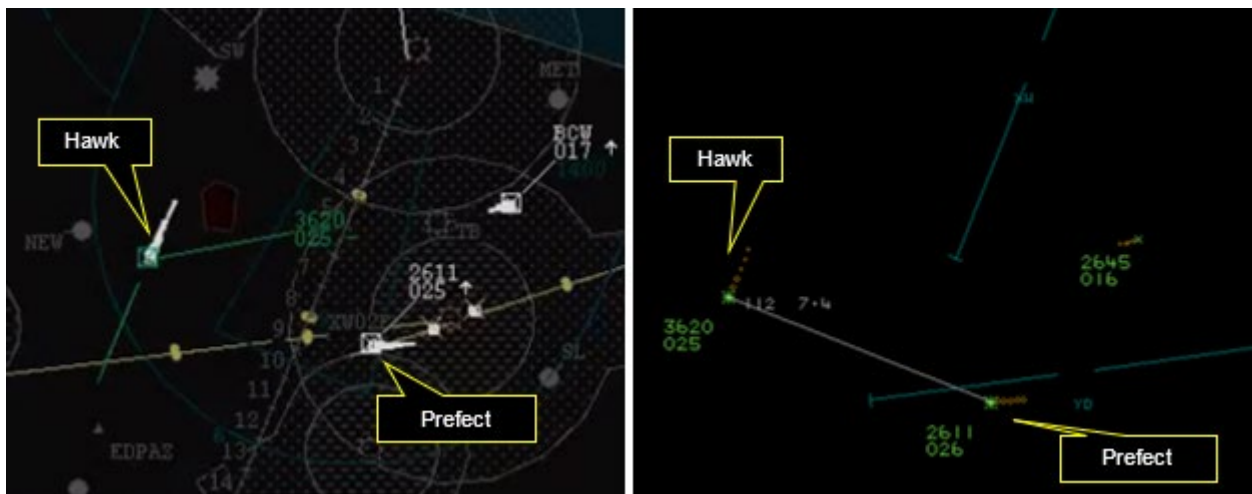
Figure 3 (1336:31) - Waddington Approach controller turned the Hawk inbound.
Separation: 7.4NM

At 1336:31, the Waddington Approach controller turned the Hawk onto a base leg heading of 110°. Immediately afterwards, they called the Cranwell Radar bank and requested Traffic Information on the Prefect. The Cranwell Approach controller answered the landline call as per local orders, and was surprised that the Prefect had not continued the climb as expected, but had instead levelled off. The Cranwell Approach controller incorrectly described the Prefect as levelling off at 2000ft, when in fact the Prefect had levelled off at 2500ft RPS.

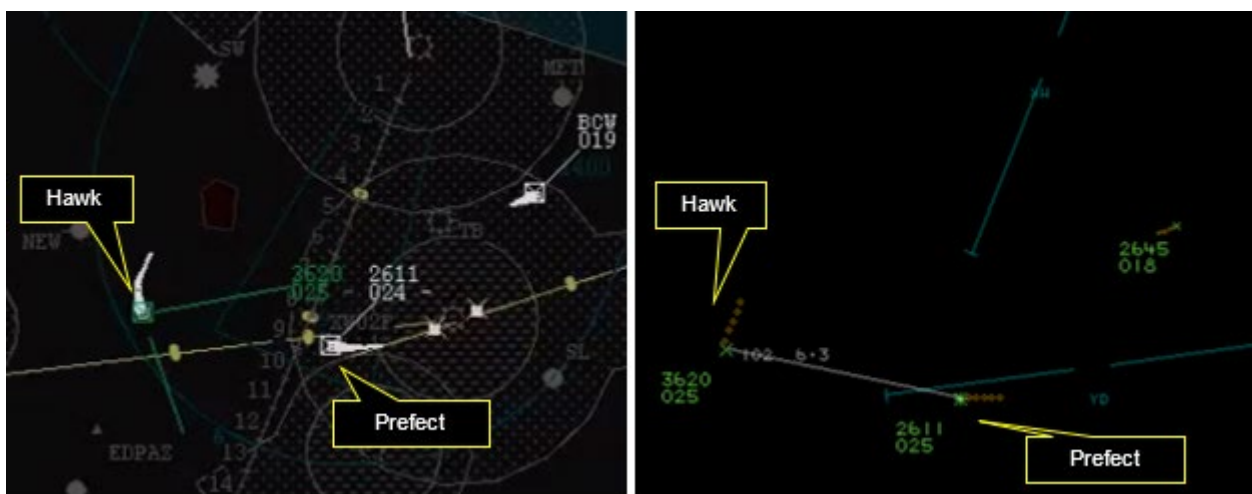
Figure 4 (1336:57) - Traffic information provided to the Hawk [pilot] on the Prefect.
Separation: 6.3NM

At 1336:57, the Waddington Approach controller provided Traffic Information to the Hawk pilot on the Prefect *“there’s traffic east 5 miles tracking westbound indicating 100ft below, I’ll give you a further turn to get you inbound on the tube”*.

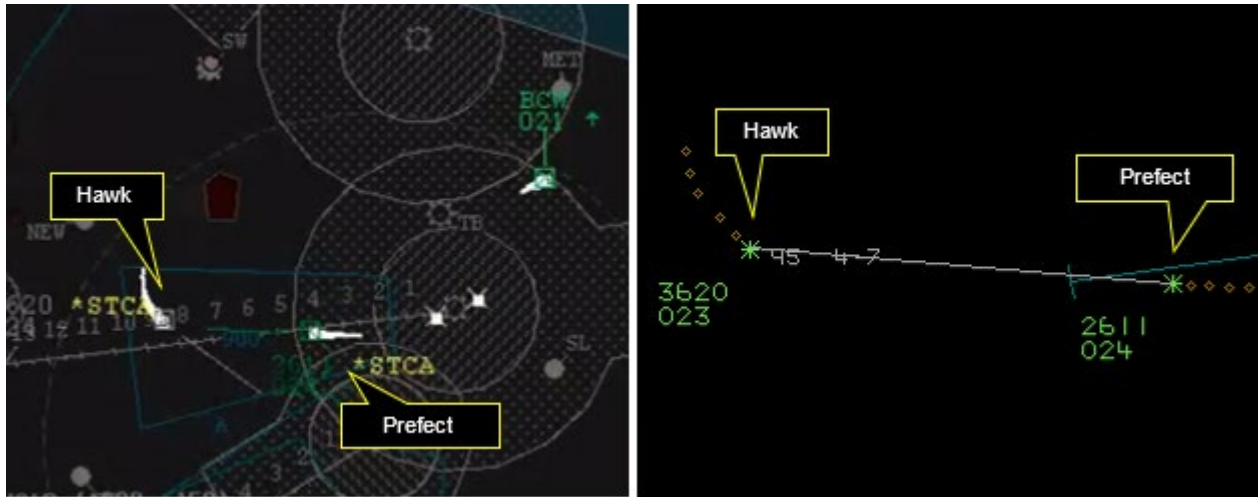
Figure 5 (1337:11) - Short Term Conflict Alert received by both controllers.
Separation: 4.5NM

At 1337:11, both the Waddington Approach and Cranwell Departures controllers received Short Term Conflict Alerts between the Hawk and Prefect.

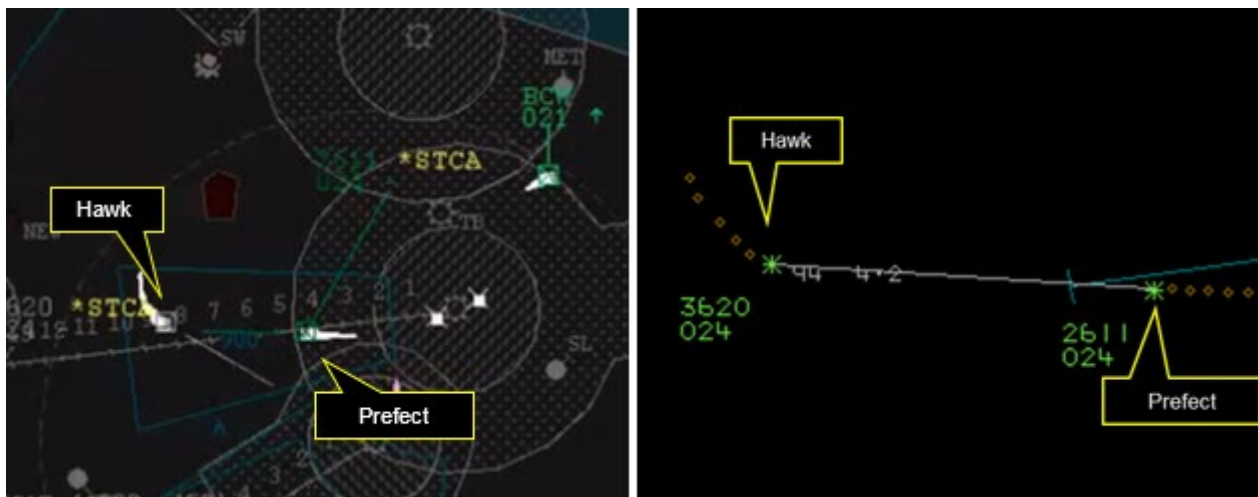
Figure 6 (1337:14) - Traffic information provided to the Prefect on the Hawk.
Separation: 4.2NM

At 1337:14, the Cranwell Departures controller provided Traffic Information to the Prefect [pilot] on the Hawk, incorrectly believing they had already passed Traffic Information, "*previous reported traffic west 1 and half miles tracking east northeast indicating similar altitude*". The Prefect pilot responded with "*traffic in sight*".

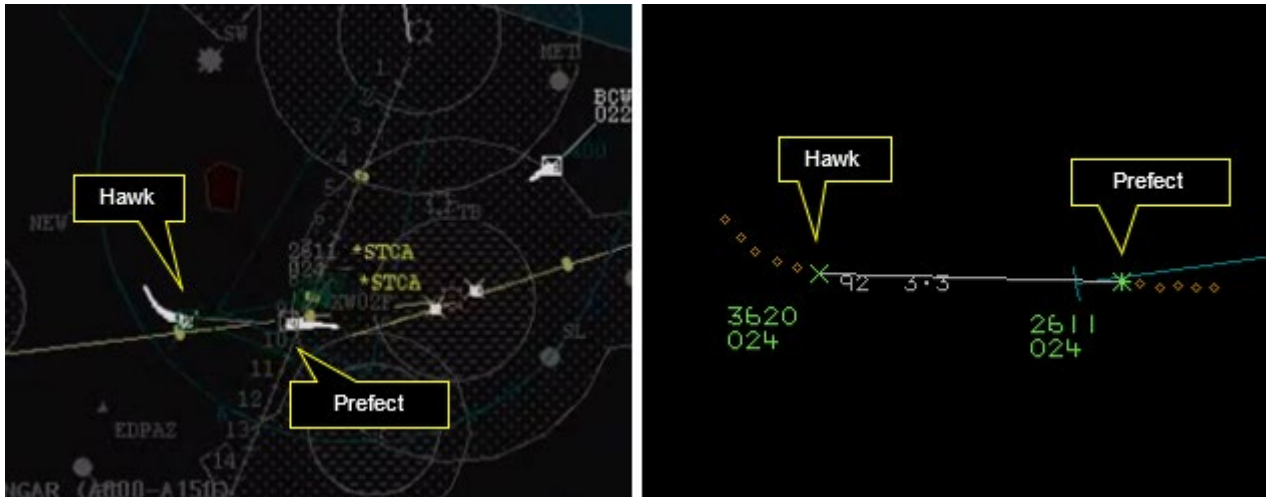
Figure 7 (1337:22) - Avoiding action turn issued to the Hawk [pilot].
Separation: 3.3NM

At 1337:22, with the Prefect pilot visual with the Hawk and continuing a northwest track, the Waddington Approach controller issued an avoiding action turn with Traffic Information on the Prefect. *“Avoiding action turn left immediately heading 060 degrees, that traffic was erm in your left 11 o’clock, 3 miles, opposite direction indicating 100ft below”*. This initial avoiding action was increased further at 1337:39, to also include a climb *“avoiding action turn left immediately heading 270 degrees, that previously reported traffic now north-east half a mile tracking north westbound indicating 100ft below and climb to alt height 3000ft”*. On receipt of the second avoiding action turn the Hawk pilot reported visual with the Prefect and re-established on the instrument pattern final heading of 060°.

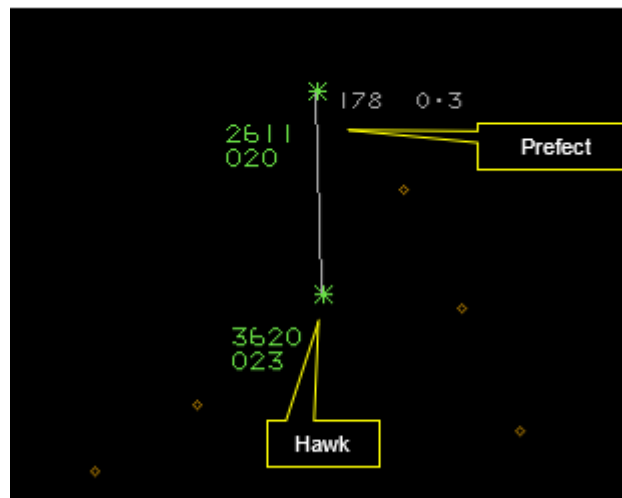
Figure 8 (1338:02) - CPA.

CPA was measured at 0.3NM and 300ft.
