AIRPROX REPORT No 2023130

Date: 22 Jun 2023 Time: 1505Z Position: 5115N 00208W Location: Westbury White Horse

PART A: SUMMARY OF INFORMATION REPORTED TO UKAB

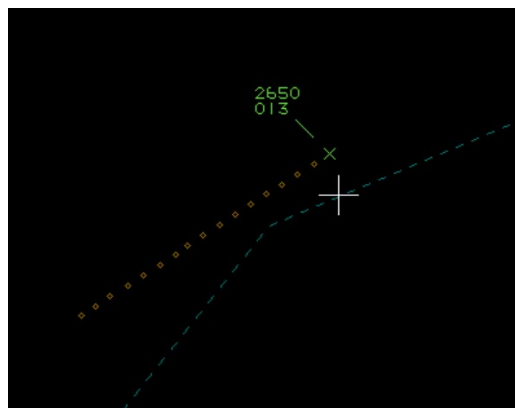
Figure 1 shows the path of the EC155 and its position at reported CPA of 1504:38. The white cross indicates Westbury White Horse

Information for this event was drawn from radar data, GPS files from the hang-glider pilot and written reports from both pilots and the Boscombe Down LARS controller. At no time did any of the hang-gliders operating in the general area show on radar. The indicated CPA is based on the reported time and position by both pilots.
