AIRPROX REPORT No 2023127

Date: 21 Jun 2023 Time: 1027Z Position: 5211N 00010W Location: 1NM W Gransden Lodge

PART A: SUMMARY OF INFORMATION REPORTED TO UKAB

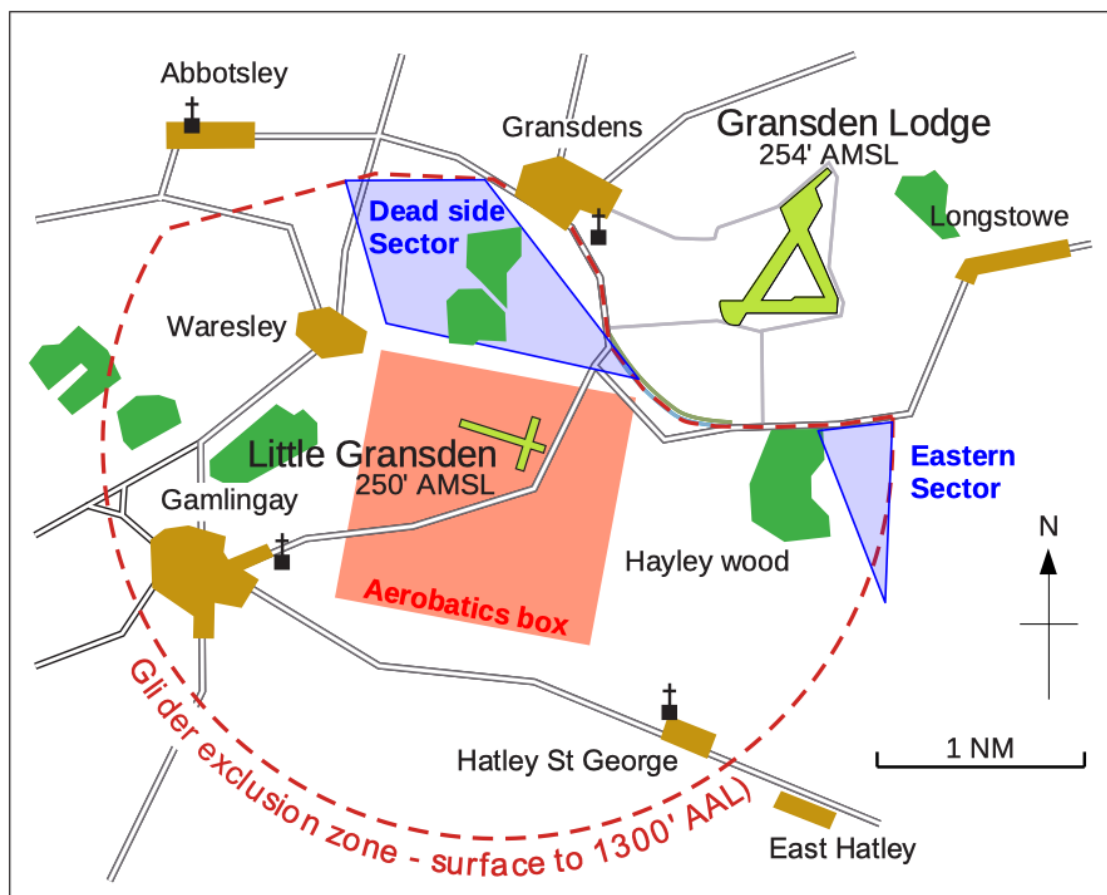
Figure 1

4. Aerotowing CGC Tugs will observe the glider exclusion zone, except for the 2 sectors shown on the map.

CGC Tugs planning to transit either of the 2 sectors will give a blind call on departure to Gransden Radio as follows:-

Eastern Sector. Once airborne but before sector entry. E.g. "Gransden Radio, Glider Tug TL climbing through the Eastern Sector"

Northern Sector. Once airborne but before sector entry. E.g. "Gransden Radio, Glider Tug TL climbing through the Dead Side"

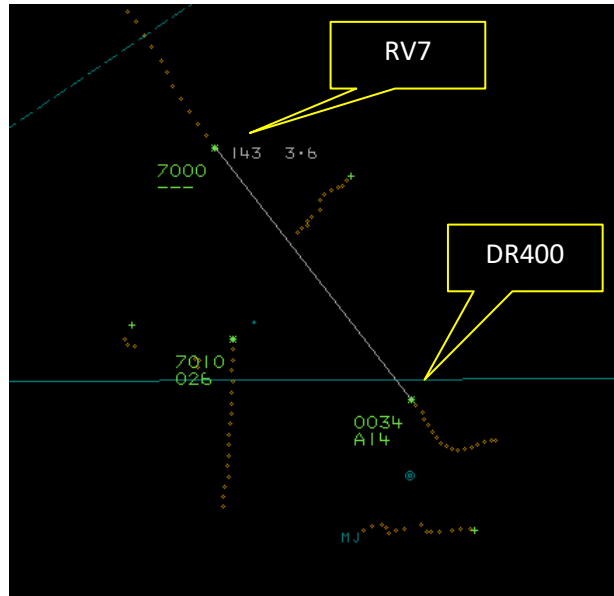
Figure 2 - 1025:54

An analysis of the NATS radar replay was undertaken. The RV7 could be identified using Mode S data, however, the Mode C data was not available throughout. The DR400 could not be identified using Mode S data, however, an aircraft with a 0034 squawk (aerial towing) following the route described by the DR400 pilot could be seen (Figure 2).

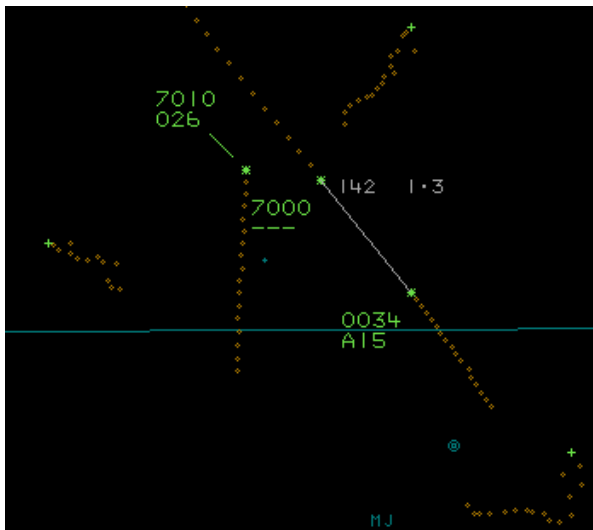
Figure 3 - 1026:30

The two aircraft continued to close (Figures 3 and 4), with the DR400 in a slow climb.

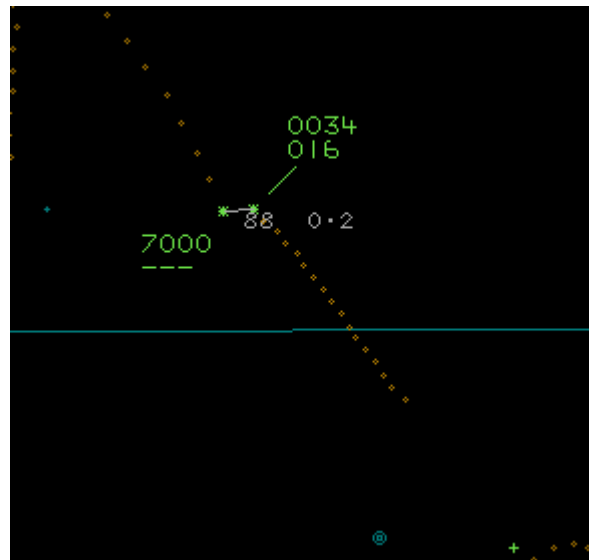
Figure 5 - CPA 1026:50

CPA occurred at 1026:50, radar separation indicated a horizontal separation of 0.2NM. The DR400 was indicating FL016 but the altitude of the RV7 was unknown.
