**AIRPROX REPORT No 2023151**

Date: 13 Jul 2023 Time: ~1747Z Position: 5332N 00304W Location: 3NM SSE Formby

**PART A: SUMMARY OF INFORMATION REPORTED TO UKAB**

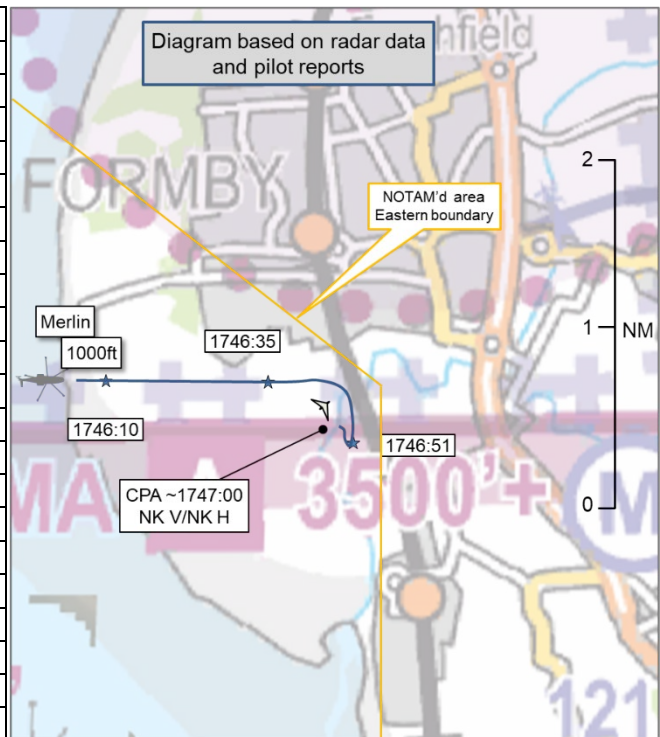
**THE MERLIN PILOT** reports that on return to [...] on completion of training with an RFA vessel, (formation callsign 4) had joined [...] via the southern gate [...] following on from formation callsign 5. During the join the crew had been looking to sight a TAS contact which turned out to be fixed-wing traffic transiting from south-to-north approximately 700ft above the aircraft. After joining through the southern gate the aircraft had then flown a downwind leg, positioning for the FARP. The ground track of the aircraft had been tight to the Western side of the A565 (a pre-agreed deconfliction with [the local] microlight site) to avoid overflight of a number of local avoids that had submitted a number of noise complaints during the exercise. At this time, the HP of the aircraft had spotted a microlight approximately 50ft below and 2 rotor spans in front of the aircraft, not transponding or displaying on TAS. As the aircraft had been in a gentle left-hand turn [they recall] on a base turn for the FARP the turn was continued which resulted in a divergence from the microlight.
