**AIRPROX REPORT No 2023168**

Date: 07 Aug 2023 Time: 1241Z Position: 5223N 00018W Location: IVO Buckworth, Cambs

**PART A: SUMMARY OF INFORMATION REPORTED TO UKAB**

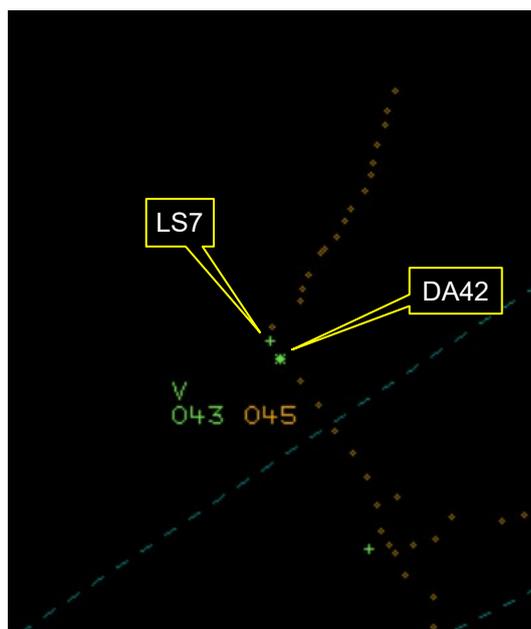
CPA minus 2 secs (1240:50)  
CPA 1240:52 170ft V/<0.1NM H
