AIRPROX REPORT No 2023171

Date: 07 Aug 2023 Time: 1310Z Position: 5355N 00025W Location: 3.5NM N Beverley

PART A: SUMMARY OF INFORMATION REPORTED TO UKAB

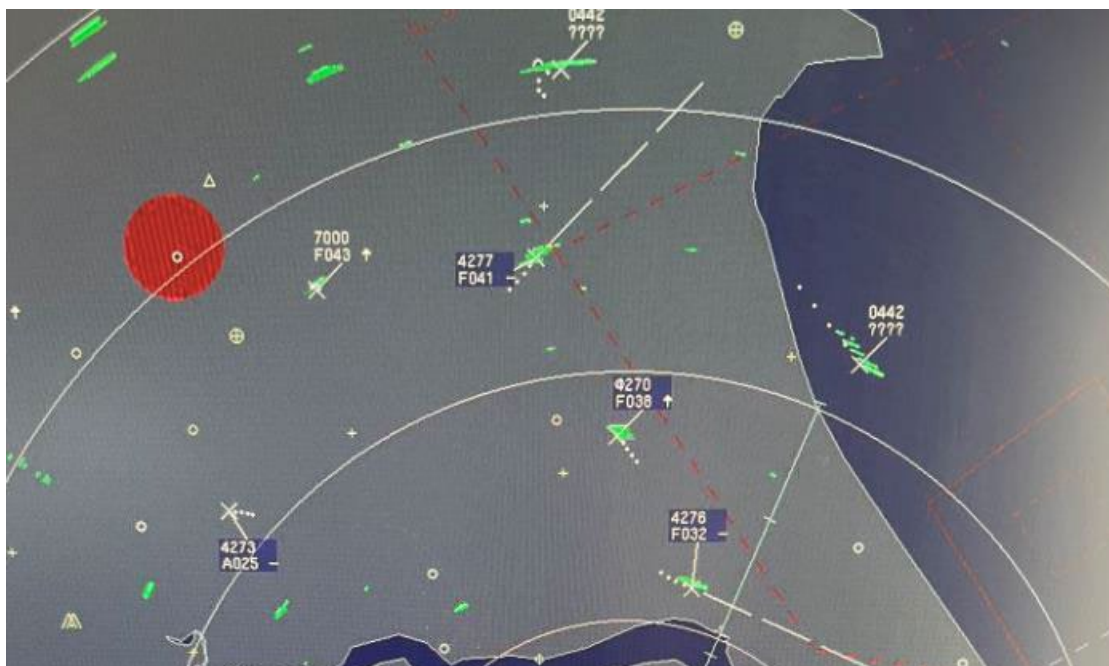
Figure 1 - 1308:51 (Prefect 4277, AC114 4270)

[Prefect C/S] routed to Driffield and turned south at 1309, altitude 4125ft (Claxby SSR). [AC114 C/S] south of Driffield altitude 3800ft (Claxby SSR). Numerous RT transmissions ongoing, with the [scheduled commercial carrier] (4252), a DS coming on frequency at 1309:20.

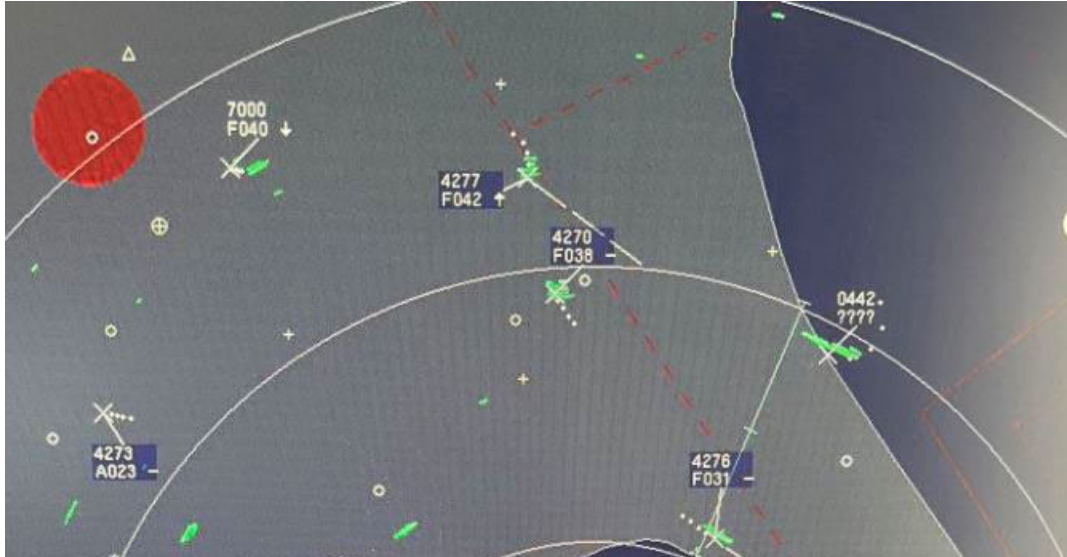
Figure 2 - 1309:40 (Prefect 4277, AC114 4270)

The Radar 1 cursor hovered momentarily over [AC114 C/S].

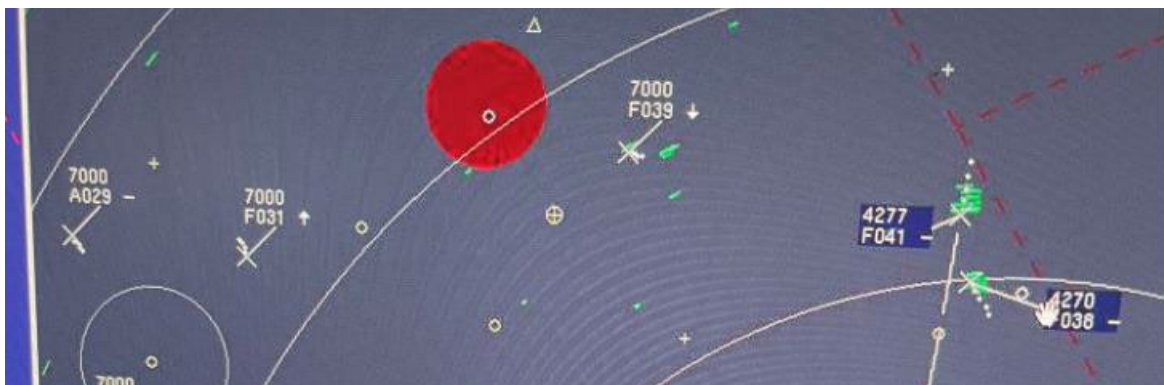
Figure 3 - 13:09:58

The Radar 1 cursor hovered momentarily over [Prefect C/S].

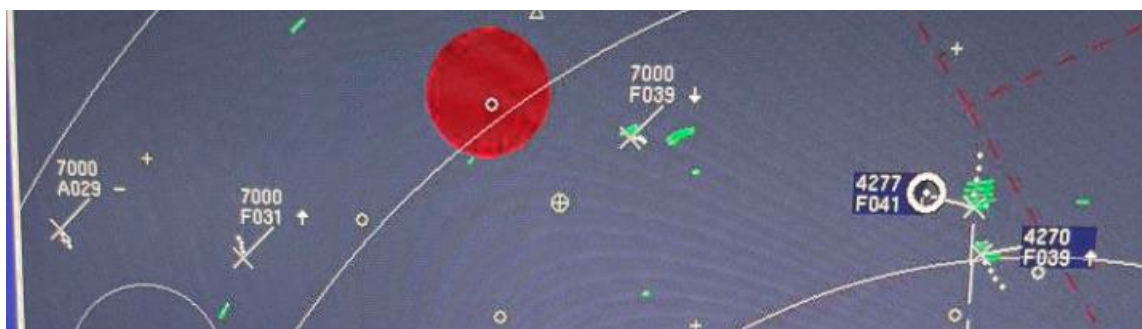
Figure 4 - 1310:10

The two aircraft converged. No Traffic Information was passed to either [pilot]. [Prefect C/S] was seen to climb as [AC114 C/S] was seen to descend as the positive indicators merged. (Altitude

difficult to see, but it appeared that the vertical distance momentarily increased from 300ft to 800ft before returning to 300ft.)
