AIRPROX REPORT No 2023162

Date: 20 Jul 2023 Time: ~1419Z Position: 5058N 00210W Location: Compton Abbas

PART A: SUMMARY OF INFORMATION REPORTED TO UKAB

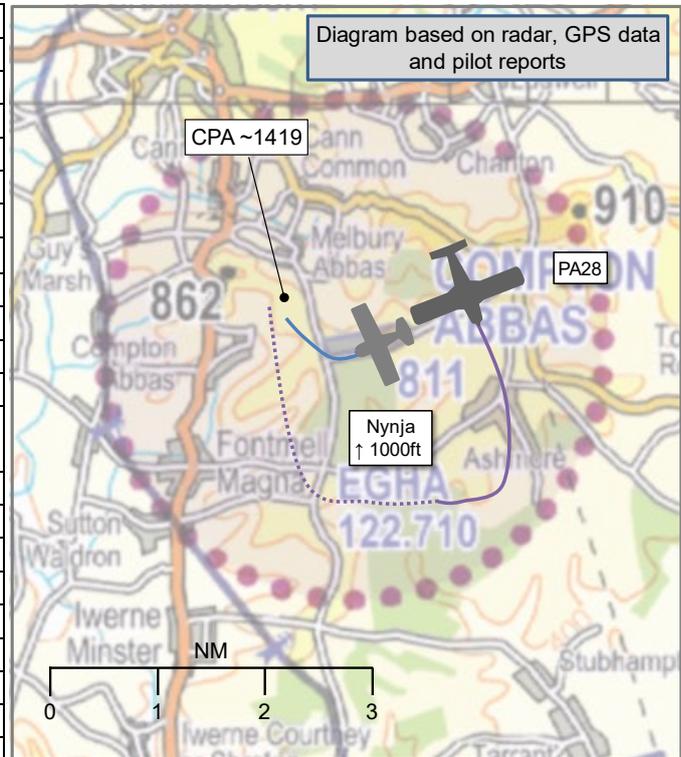
Recorded	Aircraft 1	Aircraft 2
Aircraft	Skyranger Nynja	PA28
Operator	Civ FW	Civ FW
Airspace	Compton Abbas ATZ	Compton Abbas ATZ
Class	G	G
Rules	VFR	VFR
Service	AGCS	AGCS
Provider	Compton Abbas	Compton Abbas
Altitude/FL	NK	NK
Transponder	None ¹	A, C, S
Reported		
Colours	White, Red, Blue	Blue, White
Lighting	Strobes, Landing	Strobe, Beacon, Landing
Conditions	VMC	VMC
Visibility	5-10km	>10km
Altitude/FL	800ft	1800ft
Altimeter	QFE (989hPa)	QNH
Heading	320°	340°
Speed	65kt	95kt
ACAS/TAS	SkyEcho	Not fitted
Alert	Information	N/A
Separation at CPA		
Reported	50ft V/200m H	0ft V/400m H
Recorded	NK

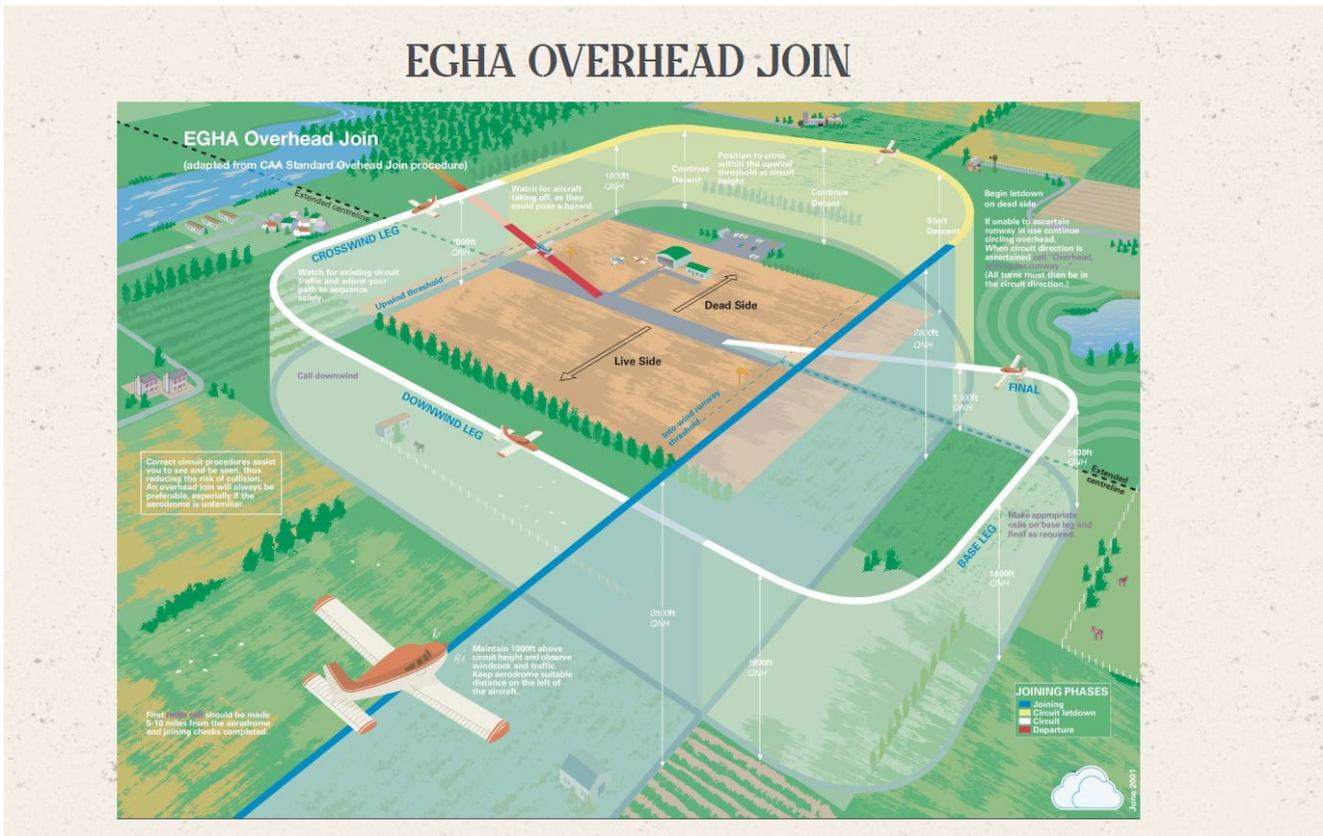
Figure 1 – Overhead join at Compton Abbas

At Figure 1 is the diagram to illustrate overhead joins as published on the Compton Abbas website. Additionally, further information is given in the form of a newsletter:

There have been observations (from airfield management and others) that Circuits and rejoin procedures are not being executed properly. This is particularly evident with incorrect Overhead joins being flown. Some pilots are flying the aerodrome noise abatement departure procedure, after reaching the Overhead Crosswind position. This is not correct. The correct action is to fly a crosswind leg at 90 degrees to the upwind end of the Runway.

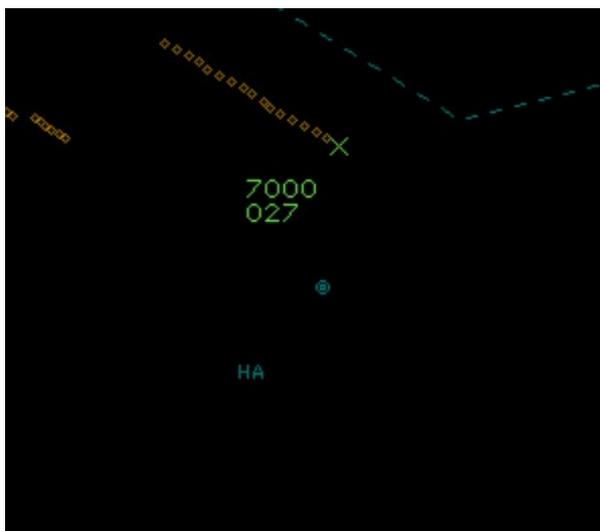
Figure 2 – 1415:39

An analysis of the NATS radar replay was undertaken. The PA28 could be identified using Mode S data and could be seen approaching the overhead at 1415. The Nynja could not be seen on the radar replay at all, however, the pilot supplied GPS data. By 1417:27 the PA28 could be seen joining in the overhead, however, it faded from radar on the next radar sweep. Therefore the exact separation could not be ascertained and the diagram at the top of the report was compiled using a mixture of radar, GPS data and pilots' reports.
