AIRPROX REPORT No 2023174

Date: 08 Aug 2023 Time: ~1930Z Position: 5512N 00638W Location: East Strand Beach, Portrush

PART A: SUMMARY OF INFORMATION REPORTED TO UKAB

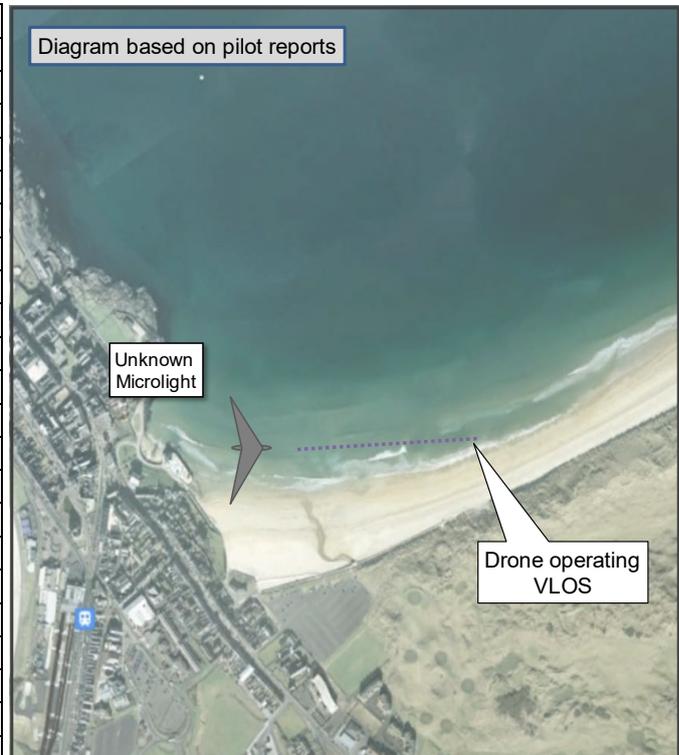
THE DJI MAVIC OPERATOR reports that they are a commercial UAS operator and were filming footage for a documentary film at East Strand Beach, Portrush. The flight was properly planned and publicly listed as an active flight on the Drone Assist application (by AltitudeAngel). They began operations from 1900 with excellent conditions and visibility, conducting very low altitude filming of an (involved) surfer featured in the film approximately 20m offshore maximum. They had received several PUSH notifications to their mobile phone from Drone Assist about [C/S redacted, a non-Airprox aircraft] a flight operating in the area 10NM west, 8NM west, and finally 6NM west from their flight. This was an acceptable separation distance so they continued their flight as planned. They received no further proximity notifications for this aircraft or any other aircraft entering potentially risky distances for the remainder of the flight. Then, at approximately 1930-1945 while filming a take of the surfer in the water (with their drone less than 5m from the water), they were verbally warned by a nearby person of another aircraft inbound and very low in altitude. They were positioned about 50m away from the drone, adjacent to the surf with excellent VLOS to their aircraft so they looked to the left and spotted an open cockpit microlight flying below 10m ASL along the water line of the beach - buzzing directly over the talent they had in the water as well as momentarily occluding their VLOS to the drone. They were already dealing with ground proximity warnings from the drone so could not safely reduce their altitude further without losing the drone to the water. When the microlight aircraft passed the drone, it occluded their line of sight to their drone, so the other pilot was dangerously low. Initially, they assumed [the other aircraft] was performing an emergency landing on the beach, however, after buzzing them, it climbed and left the area. The drone operator, the talent being filmed in the water and passers-by felt that it was a dangerous moment; had the other pilot lost control or collided with the drone that they clearly had no awareness of. There was little [the drone operator] could do beyond crashing the drone to avoid the other aircraft's low pass so unfortunately could only try and maintain as low an altitude as was safe. After the flight they searched the radar history for the aircraft that they had previously seen and could confirm that the other aircraft was not that aircraft, but was a white, open-cockpit microlight. The incident happened very quickly so they did not get a chance to identify the other craft accurately.

The pilot assessed the risk of collision as 'High'.

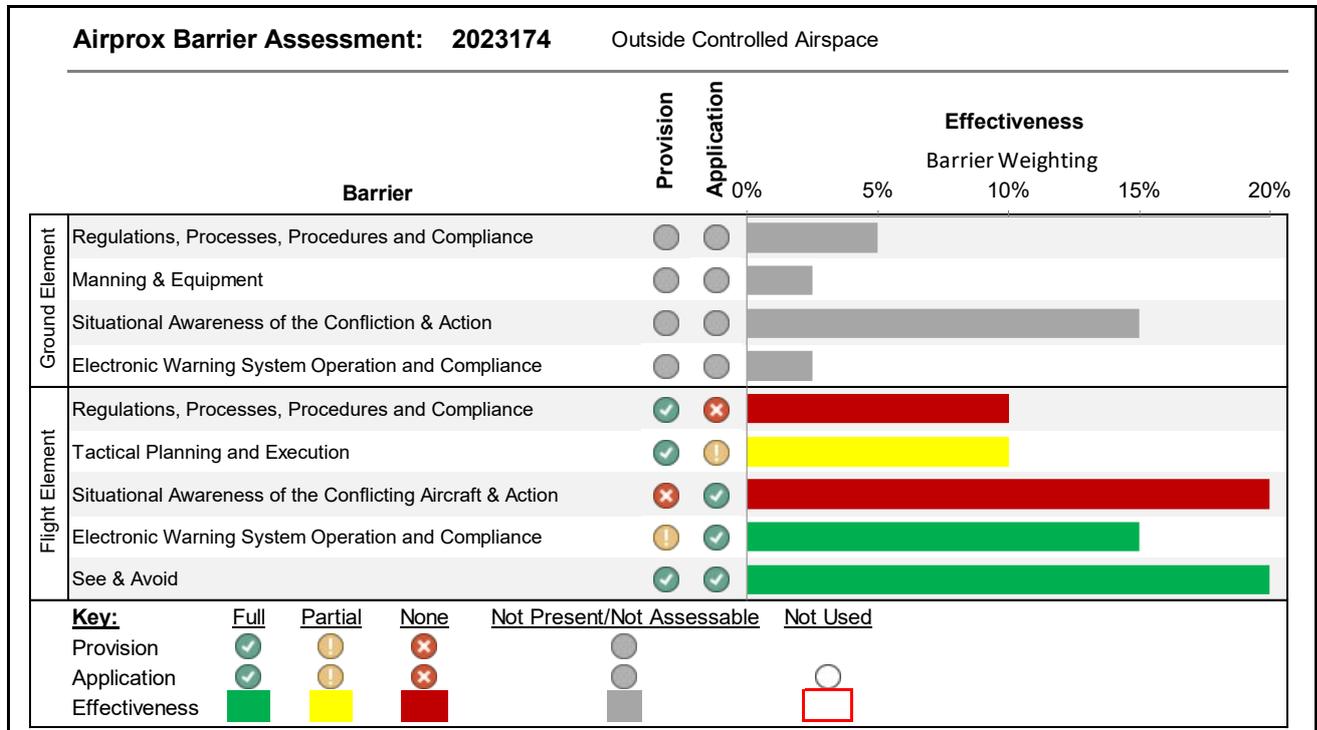
Safety Barrier Assessment⁵

Regulations, Processes, Procedures and Compliance were assessed as **ineffective** because it had been likely that the microlight pilot had flown within 500ft of the drone operator and people on the beach.

Tactical Planning and Execution was assessed as **partially effective** because if the microlight pilot had seen people on the beach they should have climbed.

Situational Awareness of the Conflicting Aircraft and Action were assessed as **ineffective** because the drone operator had received no prior situational awareness that the microlight had been approaching.
