**AIRPROX REPORT No 2023182**

Date: 16 Aug 2023 Time: 1515Z Position: 5302N 00026W Location: Cranwell

**PART A: SUMMARY OF INFORMATION REPORTED TO UKAB**

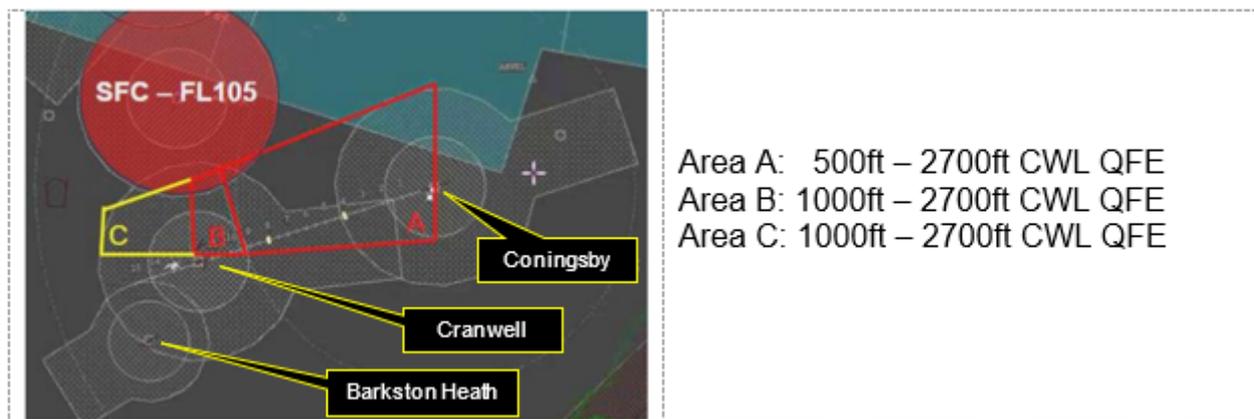
As a result of the proximity between RAF Cranwell and RAF Coningsby, local procedures are established to manage interactions between RAF Cranwell RW08RH departures and RAF Coningsby RW07RH recoveries. On this occasion, Coningsby Sterile Area A, depicted in Figure 1,

had been activated; imposing both a 'Call for Release' and Climb Out Restriction of 1400ft QFE on all RAF Cranwell RW08RH departures.<sup>2</sup>

Figure 1. Coningsby Sterile Areas.

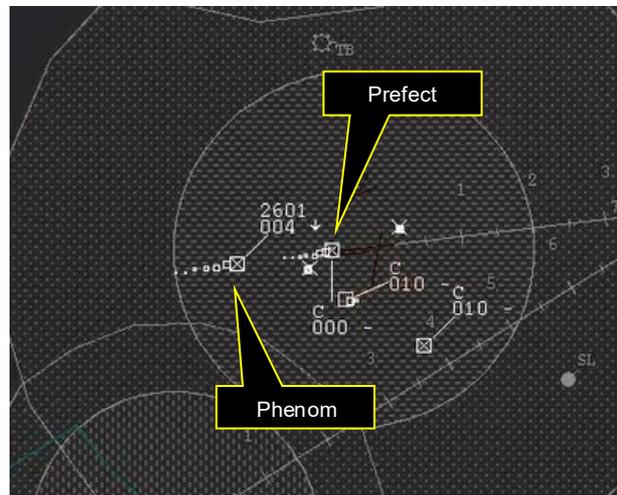
Figure 2 (1513:33) - Phenom cleared with Prefect climbing upwind.

The Cranwell Tower controller sequenced the Prefect and Phenom by clearing the Prefect to touch-and-go at 1512:00, then visually continuing the Phenom past 3 miles at 1512:42, before issuing a clearance to touch-and-go to the Phenom at 1513:33, once the Prefect was airborne.

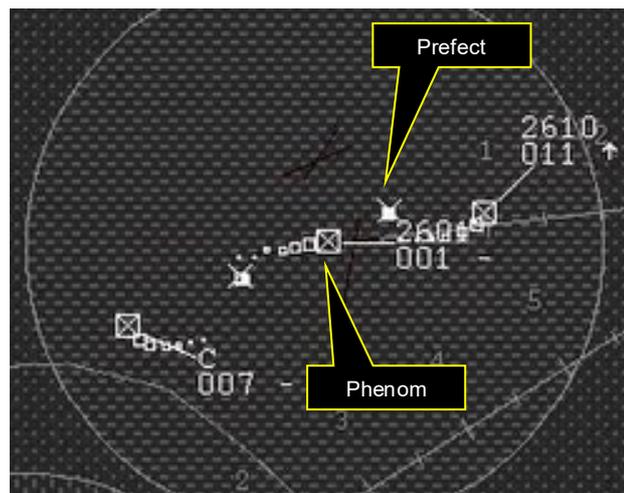
At 1514:17, whilst climbing upwind, the Prefect pilot reported changing to Cranwell Departures. The Cranwell Tower controller issued the Climb-Out Restriction of not above 1400ft, which was acknowledged by the Prefect pilot. At 1514:27, the Cranwell Tower controller observed the Prefect commencing the previously issued VFR Non-Standard Left Turn and instructed the Prefect to depart End of Downwind Leg. This resulted in the Prefect pilot reversing the turn and crossing back through the extended centreline.

Figure 3 (1514:27) - Prefect pilot instructed to depart end of downwind leg. (Separation: 1.4NM)

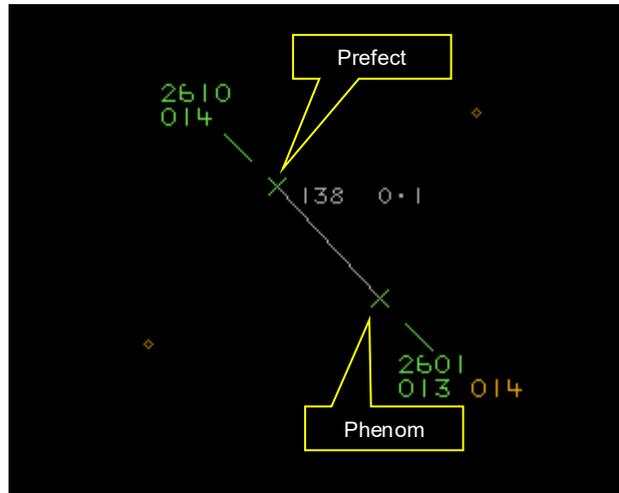
CPA occurred at 1515:11 and recorded as 0.1NM and 100ft separation.

Figure 5 (1515:11) - CPA.
