**AIRPROX REPORT No 2023189**

Date: 21 Aug 2023 Time: 1109Z Position: 5213N 00007W Location: 2.5NM N Gransden Lodge

**PART A: SUMMARY OF INFORMATION REPORTED TO UKAB**

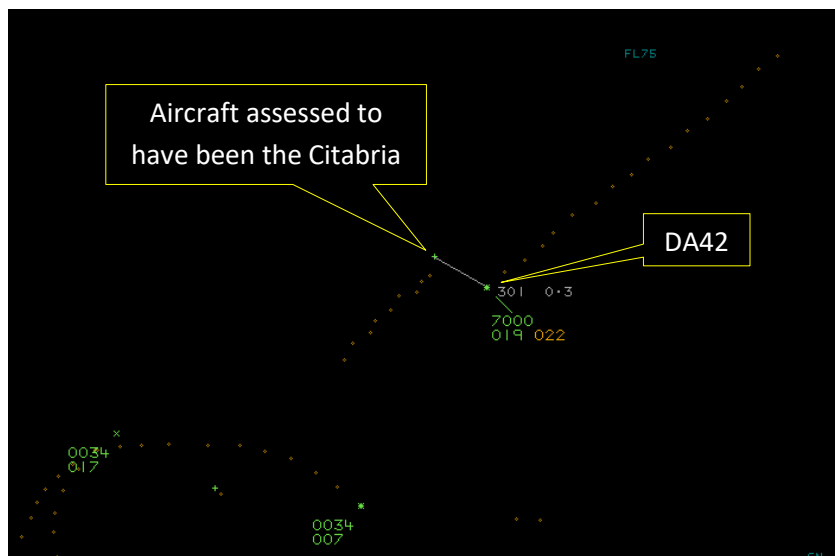
Figure 1 – CPA at 1109:30

An analysis of the NATS radar replay was undertaken and the DA42 could be positively identified from Mode S data (see Figure 1). The pilot of the glider being towed by the Citabria provided GPS track data for their flight. Although not observed on radar, the location and timings from the GPS track data for the glider (towed by the Citabria until, reportedly, 5sec before CPA) broadly corresponded to a primary-only return seen on radar.

It was by combining the separate data sources that the diagram was constructed and the horizontal separation at CPA determined. The vertical separation at CPA could not be determined. The Citabria and DA42 pilots shared an equal responsibility for collision avoidance and not to operate in such proximity to other aircraft as to create a collision hazard.<sup>2</sup> If the incident geometry is considered as head-on or nearly so then both pilots were required to turn to the right.<sup>3</sup>

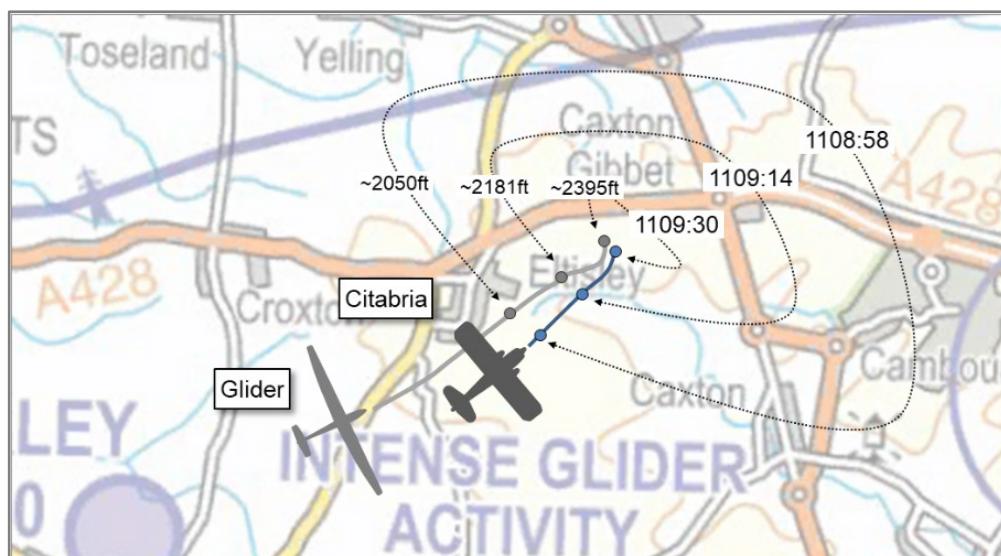
Figure 2 – The GPS track of the glider combined with the radar track of the Citabria

Although there existed some lateral displacement between the GPS track and the radar track, the primary-only return was assessed to have been the Citabria (see Figure 2).

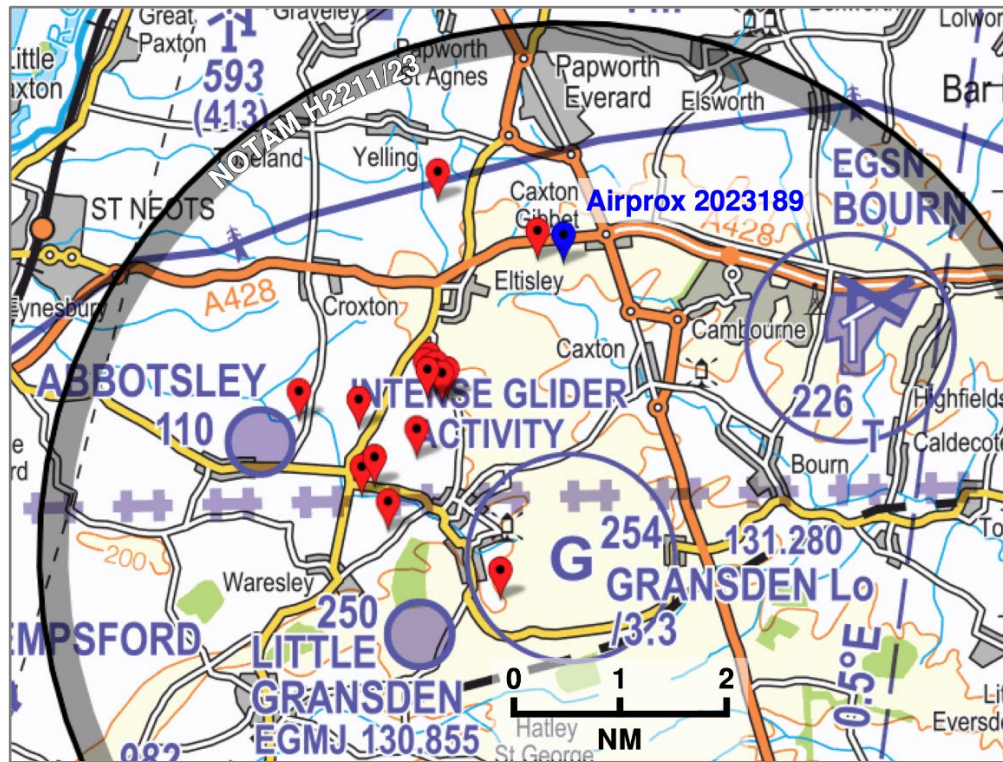
Figure 3 - Locations of the 15 launched competition gliders at the time of CPA

The red markers in Figure 3 show the positions of the 15 competition gliders in the air at the time of the Airprox (1109:30), based on data from the secure GPS loggers carried by each contestant. These gliders' altitudes range from 720ft AMSL (while on tow) to 3050ft AMSL (i.e. soaring near cloudbase). At this time there were also six tow-planes flying in the NOTAM'd area between Gransden Lodge airfield and Caxton Gibbet at altitudes up to 2300ft AMSL; they are not shown in Figure 3. The blue marker shows the location of the Airprox.

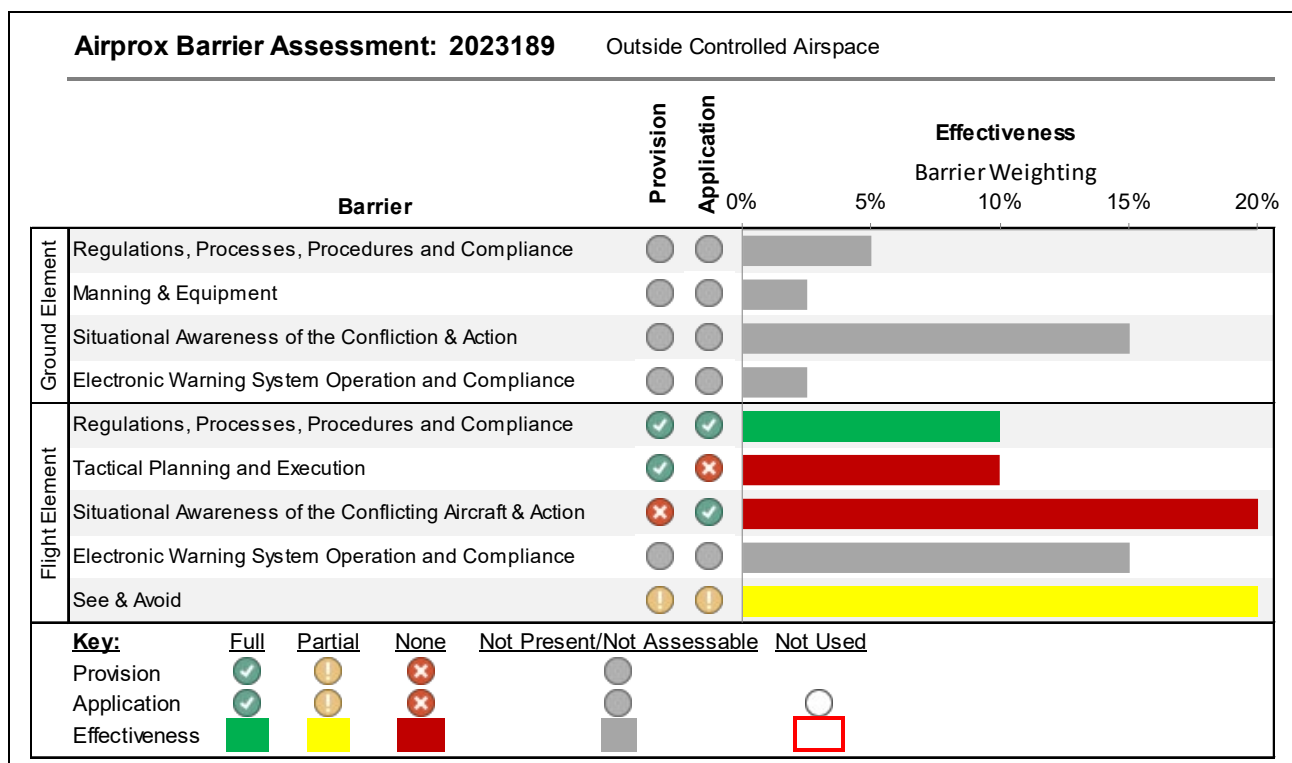
**Tactical Planning and Execution** was assessed as **ineffective** because the pilot of the DA42 had transited through an area of intense glider activity and had not transmitted their intentions on the Gransden Lodge Traffic frequency.

**Situational Awareness of the Conflicting Aircraft and Action** were assessed as **ineffective** because the pilot of the Citabria had not had situational awareness of the presence of the DA42.

**See and Avoid** were assessed as **partially effective** because the pilot of the Citabria had sighted the DA42 late.
