AIRPROX REPORT No 2023261

Date: 05 Dec 2023 Time: ~1532Z Position: 5625N 00324W Location: Perth ATZ

PART A: SUMMARY OF INFORMATION REPORTED TO UKAB

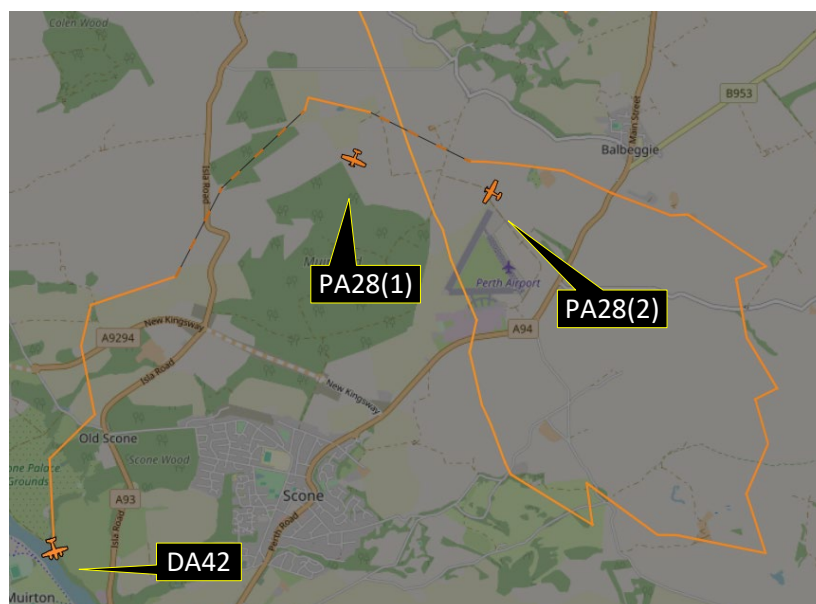
An analysis of the NATS radar replay was undertaken. No aircraft were observed on radar in the moments leading up to CPA. The DA42 was observed from MLAT data (Figure 1) although the track data was fragmented and the DA42 disappeared from view at approximately 1530:10.

Figure 1 – Aircraft positions at 1531:10 (approximately 30sec before CPA) (MLAT and ADS-B data)

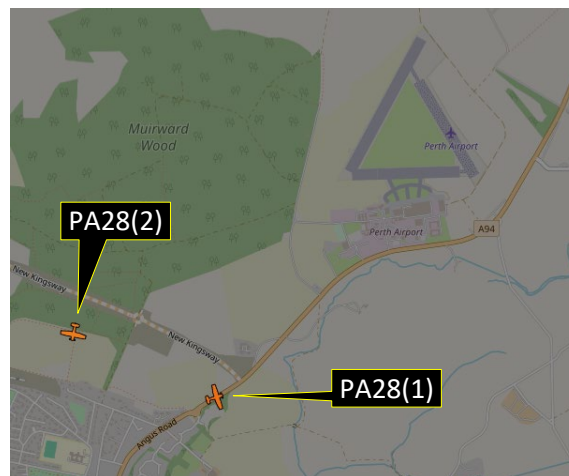
A review of ADS-B data replay was undertaken and both PA28s were observed. The pilot of PA28(1) (who supplied a narrative report as reproduced above) appeared to have been ahead of PA28(2) in the circuit and had turned onto final-approach in the moments leading up to CPA (Figure 2). The relative positions of all 3 aircraft at the moment of CPA could not be determined.

Figure 2 - The relative positions of PA28(1) and PA28(2) at 1531:40 (approximate time of CPA) (ADS-B data)
