**AIRPROX REPORT No 2024143**

Date: 23 Jun 2024 Time: 0915Z Position: 5155N 00118W Location: 5NM NNE of Oxford Kidlington

**PART A: SUMMARY OF INFORMATION REPORTED TO UKAB**

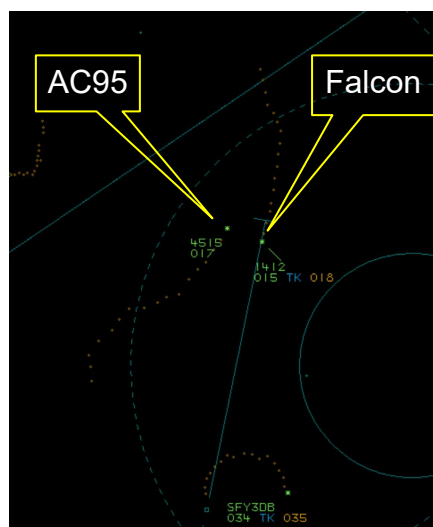
been level at 1800ft, and was approximately 1NM from commencing final descent). The Falcon pilot responded with "got it on TCAS". The CPA occurred at approximately 0915:15, the two aircraft approximately 3/4 mile apart on roughly reciprocal headings, with Mode C showing a 200ft variance, with the AC95 being above the Falcon.

This difference is smaller than the minimum accuracy of Mode C (+/- 200 feet), making the actual variance in the range 0-600ft. The AC95, having passed to the right of the Falcon, had resumed a more northeasterly course and passed behind it. No TCAS RA was reported by either pilot on RT, but the crew of the Falcon reported the RA by telephone after landing.

CPA 0915:14 200ft V/0.7NM H
