AIRPROX REPORT No 2024223

Date: 28 Aug 2024 Time: 1130Z Position: 5627N 00315W Location: 4NM east of Perth

PART A: SUMMARY OF INFORMATION REPORTED TO UKAB

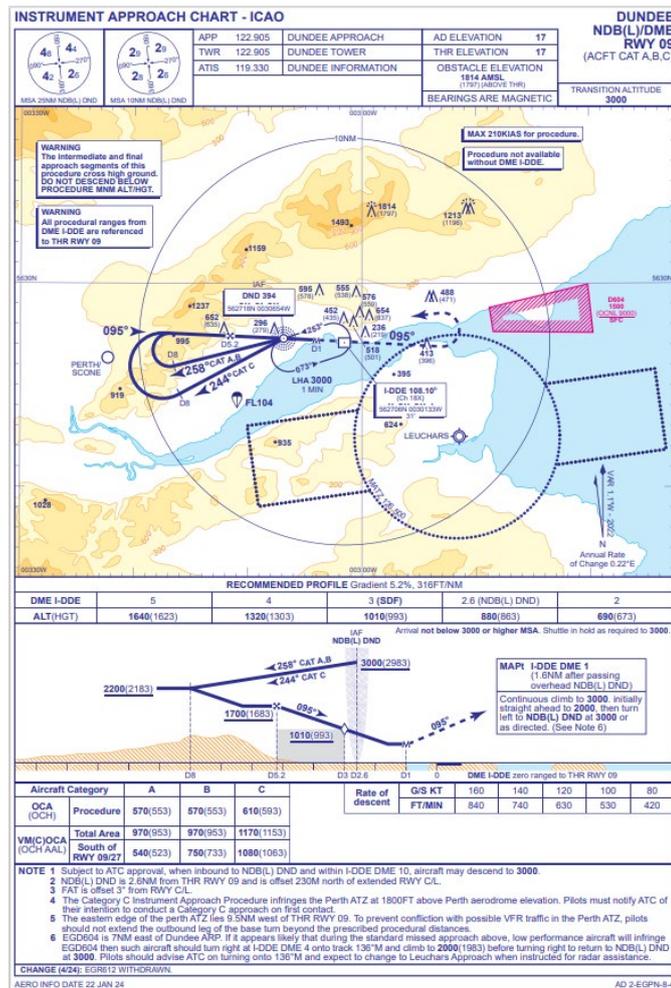
Figure 1 – Dundee NDB(Loc)/DME Approach RW09 procedure

The approach procedure that [the DA42 pilot] was completing was the NDB (Loc)/DME approach to RW09 (Figure 1).

At the approximate point of the Airprox, [the DA42] would have been descending from 2200ft Dundee QNH to not below altitude 1700ft Dundee QNH.

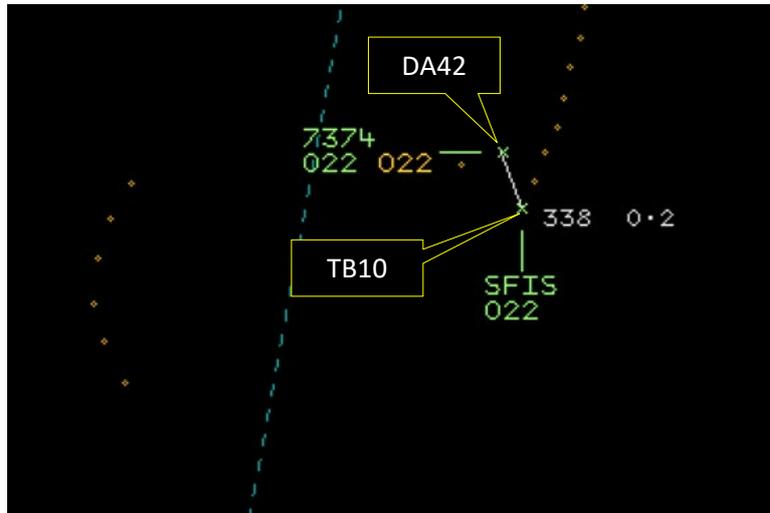
Figure 2 – 1130:11 CPA separation 0.2NM and 0ft

CPA was assessed to have occurred at 1130:11 with 0.2NM horizontal and 0ft vertical separation.
