AIRPROX REPORT No 2024227

Date: 29 Aug 2024 Time: 1420Z Position: 5324N 00008W Location: Kelstern

PART A: SUMMARY OF INFORMATION REPORTED TO UKAB

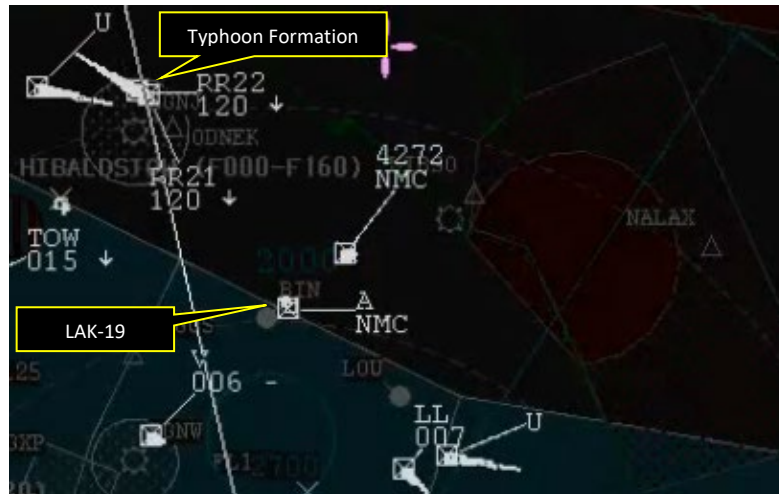
Figure 1 (1417:57). Typhoon formation checked in.

At 1417:57, the Typhoon formation level at FL120 contacted the Coningsby Approach controller requested a Traffic Service following a radar handover from Swanwick Military. The Coningsby Approach controller acknowledged FL120, issued a Traffic Service and then passed the Coningsby information Code for recovery.

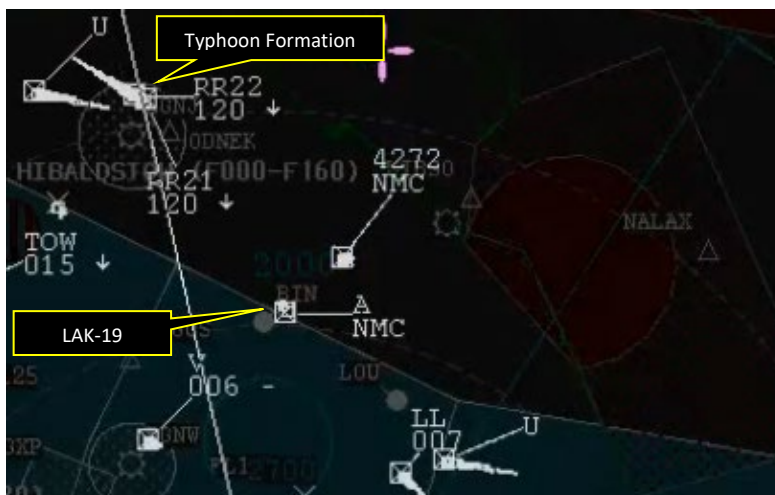
Figure 2 (1418:22). Typhoon formation cleared for Visual Recovery.

At 1418:22, the Coningsby Approach controller cleared the Typhoon formation “own navigation, taking your own terrain separation descent is approved, there’s no radar traffic to affect and the visual circuit is currently clear. Report aerodrome in sight”.

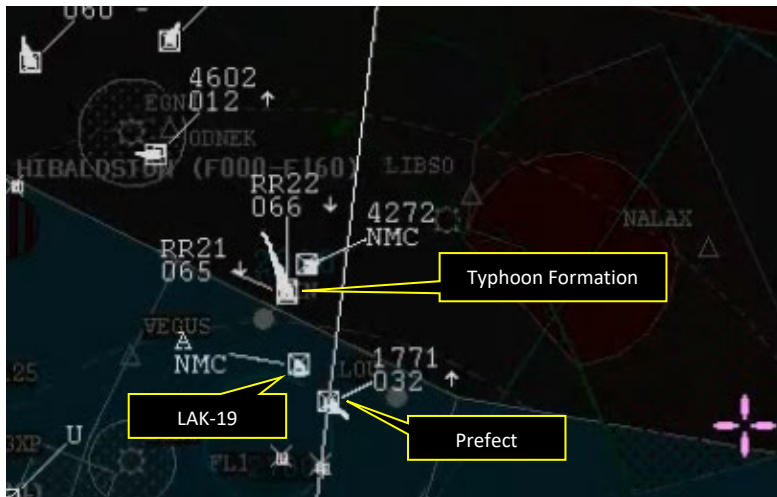
Figure 3 (1419:49). Typhoon formation provided Traffic Information.

At 1419:49, the Coningsby Approach controller provided the Typhoon formation with Traffic Information regarding the Prefect *“traffic, south-east, 3 miles, tracking north-west, indicating 3000ft and climbing a Prefect”*. The Typhoon formation acknowledged the Traffic Information, reported sensor contact³ and that they would not descend below 5000ft.

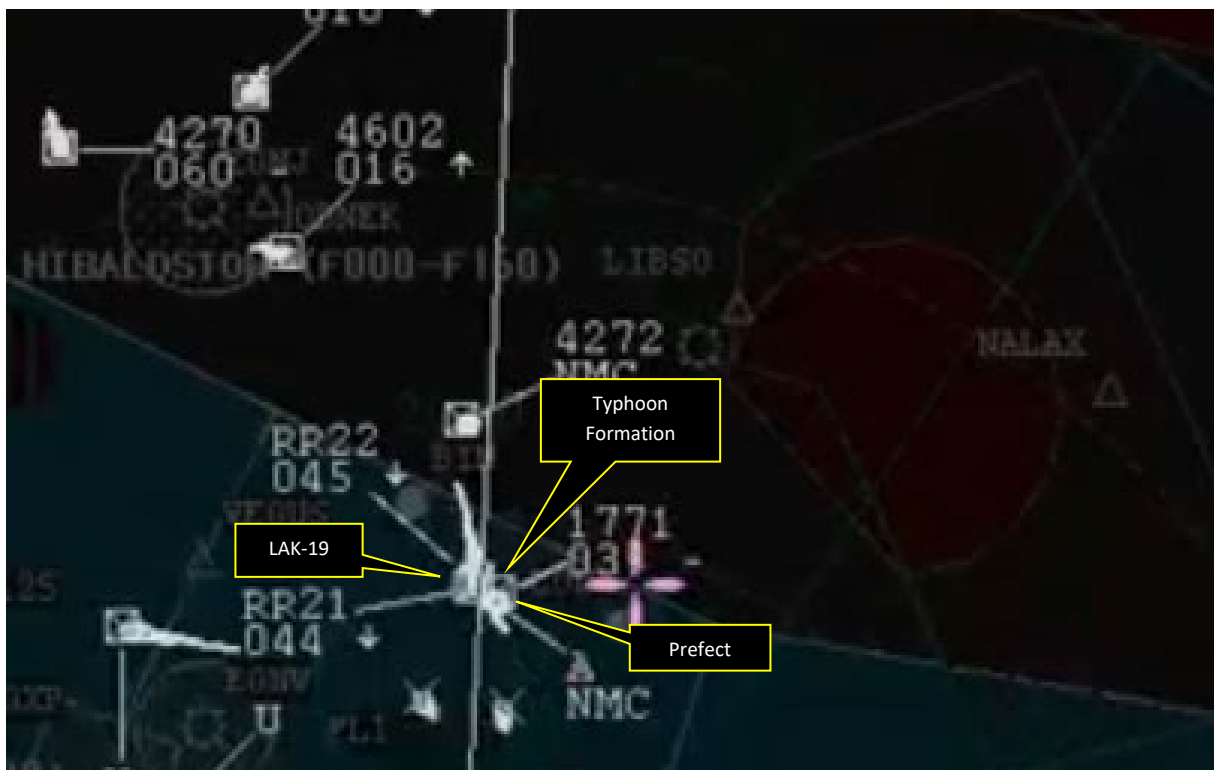
Figure 4 (1420:25). Reported CPA.

CPA occurred at approximately 1420:25 and reported as 100-200ft horizontal and 0ft vertical separation.
