AIRPROX REPORT No 2024229

Date: 31 Aug 2024 Time: 1051Z Position: 5005N 00540W Location: 1NM SSE of Land's End Airfield

PART A: SUMMARY OF INFORMATION REPORTED TO UKAB

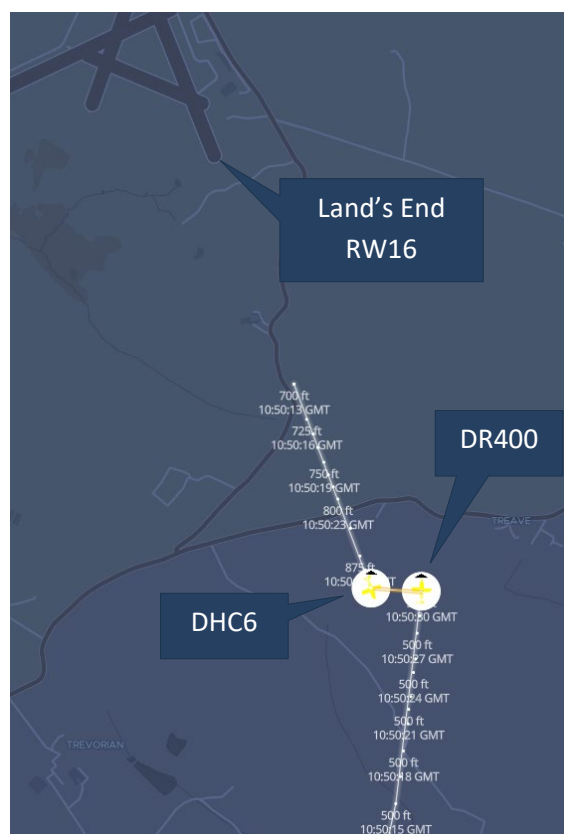
Figure 2 – 1050:30 CPA separation 480ft and <0.1NM

An analysis of ADS-B data was undertaken with both aircraft visible throughout. The CPA was assessed to have occurred at 1050:30 with 480ft vertical and less than 0.1NM lateral separation (Figure 2).

It was noted that the closest recorded vertical separation was 240ft when the DHC6 appeared on ADS-B software data and the DR400 was at 0.8NM horizontally at 1050:15. Tracks and altitudes were taken from the GPS navigation data supplied by both pilots which verified the ADS-B tracks.
