**AIRPROX REPORT No 2024234**

Date: 13 Sep 2024 Time: 0852Z Position: 5141N 00002W Location: Cheshunt

**PART A: SUMMARY OF INFORMATION REPORTED TO UKAB**

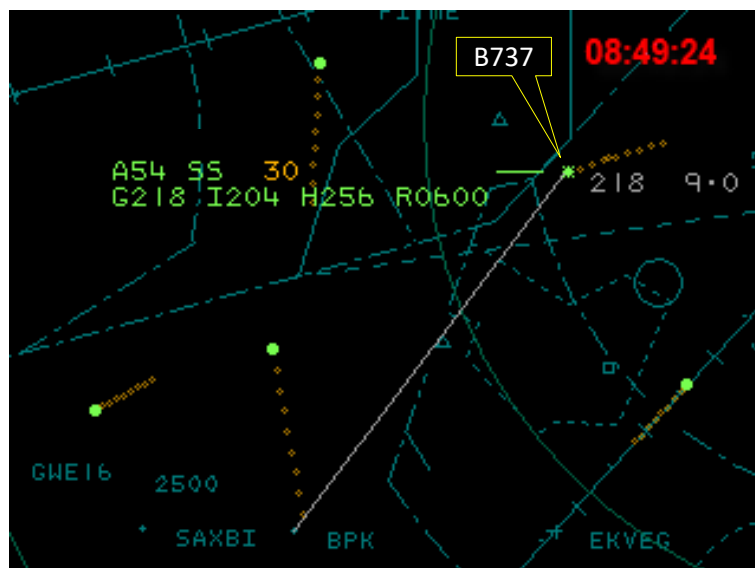
Figure 1

[The B737] crossed BPK DME 9NM at 0849:24 at 5400ft with a rate of descent of 600fpm (see Figure 1).

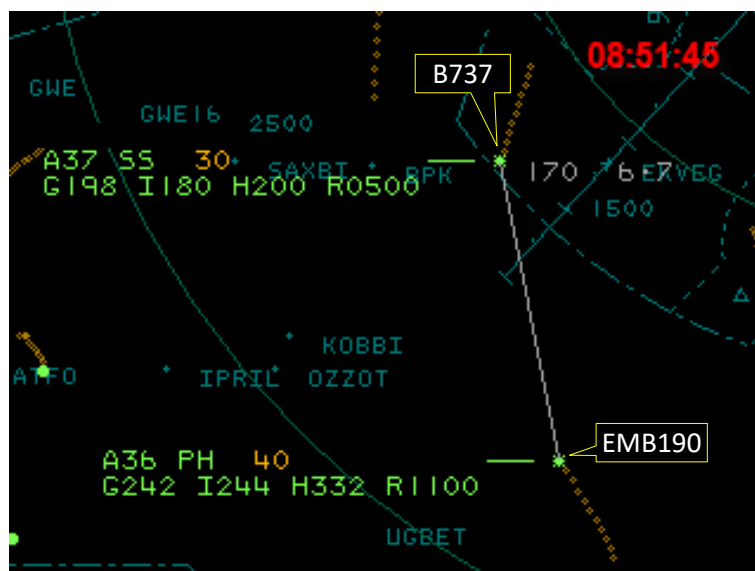
Figure 2

At 0851:45 the TC NE controller instructed the pilot of [the EMB190], *"Avoiding action, turn left immediately heading of two nine zero degrees"* (see Figure 2).

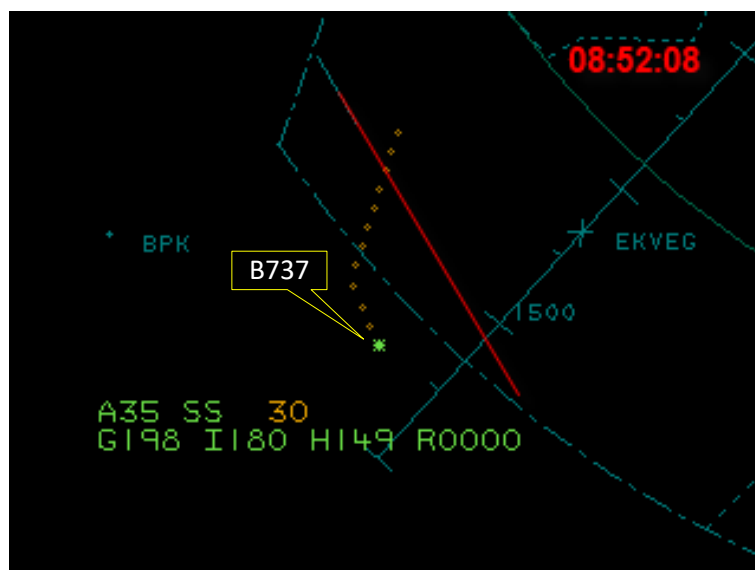
As the initial instruction to turn left to EKVEG was given by the SS INT controller (0851:28), [the B737] was abeam the line displayed on the radar map which is 3NM from the CPT/BPK London City SID track. The left turn resulted in the aircraft positioning south of the line (see Figure 3, which shows the aircraft's position 40sec after the initial instruction was given).

Note: The referenced radar-displayed line has been extended (red line) in Figure 3 by Safety Investigations.

TC MATS Part 2 STN 5.2.2 Procedures RMA-E further detailed 'TC Stansted will ensure that aircraft in the 3000ft portion of the Stansted RMA are separated from London City departures via BPK. To assist in compliance with this requirement, a line has been added to the Stansted radar map to denote a position 3NM from and parallel to the London City - CPT/BPK SID track.' (Figure 3)

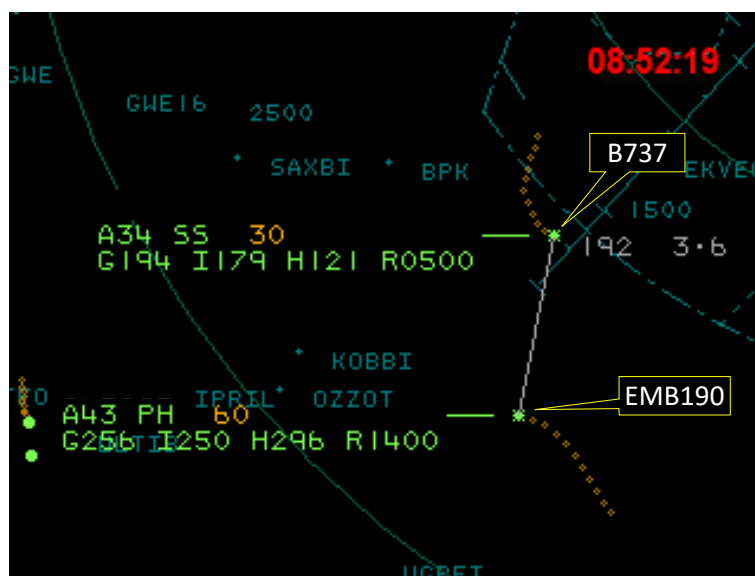
Figure 4 – CPA at 0852:19

At 0852:19 the TC NE controller informed the pilot of [the EMB190] they were clear of traffic and instructed them to turn right heading 325° (see Figure 4).

Separation was maintained throughout the event and the pilot of [the EMB190] subsequently submitted an Airprox report. The minimum lateral distance between the two aircraft was 3.6NM (see Figure 4), where 3NM was required.
