**AIRPROX REPORT No 2024235**

Date: 13 Sep 2024 Time: 1209Z Position: 5115N 00108W Location: Basingstoke

**PART A: SUMMARY OF INFORMATION REPORTED TO UKAB**

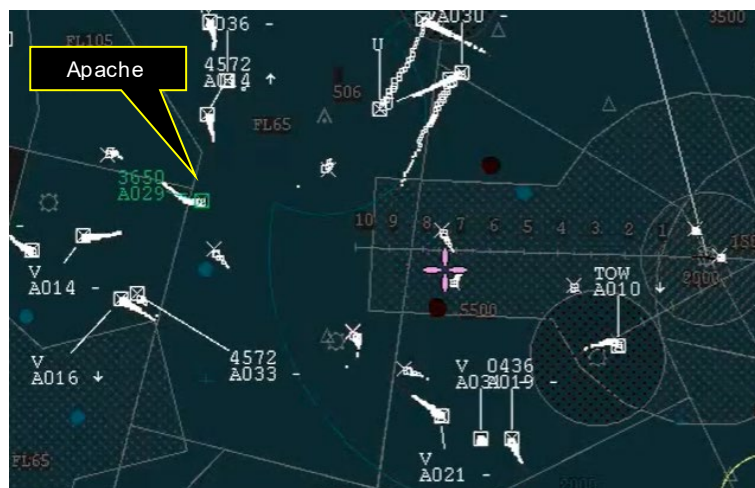
Figure 1 (1204:42). Apache pilot was approved for the procedure

At 1204:42, the Odiham Approach controller cleared the Apache pilot for own navigation to the COPTER TAC Initial Approach Fix. The Odiham Approach controller provided multiple Traffic Information calls with the Apache pilot initially reporting 'traffic not sighted' for all.

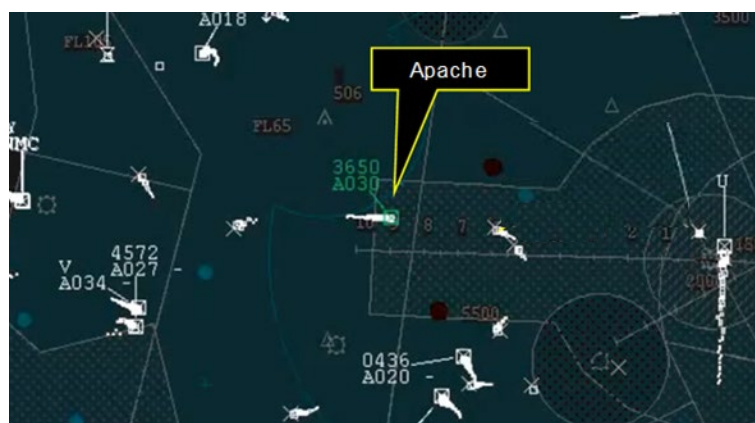
Figure 2 (1207:27)

At 1207:27, the Odiham Approach controller provided Traffic Information to the Apache pilot relating to an ASW27: *"traffic, east, 3 miles, tracking northwest, no height information, possible glider"*. The Apache pilot reported *"traffic not sighted"* (Figure 2).

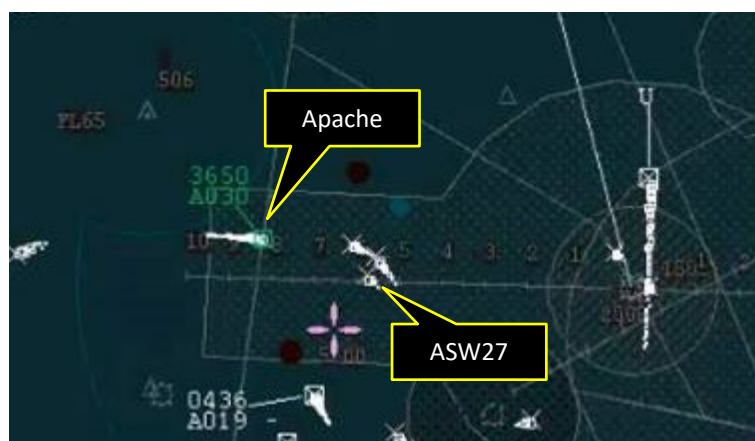
At 1207:48, updated Traffic Information was provided: *"previously called traffic, east, 2 miles tracking northwest, no height information, 3 tracks, possible gliders"*. Again, the Apache pilot reported *"still not sighted"* (Figure 3).

Figure 3 – 1207:49 (The ASW27 appeared as a primary-only contact).

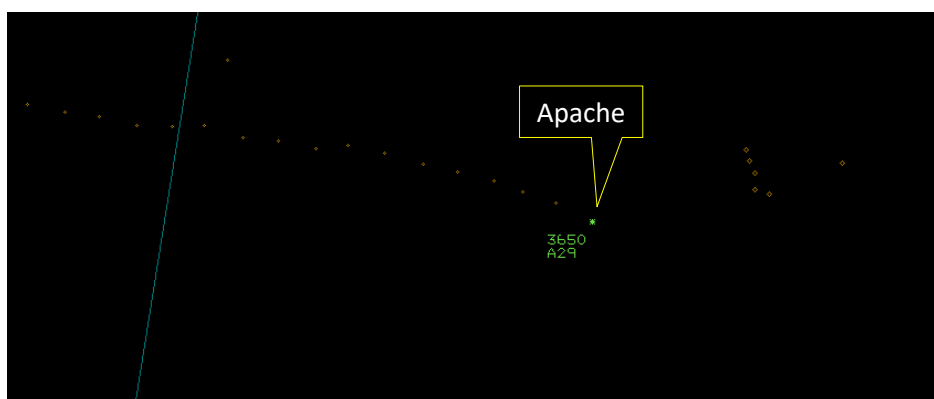
An analysis of the NATS radar replay was undertaken and the Apache was positively identified from Mode S data (Figure 4). The ASW27 could not be observed on the NATS radar replay.

Figure 4 – CPA at 1208:38 from NATS radar data

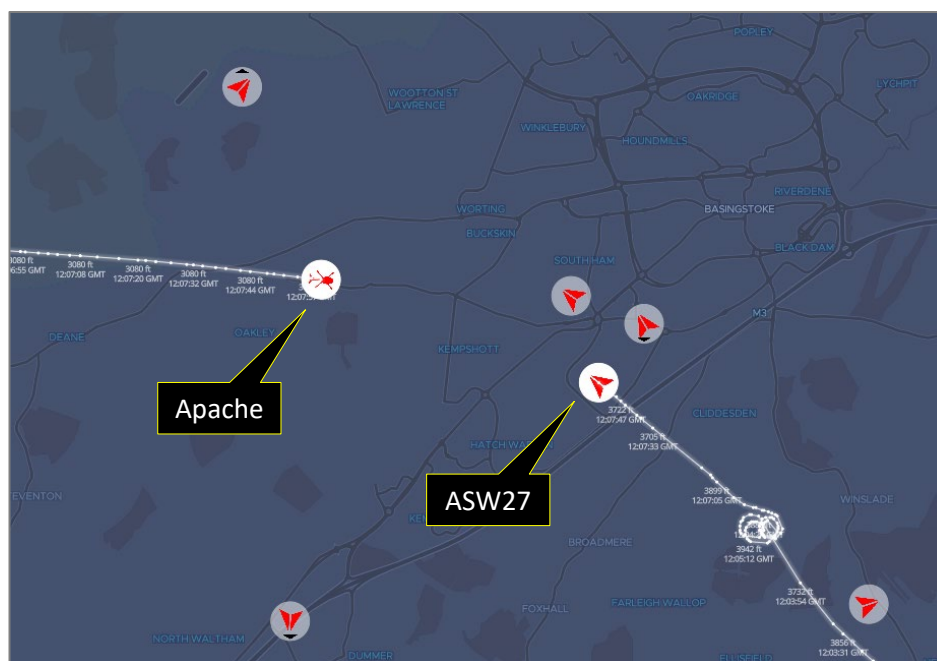
Figure 5 – The traffic situation at 1208 (38sec before CPA) from GPS data

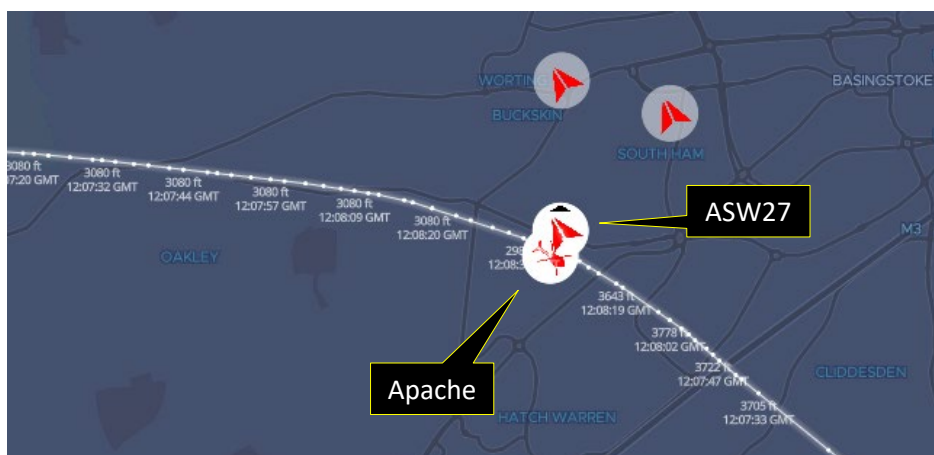
Figure 6 – 1208:40 (2sec after CPA) from GPS data

The pilot of the ASW27 kindly supplied GPS track data for their flight. The diagram was constructed and the separation at CPA determined by combining the various data sources. CPA was assessed to have occurred at 1208:38.
