**AIRPROX REPORT No 2024237**

Date: 17 Sep 2024 Time: 1333Z Position: 5243N 00037W Location: Kendrew Barracks, Rutland

**PART A: SUMMARY OF INFORMATION REPORTED TO UKAB**

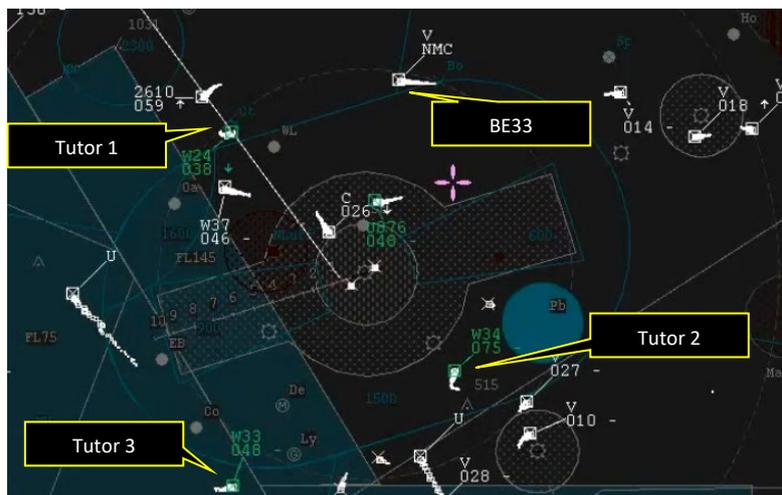
At 1332:02, the outgoing Wittering Zone controller passed further Traffic Information to the pilot of Tutor 3. The conflicting traffic was at a range of 3NM with no height information and with an opposite direction profile. The pilot of Tutor 3 requested the Traffic Information to be repeated, which the outgoing Wittering Zone controller did.

Figure 1 (1332:02). Traffic Information provided to the pilot of Tutor 3.  
(Separation: Tutor 1 to BE33 2.9NM)

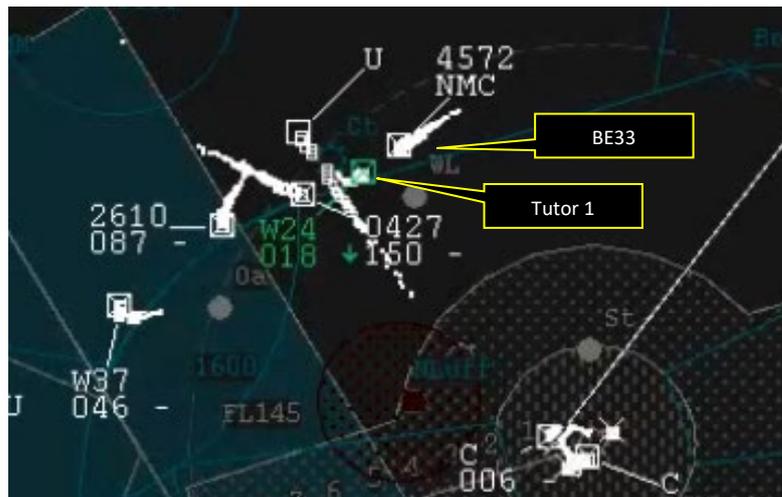
At 1332:40, the Wittering Zone controller provided Traffic Information to the pilot of Tutor 1; *“traffic northeast 1NM, tracking southwest, faster moving, no height information”*. The Tutor 1 pilot did not respond to the Traffic Information call.

Figure 2 (1322:40). Traffic information provided to Tutor 1.  
(Separation: 0.7NM)

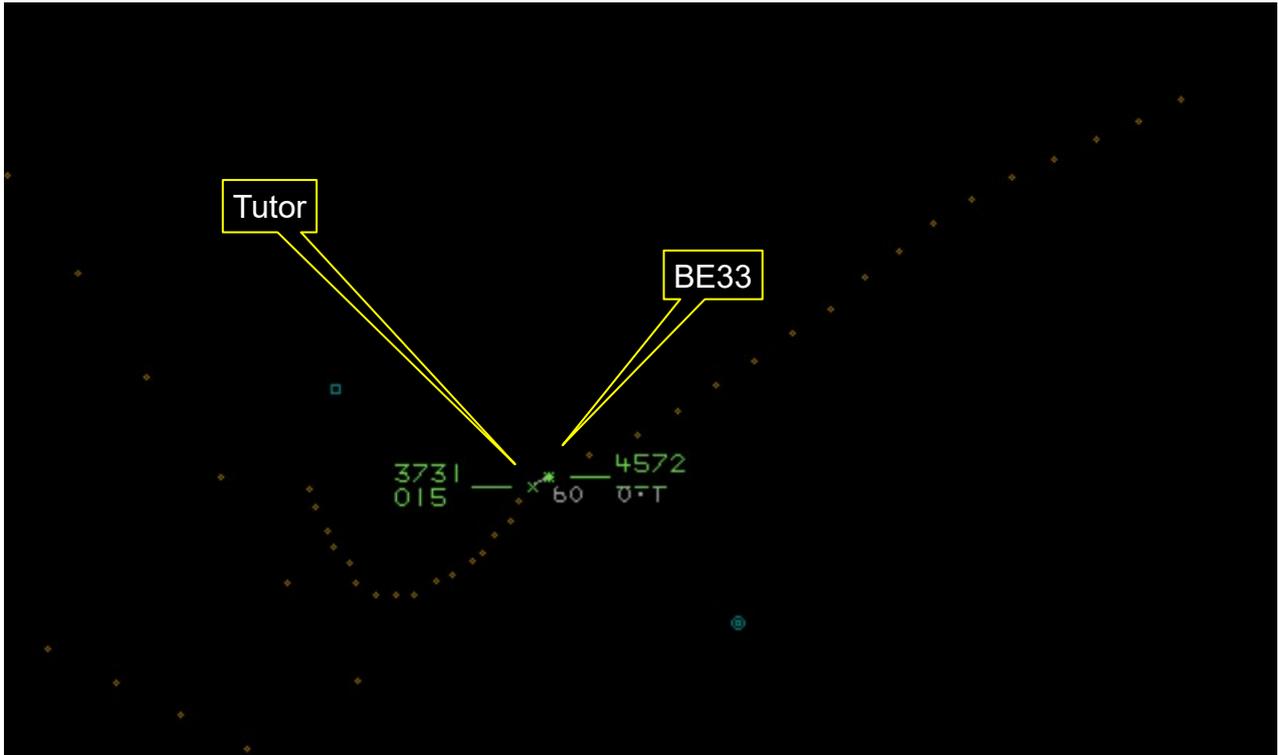
CPA occurred at 1332:47 and was recorded as 0.1NM with reported 100ft separation.

Figure 3: At CPA minus 1sec (1332:46) NK ft V/<0.1NM H
