AIRPROX REPORT No 2024238

Date: 17 Sep 2024 Time: 1139Z Position: 5140N 00027W Location: 1NM SW of Watford

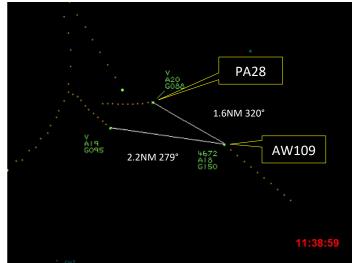
Figure 1 – Time 1138:59

The pilot read back, *"reduced Traffic Service, [c/s]"* at 1138:59. Radar recordings showed that two contacts, both squawking VFR conspicuity, were potentially present in the position of the traffic described by the pilot of the [AW109] (Figure 1).

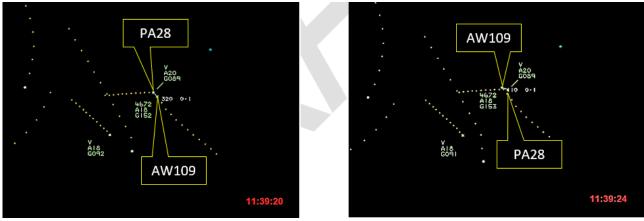
Figure 2 – Time 1139:20

The Luton Radar controller then transmitted "[AW109 c/s], cleared to transit VFR not above altitude two thousand four hundred feet, remaining west of Dunstable Downs gliding site, who are active". The pilot completed read back of the clearance at 1139:18. All three aircraft continued on the trajectories as displayed in Figure 1, with the more westerly of the tracks passing down the left-hand side of [AW109] whilst the other, identified by Mode S, PA28 indicating 2000ft on Mode C, continued to cross the track of [the AW109] (Figure 2 and 3).

The closest point of approach, measured at 0NM laterally and 200ft vertically, occurred as the aircraft tracks passed, between the two radar updates at approximately 1139:22.

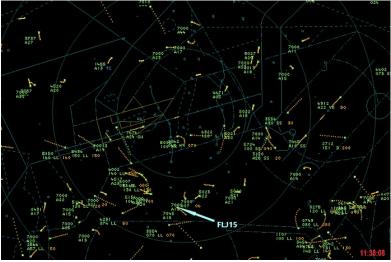
Figure 4 – Prior to the AW109 changing to Luton squawk

The Luton Radar controller was highly experienced in their role and described that providing services to aircraft outside controlled airspace was a task they carried out multiple times a day. They were operating both Luton Intermediate and Final Director positions at the time of the event; traffic levels and workload on the sector were low, with their attention being given to establishing the positioning of aircraft expected on frequency to formulate a plan for sequencing. Visibility and weather conditions were good [see METAR above]. Outside the Luton sectors, a significant number of Heathrow arrivals were holding at the various stacks under the control of Heathrow Approach and other TC sectors. When the pilot of [the AW109] first contacted the Luton radar controller, the aircraft was 8NM southeast of Bovingdon (BNN) on a track towards the beacon, whilst four aircraft were established in the published BNN hold pattern. This area was in the bottom left-hand corner of the GW Radar controller's display (Figure 4), with the holding traffic causing significant radar clutter ahead of the track of [the AW109].

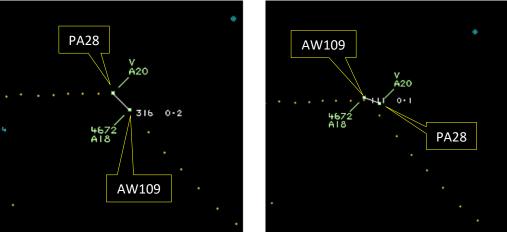
Figure 5 - Time 1139:22

An analysis of the NATS radar replay was undertaken and both aircraft were identified using Mode S data. The AW109 was heading approximately northwest at a steady altitude of 1800ft and the PA28 was identified flying three anticlockwise orbits before heading south, then east towards the AW109 at 2000ft. NATS radar altitudes are based on London QNH 1031hPa (Figures 5 and 6).

Interpolation of the aircraft positions between 1139:22, where the aircraft were 0.2NM apart, and 1139:26, where the aircraft were 0.1NM apart having crossed tracks, indicated the CPA at 1139:25 with a lateral separation of less than 0.1NM and a vertical separation of 200ft.
