**AIRPROX REPORT No 2024239**

Date: 20 Sep 2024 Time: 1454Z Position: 5302N 00030W Location: Cranwell ATZ

**PART A: SUMMARY OF INFORMATION REPORTED TO UKAB**

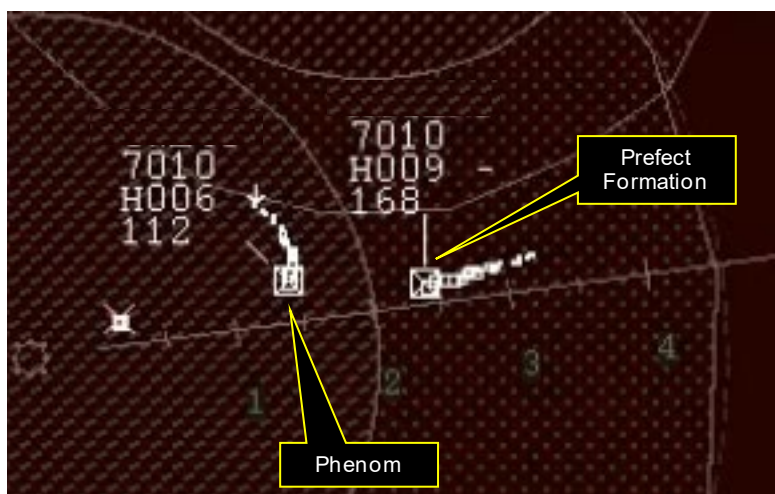
Figure 1 - 1453:00. Prefect formation reported at initial.

At 1453:00, the Prefect formation reported at initial. The Cranwell Tower controller acknowledged that and provided standard circuit Traffic Information: *“Phenom short finals, touch-and-go, remain, wind 050 12”*. The Prefect formation had positioned for a low-level circuit, established at 500ft on Cranwell QFE.

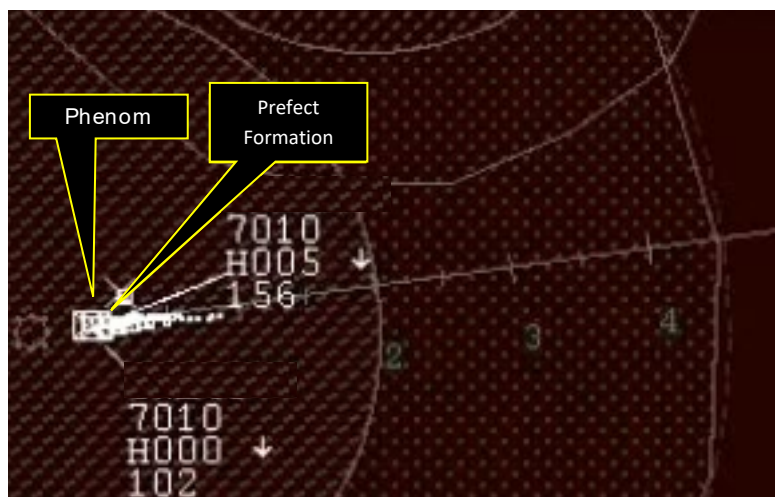
Figure 2 (1453:54). Prefect formation reported on the break.

At 1453:54, the Prefect formation reported on the break with an intention for a low circuit to land in the order 1, 2, 3. Breaking last, Prefect 3 turned right-to-left across and overhead the Phenom, causing the Phenom pilot to level-out from the climb following the touch-and-go.

CPA occurred at 1453:56 and was recorded as 0.0NM and 400ft separation.

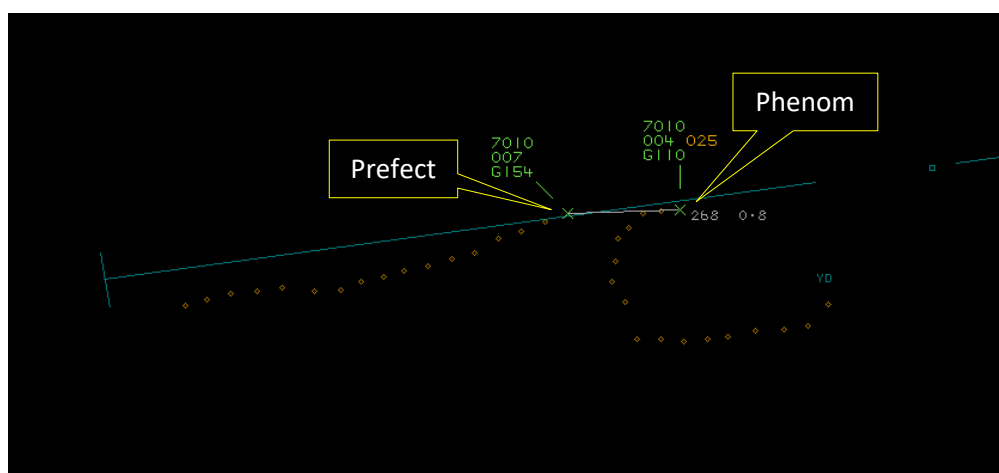
Figure 3 – Aircraft positions at 1453:18

An analysis of the NATS radar replay was undertaken and the Phenom could be positively identified from Mode S data. The formation-lead Prefect could be positively identified from Mode S data. The three Prefects in formation were not observed individually on the replay due to system processing resolving the radar returns into a single contact (Figure 3).
