**AIRPROX REPORT No 2024242**

Date: 17 Sep 2024 Time: 1349Z Position: 5054N 00111W Location: Wickham VRP

**PART A: SUMMARY OF INFORMATION REPORTED TO UKAB**

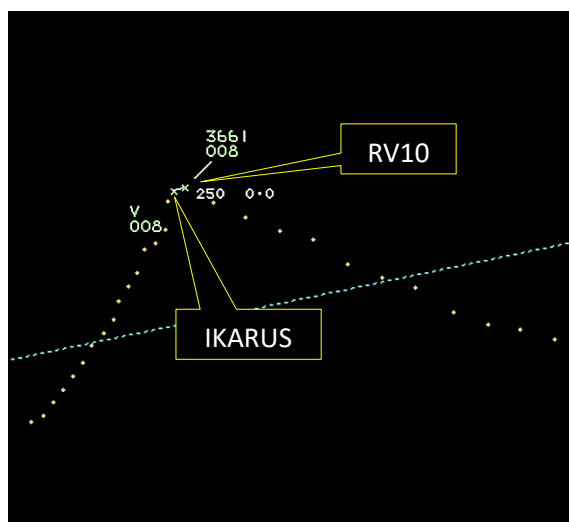
An analysis of the NATS radar replay was undertaken and both aircraft were positively identified using Mode S data. CPA was assessed to have occurred at 1349:22 with the aircraft co-altitude at 800ft on 1013hPa (Figure 1).

Figure 1 – Time 1349:22 CPA 0ft vertical and less than 0.1NM lateral separation

Further analysis was undertaken from the aircraft navigation GPS data, which verified the tracks converging at VRP Wickham.
