AIRPROX REPORT No 2024246

Date: 28 Sep 2024 Time: 1126Z Position: 5109N 00103W Location: 2.5NM SSW Lasham

PART A: SUMMARY OF INFORMATION REPORTED TO UKAB

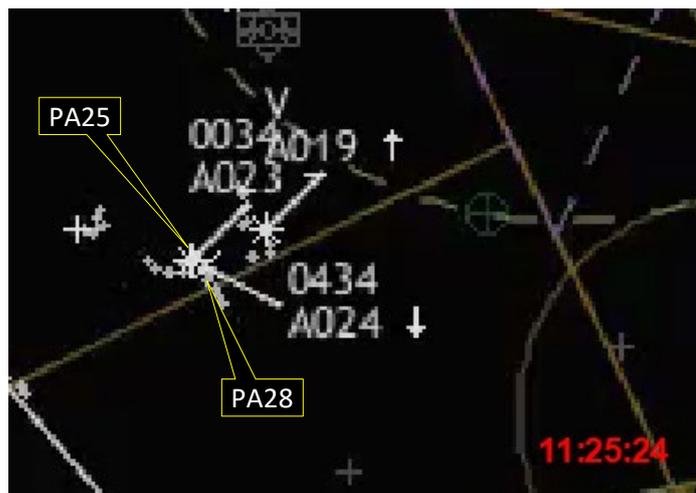
Figure 1

At 1125:24, the LF LARS controller issued Traffic Information to the pilot of [the PA28], advising them to “*keep a very good lookout, got multiple contacts in your vicinity, some of which are indicating very similar level to yourself. On the..., particularly..., i think there's one manoeuvring just off your left hand side, slightly ahead.*” The pilot acknowledged the call (Figure 1).

The Traffic Information was followed by the LF LARS controller informing the pilot at 1125:35 that the other aircraft was “*indicating a glider tow so keep a very good lookout*”, the pilot replied, “*I have two in sight*”.

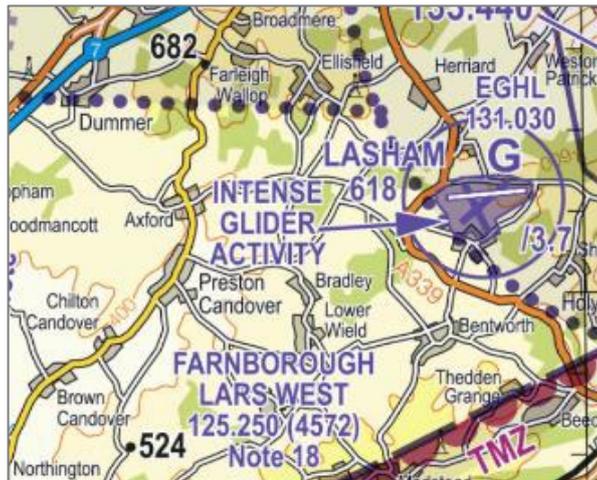
Figure 2

An 'Intense Glider Activity' area is identified in the vicinity of Lasham Aerodrome on VFR aeronautical charts (Figure 2).

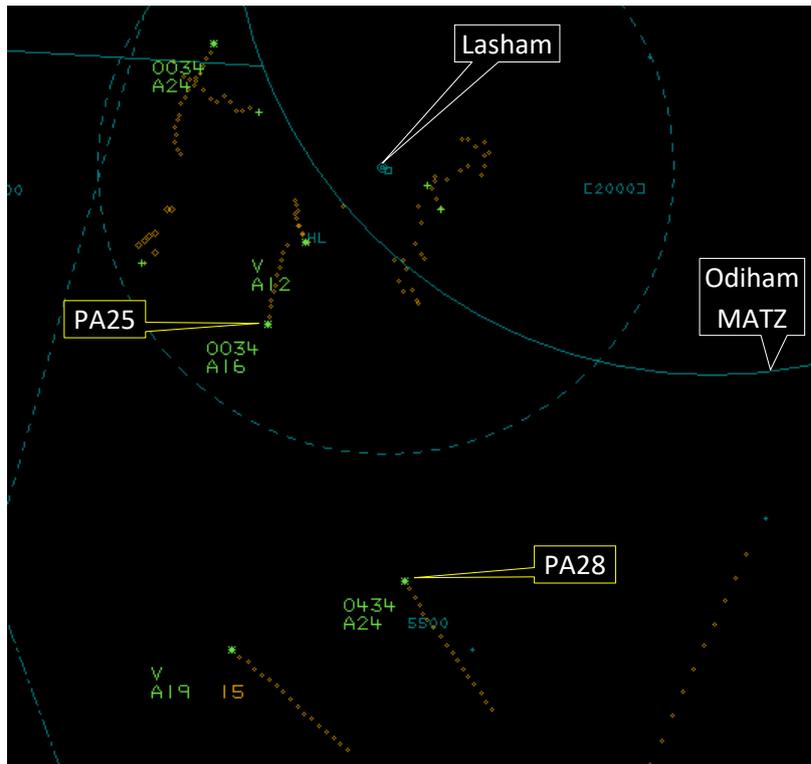
Figure 3 – 1124:06. The separation between the PA25 and PA38 was 3NM

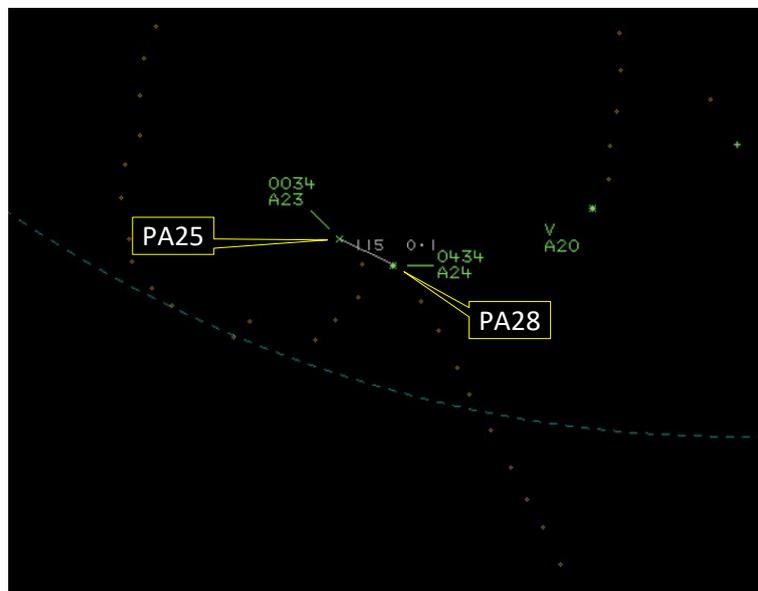
CPA was assessed to have occurred between the radar sweeps at 1125:30 and 1125:34 (Figures 4 and 5). The vertical separation at CPA has been assessed as approximately 0ft as the PA25 had climbed, and the PA28 had descended, between sequential sweeps.

Figure 4 – Aircraft positions at 1125:30

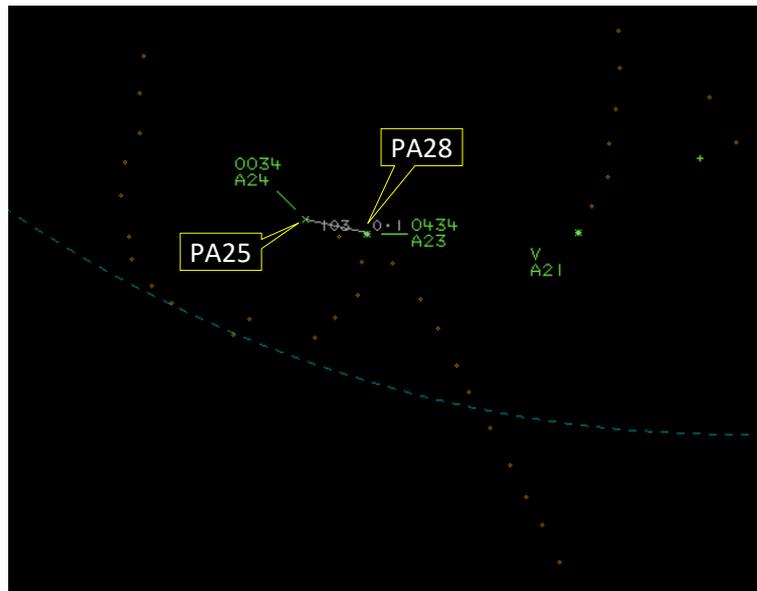
Figure 5 – Aircraft positions at 1125:34
