AIRPROX REPORT No 2024247

Date: 28 Sep 2024 Time: 1225Z Position: 5118N 00051W Location: Blackbushe circuit

PART A: SUMMARY OF INFORMATION REPORTED TO UKAB

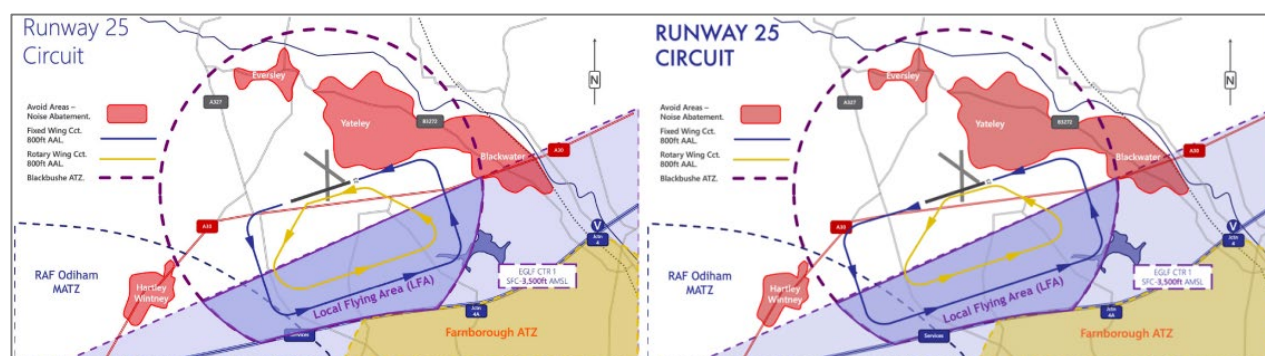
On reviewing the published circuit diagrams, it was observed that the crosswind leg for a RW25 circuit was shown quite tight. These diagrams had been published in 2018 and were not intended to be to scale, rather to indicate the direction of travel. The circuit usually established by long-time resident pilots is usually quite a bit wider. It may be considered that the operator of [the PA28], who has been resident at the aerodrome only for the last couple of years, may have considered the published circuit diagram to be to scale, and followed it accordingly. In light of this, Blackbushe Airport has updated its Rules & Procedures, effective 6th November 2024 to version 8b. The 8a (left) and 8b (right) diagrams are shown below (Figure 1).

Figure 1 – Blackbushe circuit pattern at time of Airprox (V8a) and revised version (V8b)

The occurrence was discussed amongst the AAM, Technical Officer, Tower Manager and duty AFISO. It was agreed that it would be beneficial to produce updated circuit diagrams (distributed on the website, and navigation devices) to indicate a slightly larger circuit (laterally). This may aid the integration of traffic joining from the north/west and provide more time for those aircraft to observe established circuit aircraft whilst on the climbout. At the time of completing this report, these diagrams have been published effective 6th November 2024.

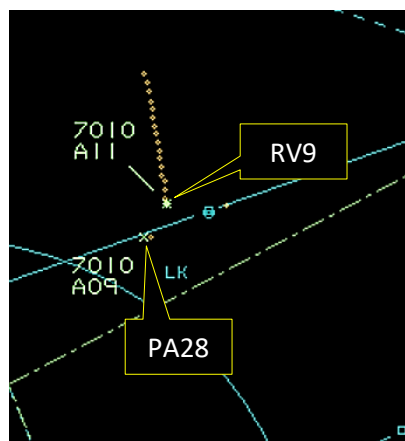
An analysis of the NATS radar replay was undertaken and both aircraft were identified using Mode S data. The PA28 was in the circuit at Blackbushe and became visible on radar during its climbout from a 'touch and go' at 1223:50 while the RV9 joined the circuit from the deadside (Figure 2).

Figure2 – Time 1223:50 the PA28 climbing out and the RV9 joining.
