AIRPROX REPORT No 2024249

Date: 02 Oct 2024 Time: 1131Z Position: 5414N 00109W Location: 1NM NNE of Sutton Bank

PART A: SUMMARY OF INFORMATION REPORTED TO UKAB

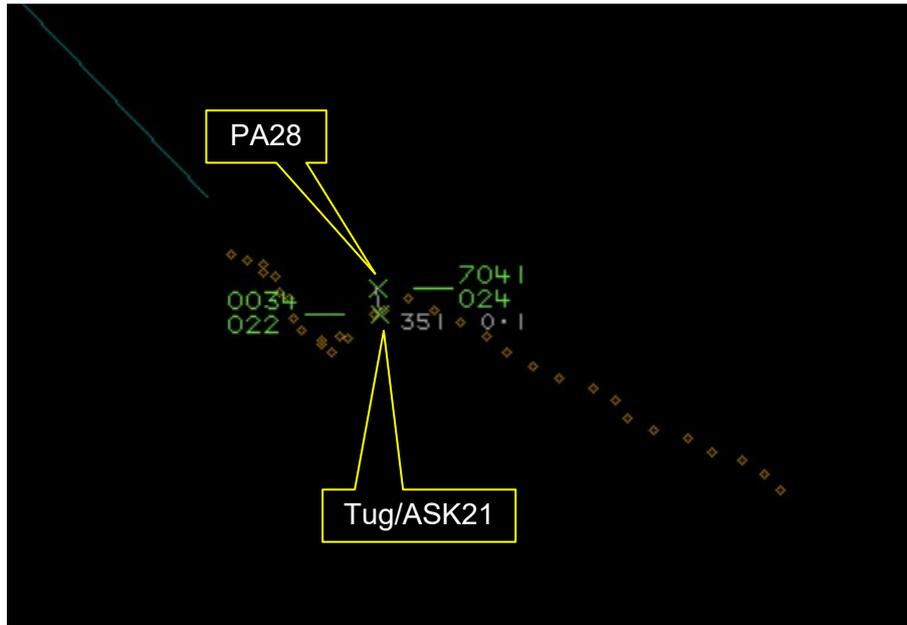
Figure 1 - CPA: 1130:58 200ft V/0.1NM H

The ASK21 and PA28 pilots shared an equal responsibility for collision avoidance and not to operate in such proximity to other aircraft as to create a collision hazard.² If the incident geometry is considered as converging then the PA28 pilot was required to give way to the ASK21.³

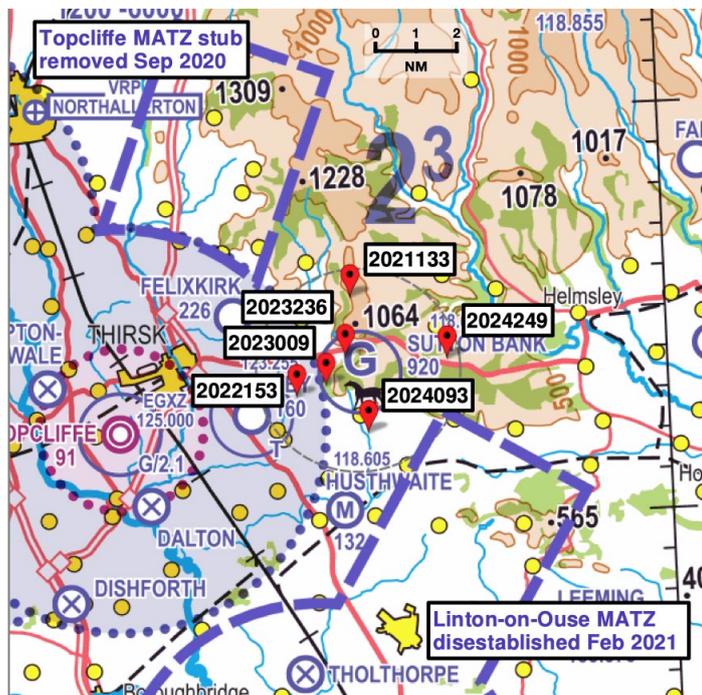
Before February 2021, pilots transiting north or south through this area who wished to remain laterally clear of MATZs would have routed well to the east of Sutton Bank, thus avoiding this area of intense gliding activity. However, since February 2021 transit traffic laterally avoiding the remaining MATZs could instead be funnelled close to Sutton Bank airfield, whose western extremity is only 0.9NM from the current RAF Topcliffe MATZ boundary.

This new Airprox cluster near this busy gliding site is a significant cause for concern.

Figure 2: Non-military Airprox near Sutton Bank between February 2021 and October 2024
