AIRPROX REPORT No 2024250

Date: 29 Sep 2024 Time: 1156Z Position: 5109N 00102W Location: 2NM S Lasham

PART A: SUMMARY OF INFORMATION REPORTED TO UKAB

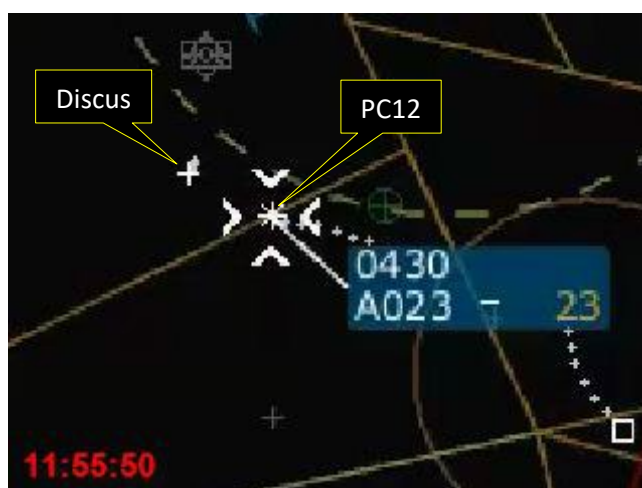
Figure 1 – Aircraft positions at 1155:50

At 1155:50, the RT exchange with [an uninvolved pilot] ended with the Farnborough controller immediately providing the pilot of [the PC12] with Traffic Information of; *“pop up traffic, twelve o’clock, range of a mile, no height or type, possible a glider.”* This was acknowledged by the pilot as *“[PC12 c/s], looking.”* (Figure 1).

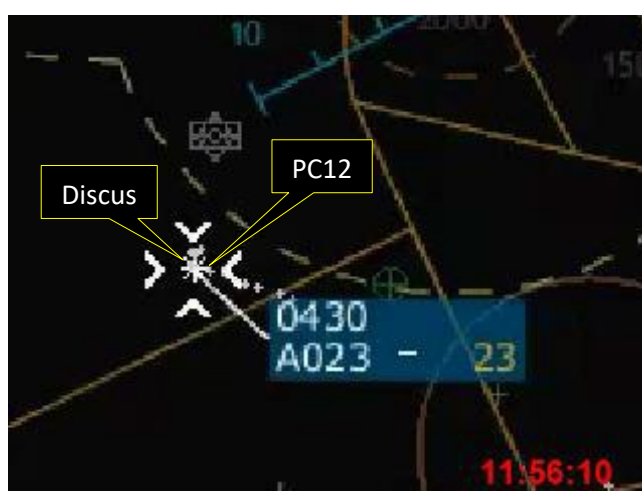
Figure 2 – Aircraft positions at 1156:10

The primary contact and [the PC12] appeared to laterally merge at 1156:10, which was considered to be the Closest Point of Approach with no vertical data available from the primary contact aircraft (Figure 2).

The primary contact disappeared from radar after the two returns passed.

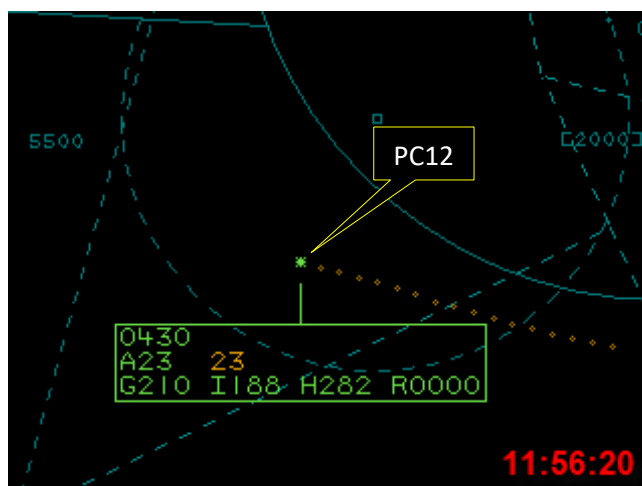
Figure 3 – 1156:20 (16sec after CPA)

Review of multitrack radar displayed that [the pilot of the PC12] did not deviate from their track (primary contact not displayed on radar) (Figure 3).
