AIRPROX REPORT No 2024241

Date: 23 Sep 2024 Time: 1107Z Position: 5536N 00213E Location: 11NM NNE GOTGO

PART A: SUMMARY OF INFORMATION REPORTED TO UKAB

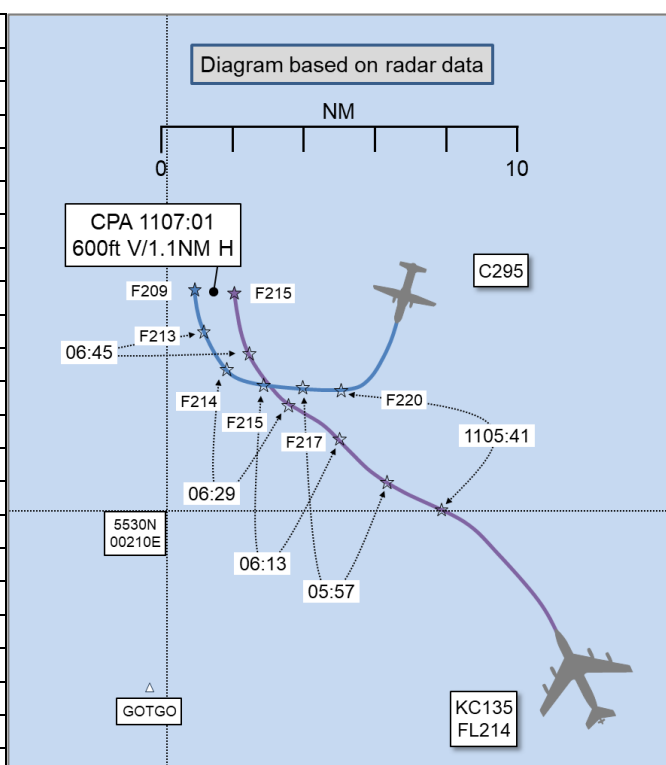
Recorded	Aircraft 1	Aircraft 2
Aircraft	CASA 295	KC135
Operator	Foreign Mil	Foreign Mil
Airspace	Scottish UIR	Scottish UIR
Class	C	C
Rules	IFR	IFR
Service	Deconfliction	Traffic
Provider	Swanwick(Mil)	Boulmer
Altitude/FL	FL209	FL215
Transponder	A, C, S+	A, C, S
Reported		
Colours	Grey	Grey
Lighting	Nav, beacon	Nav
Conditions	IMC	VMC
Visibility	<5km	5-10km
Altitude/FL	FL220	21,000ft
Altimeter	SPS	QNH (999hPa)
Heading	270°	270°
Speed	252kt	NK
ACAS/TAS	TCAS II	TCAS II
Alert	RA (Descend)	Information
Separation at CPA		
Reported	600ft V/3NM H	0ft V/<2NM H
Recorded	600ft V/1.1NM H

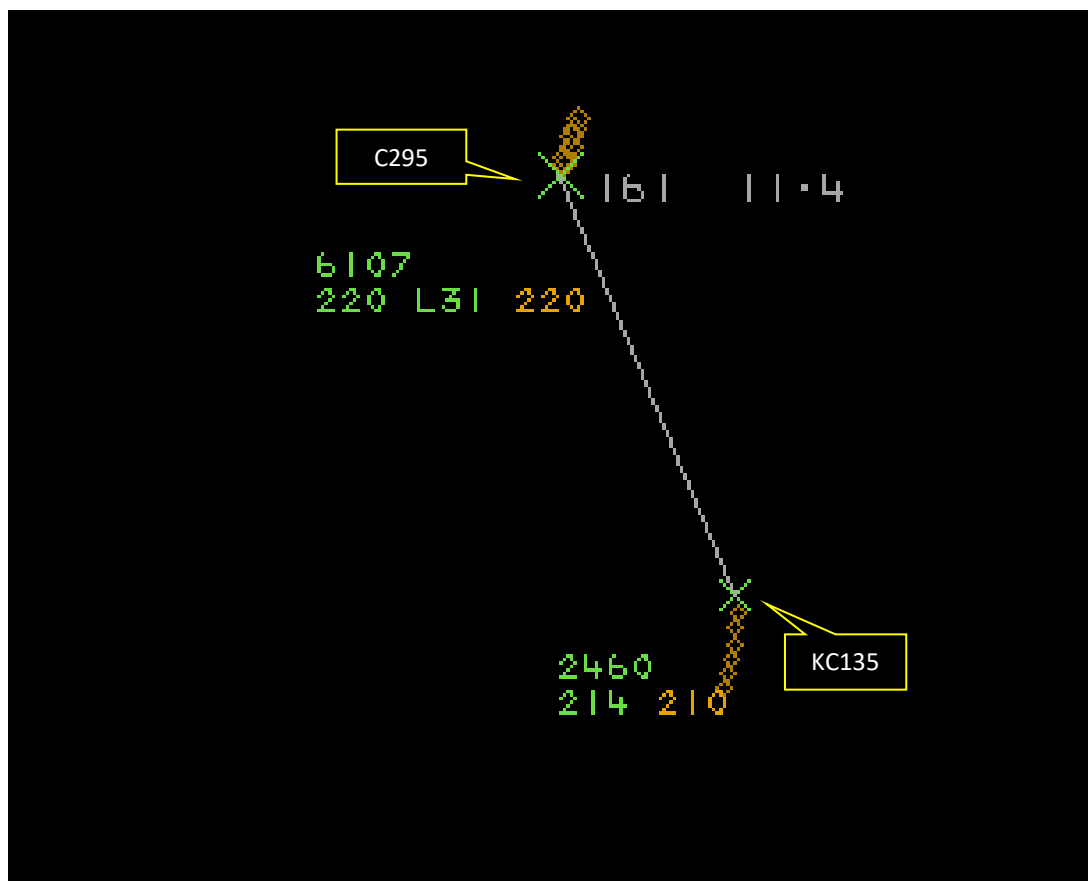
Figure 3 (1104:45). KC135 commencing left-hand turn.

At 1104:24, the Swanwick Military Trainer instructed the C295 [pilot] to descend to FL180, which the C295 [pilot] acknowledged. At 1104:44 the Swanwick Military Trainer, observing the left-hand turn of the KC135, issued an avoiding action for the C295 [pilot] in addition to the descent “*avoiding action turn right heading 270 degrees, traffic was southwest 10 miles manoeuvring indicating 600 feet below.*” Following a request to repeat the heading the C295 [pilot] acknowledged the heading change. Also observing the left-hand turn of the KC135, the CRC Boulmer controller instructed the KC135 [pilot] to remain in formation with their refuelling receiver aircraft. The KC135 had no receiver aircraft in formation, however a legacy aircraft’s data block had remained attached to the KC135 which resulted in it presenting as if refuelling was ongoing. The KC135 [pilot] requested the instruction to be repeated, however, at 1104:58, the CRC Boulmer controller attempted to issue a turn to the KC135 [pilot] but incorrectly used another callsign in use with another KC135 on frequency.
