**AIRPROX REPORT No 2024251**

Date: 03 Oct 2024 Time: 1155Z Position: 5154N 00210W Location: Gloucestershire Airport

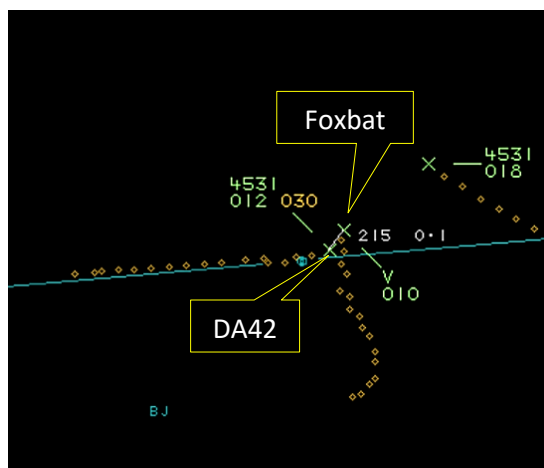
An analysis of the NATS radar replay was undertaken and both aircraft were positively identified. CPA was assessed to have occurred at 1155:23 with 200ft vertical and 0.1NM lateral separation (Figure 1). The Foxbat's track was verified by aircraft navigation equipment GPS data supplied by the pilot.

Figure 1. Time 1155:23 CPA 0.1NM and 200ft separation.
