**AIRPROX REPORT No 2024253**

Date: 05 Oct 2023 Time: ~0923Z Position: 5139N 00020W Location: Elstree ATZ

**PART A: SUMMARY OF INFORMATION REPORTED TO UKAB**

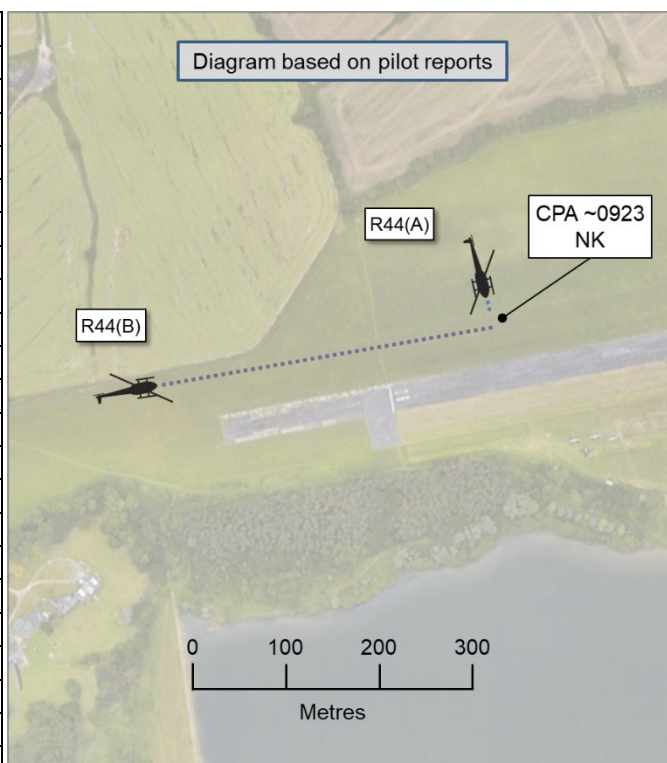
An analysis of the NATS radar replay was undertaken and both aircraft could be positively identified from Mode S data. However, neither aircraft appeared on the replay at the reported time of the Airprox and were assessed to have been below radar cover at CPA. The diagram was constructed by reference to the pilot's narrative reports. The aircraft tracks are shown as dotted lines to indicate their approximate positions. The separation at CPA could not be determined.

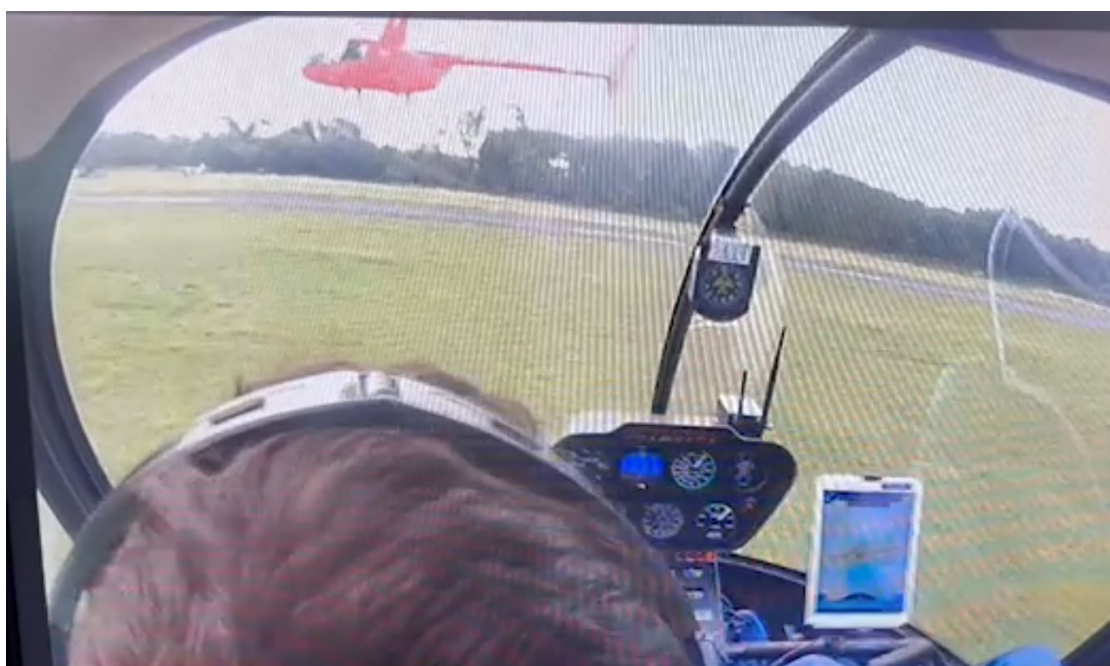
The [instructor in the other helicopter] was with a student on final approach to the north-side grass but decided to fly low, right in front of them and close to the runway in use. [The pilot of R44(A)] had to immediately take control to avoid a collision as they were moving slowly towards the [R44(B)] as it passed in front of them. They have video evidence from their on-board camera.

Figure 1 – A frame taken from the in-cockpit camera fitted to R44(A)
