AIRPROX REPORT No 2024254

Date: 05 Oct 2024 Time: 1404Z Position: 5213N 00137W Location: Wellesbourne RW18 Final

PART A: SUMMARY OF INFORMATION REPORTED TO UKAB

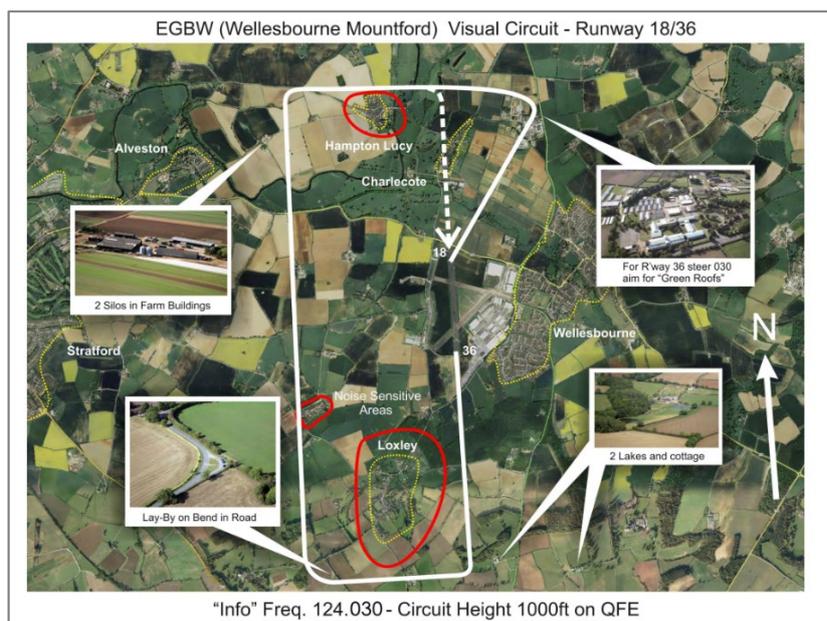
Figure 1 Wellesbourne circuit pattern RW18

RWY 18 & 23 RHC (See diagram below)

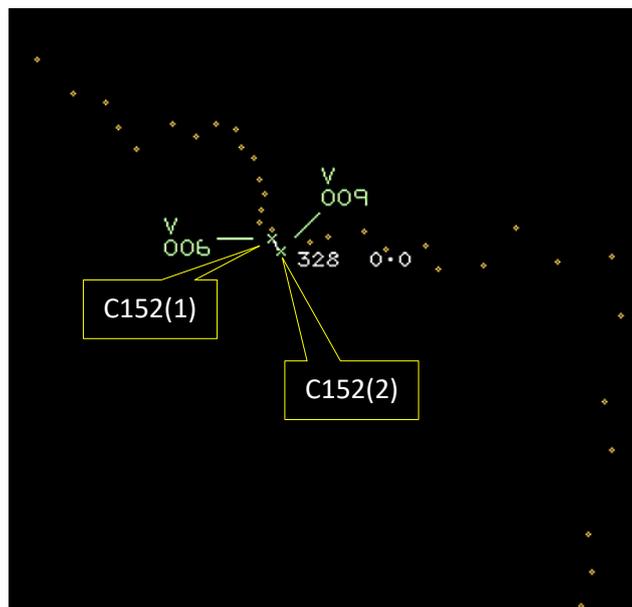
An analysis of the NATS radar replay was undertaken and both aircraft were positively identified using Mode S data. CPA was assessed as being at 1403:54 with 300ft vertical and less than 0.1NM lateral separation.

Figure 2 Time 1403:54 CPA separation 300ft vertically and less than 0.1NM horizontally.
